# Rapid Update 686

## Grecale – Bowden cable Connection Check

DATE: DECEMBER 15 2023

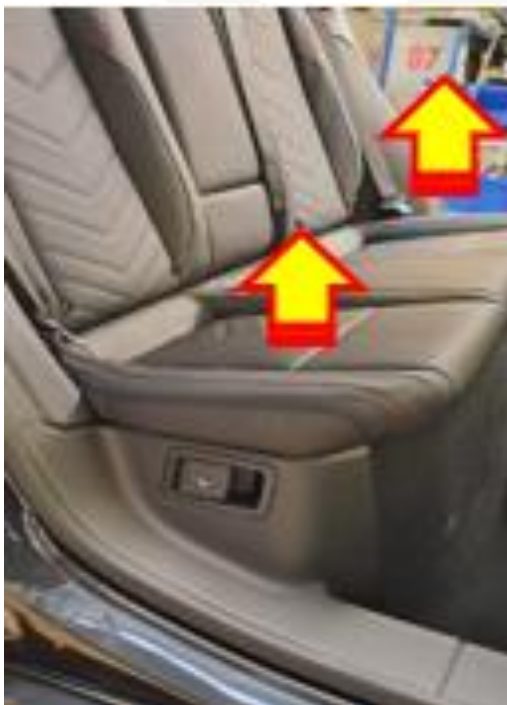
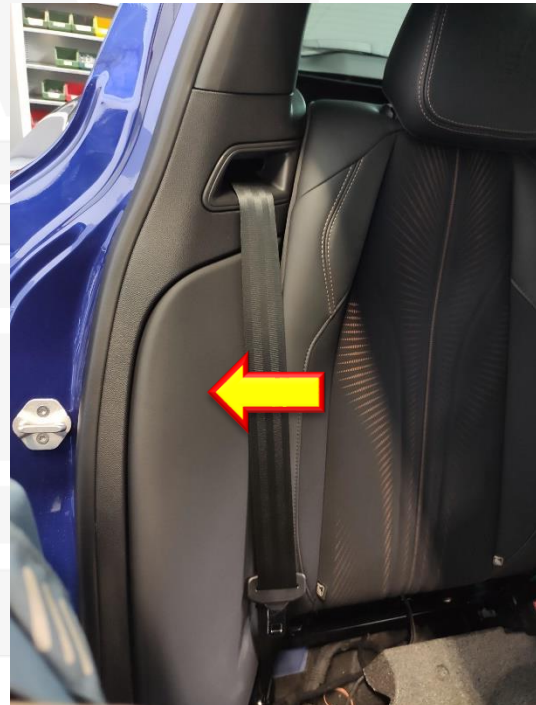
- **OK ►** Both left and right side backrest release handles operate correctly. No further action needed. Release the vehicle.
  - **NOT OK ►** The release handle on either or both the left and right sides is not functioning as expected when attempting to fold down the backrest. Proceed to **step 6**.
6. Remove the rear cushion following the procedure given in the workshop manual:
    - **09.42.006 REAR SEAT - Removal and Refitting**
  7. Remove the side pillar trim:
    - **9.44.226 FINISHING RH LOWER REAR A PILLAR COVERING Removal-Refitting /Replacement**

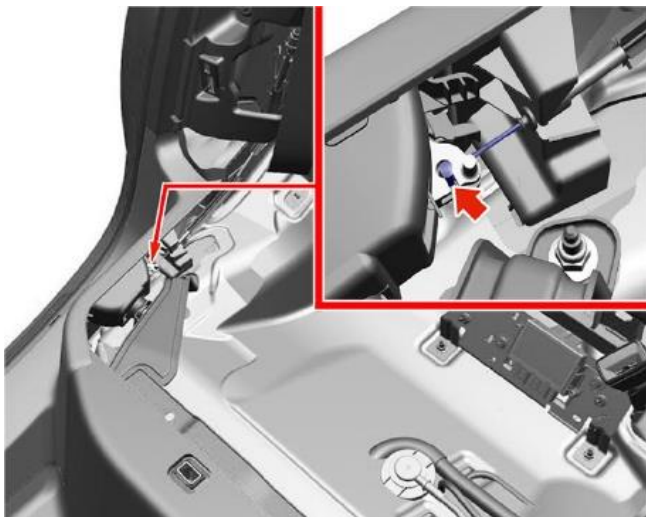
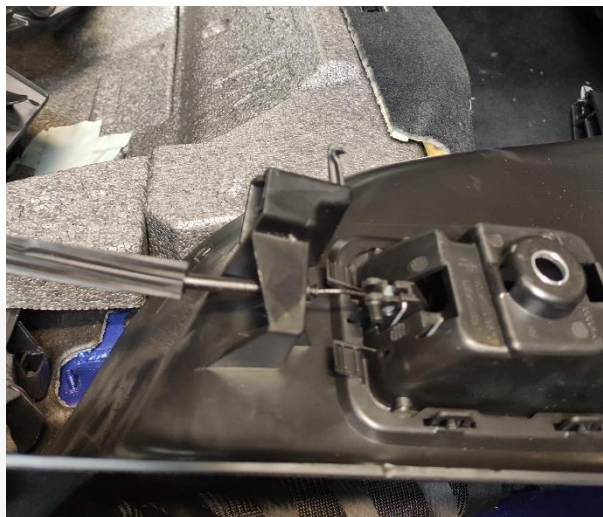
On some vehicles, it is necessary to verify that the release cable, used to fold down the backrest of the rear seats, is correctly connected to the release handle. If the cable is not properly attached, customers may have trouble releasing the backrest to fold down.

11. Locate the Bowden cable and the retaining clip on the handle.

12. Restore the correct connection on the bracket.

13. Restore any components removed by following the procedure in reverse order.
