FROM: Maserati TSO

## Rapid Update 695 Grecale – Steering wheel switch noise

DATE: DECEMBER 18 2023

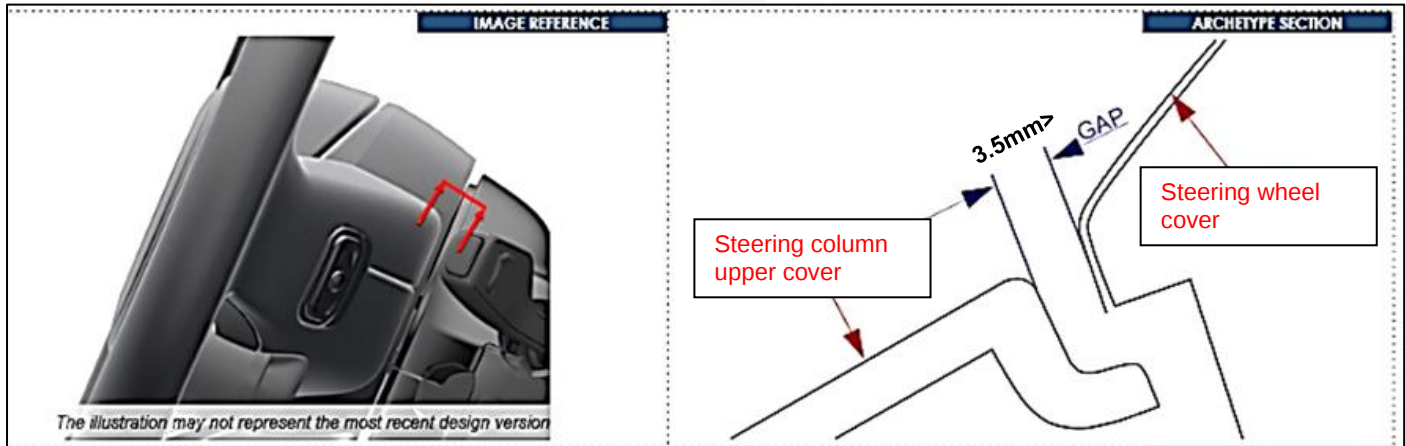
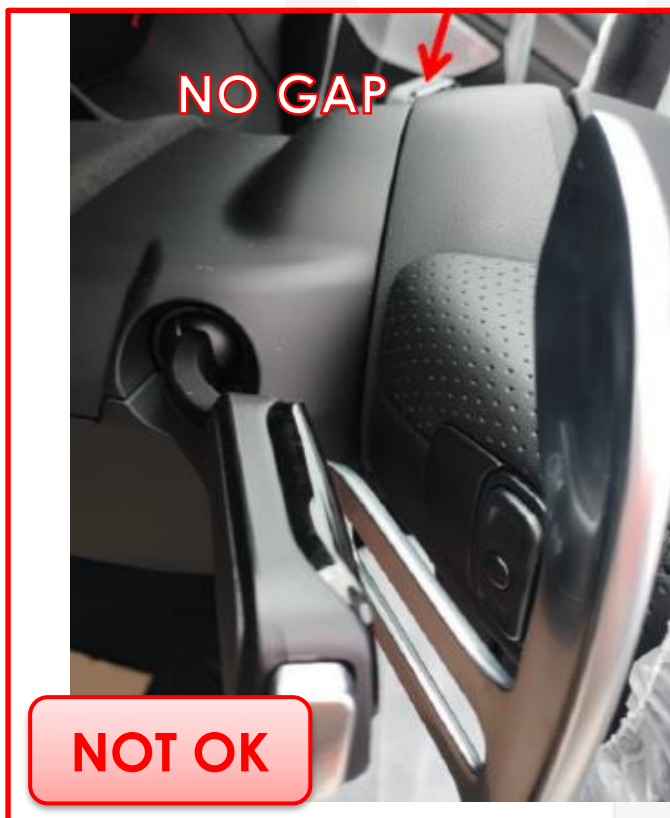
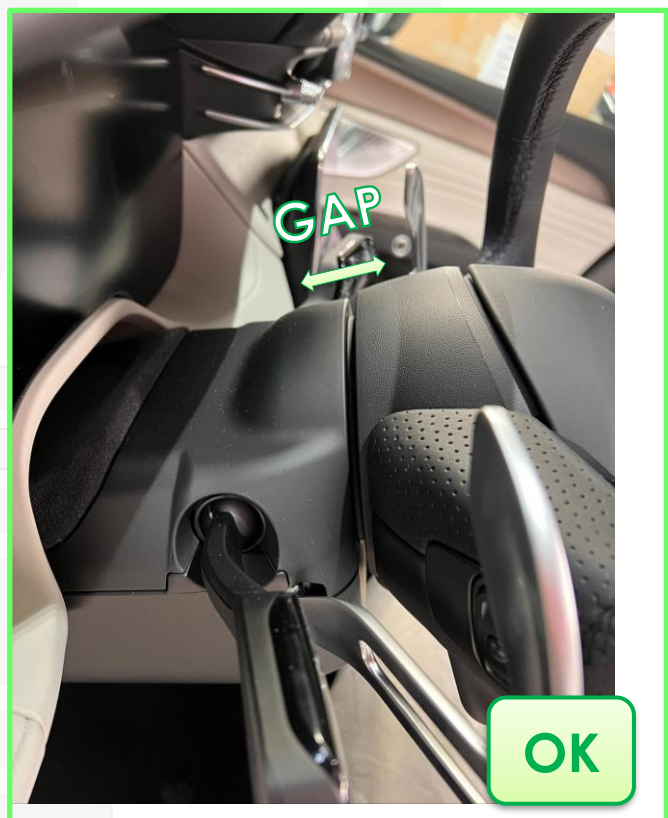
1. Always check ModisCS+ to see if the vehicle is involved in this action and if it has not been previously performed.
2. First, **rotate the steering wheel lock to lock at least 5 times** completing the entire turn, both all the way to the right and to the left to check that there are no excessive sliding noises.
3. Inspect the gap clearance between the steering wheel cover and the column cover as illustrated in the photos below visually and using a measurement tool (e.g. Digital caliper).

## 4. INSPECTION RESULTS:

- **OK** ► gap is **greater than 3.5 mm**> the component is **OK**. No further action is needed. Release the vehicle.
- **NOT OK** ► gap is **less than 3.5 mm**< or even absent (see above photo). Replace the Complete Steering Column following the instructions in the workshop manual:
  - Section 05.00 – 1 (05.00.001 COMPLETE STEERING COLUMN - Removal-Refitting or Replacement)
