Preliminary Information

PIT5359D Radio Back Lighting Stays on After Key Off / Dead Battery / TCCM Repeat Failure

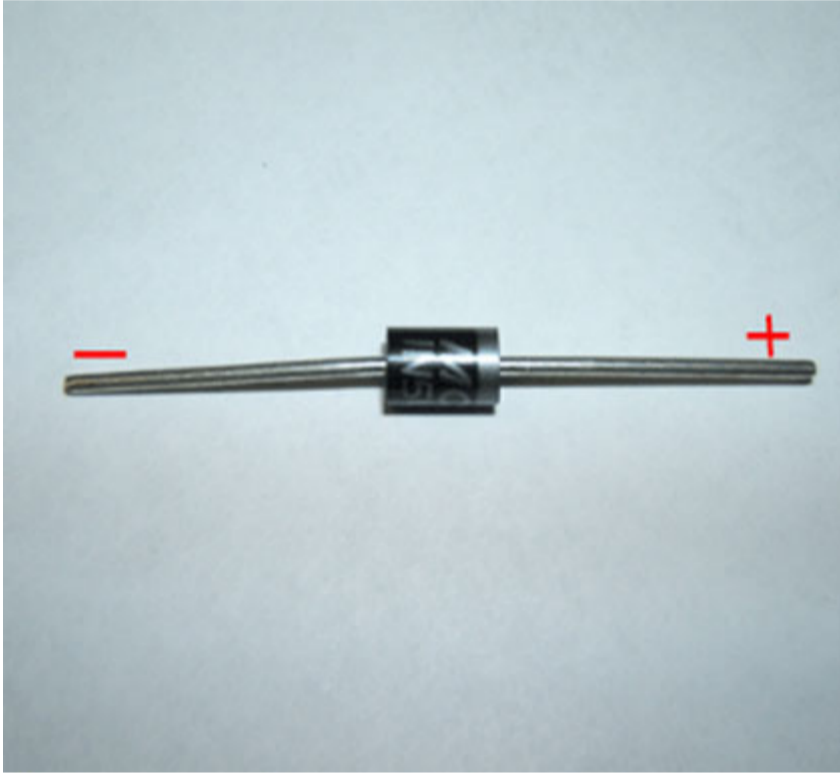
To prevent damage to any of the sensitive electronic components on the bussed circuit, the solenoid/relay **MUST** have the control circuit suppressed with a diode. The diode will prevent the voltage spikes from being transmitted onto the Run/Crank circuit.

Install a diode, P/N 12112422, across the coil of the solenoid. It is important that the striped end of the diode be connected to the positive terminal of the coil and the other end of the diode be connected to ground.
