Bulletin No.: PIC6526A  
Published date: 12/7/2023

## PIC6526A Service High Voltage with Reduced Propulsion and Battery Light Illuminated

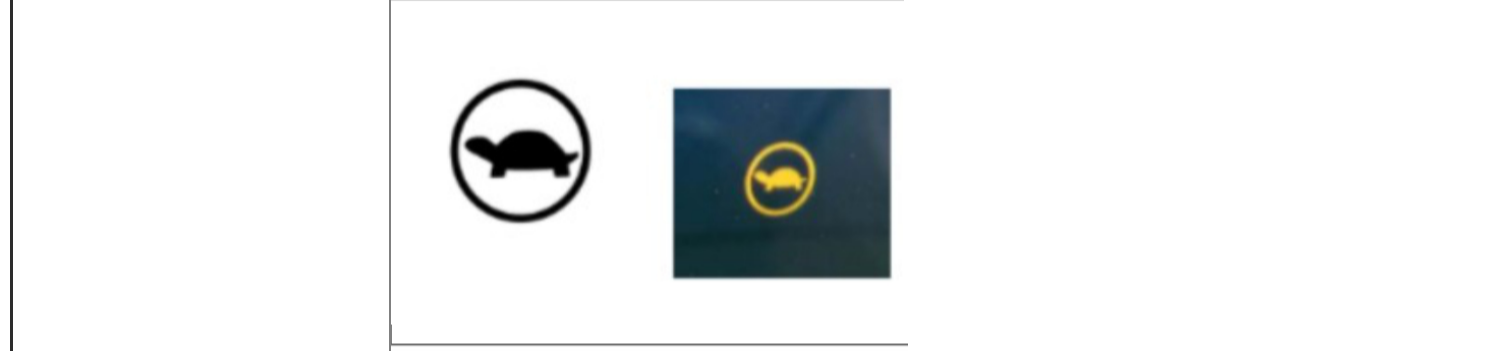
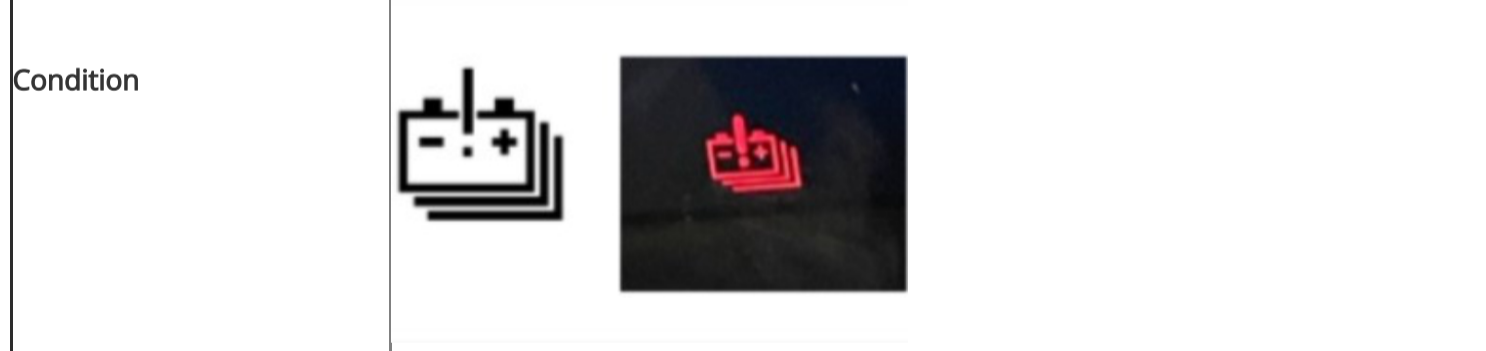
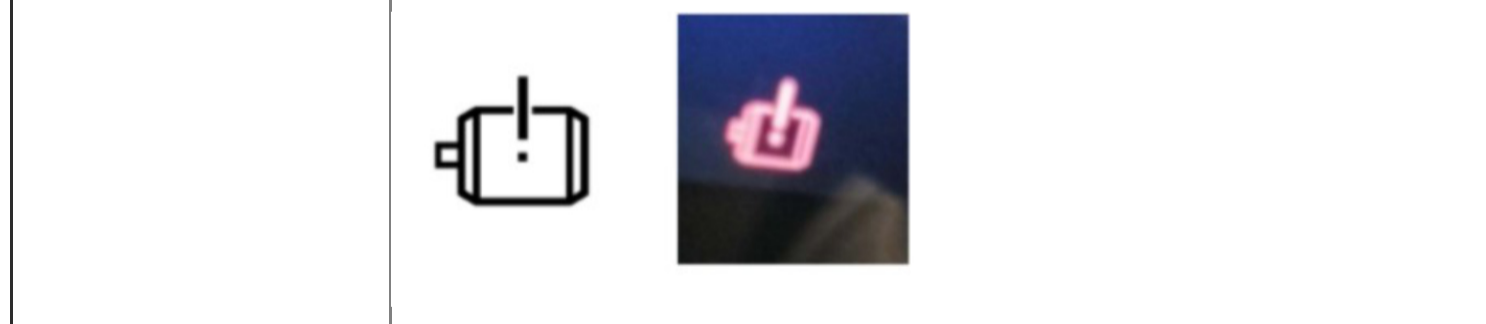
Some customers may see a Service High Voltage message with the battery icon and reduced propulsion light illuminated.

Cause: A11 Radio calibration.

The technician will need to USB update the A11 radio followed with a radio reprogramming in SPS2.

Please follow SI document ID 6442935 for programming procedure.
