Preliminary Information

PIT5386J Back Up Alarm Inoperative and needs to be Connected During PDI

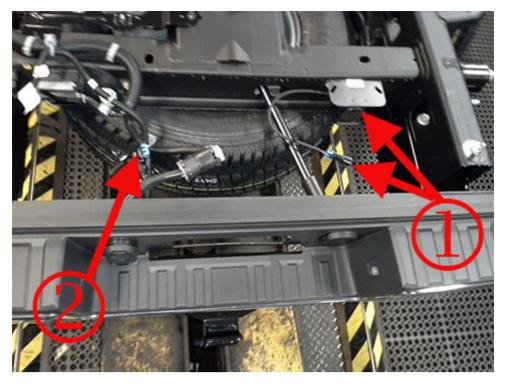
During the PDI it may be noticed that the backup alarm is inoperative. Trucks equipped with the Back Up Alarm (RPO 8S3), the alarm will be intentionally left disconnected from the assembly plant.

- 1. Back Up Alarm/Connector
- 2. Chassis Harness Alarm Connector

- For 2020 and later 3500 Chassis Cab models (31003, 31043, and 31403) the back up alarm is not installed on the truck's frame and it has been left loose inside the cab from the assembly plant. It is the upfitters responsibility to mount the back up alarm and splice into the reverse circuit. The labor op listed below does not apply to these vehicles because no additional work is needed during PDI. Refer to the latest revision of UI Bulletin 175 (https://www.gmupfitter.com/technical-bulletins/) for more information
- For All Other Trucks, the alarm is located on the right rear of the frame, and the chassis harness alarm connector is located on the left rear of the frame. Route the harness up and over the spare tire hoist tube and connect to the backup alarm.
