**Volvo Car USA LLC****Technical Journal**

Technical Journal Title		Ref. No.	
P5(SPA)/P6(CMA) Software Download Guide		TJ 31543.9.4	
Issuer (Dept.)		Issue Date	Status Date
Technical Service		11/30/23	11/30/23
Car Market	Partner	Function Group	
United States and Canada	3 US 7510 Volvo Car USA	3018	
Function Description		Page	
Software		Page 1 of 3

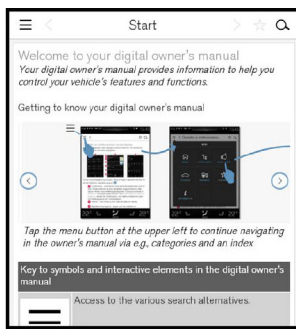
Before Courtesy Upgrade

- Courtesy Upgrade C10006, 31483274, then 31483275, see TJ 30991
- QB 39816: 31483300 (XC90), 31682450 (S90/V90/V90CC)
- QB R89702: 31483292 (Panoramic Sun Roof Switch SW)
- QB 39820: 31678916 (T8 ERS)
- QB 39835: 31483292 (XC90), 31654144 (S90/V90/V90CC) (VCM)
- DTC IHU-U130B87 (LIN BUS #19) may be present after an Upgrade and can be ignored.
- Some functions, such as the climate system, may not resume normal operation until the car has been locked for 15 minutes.

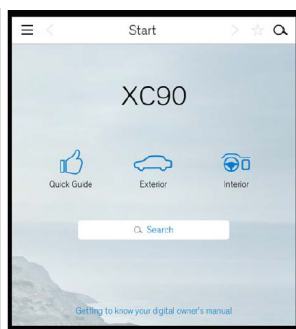
After Courtesy Upgrade
