Volvo Car USA LLC

Technical Journal

Technical Journal Title SiriusXM not Available		Ref. No. TJ 36771.1.2	
Issuer (Dept.) Technical Service		Issue Date 11/1/23	Status Date 11/30/23
Car Market United States and Canada	Partner 3 US 7510 Volvo Car USA	Function Group 3957	
Function Description Radio Tuner Module		Page Page 1 of 4

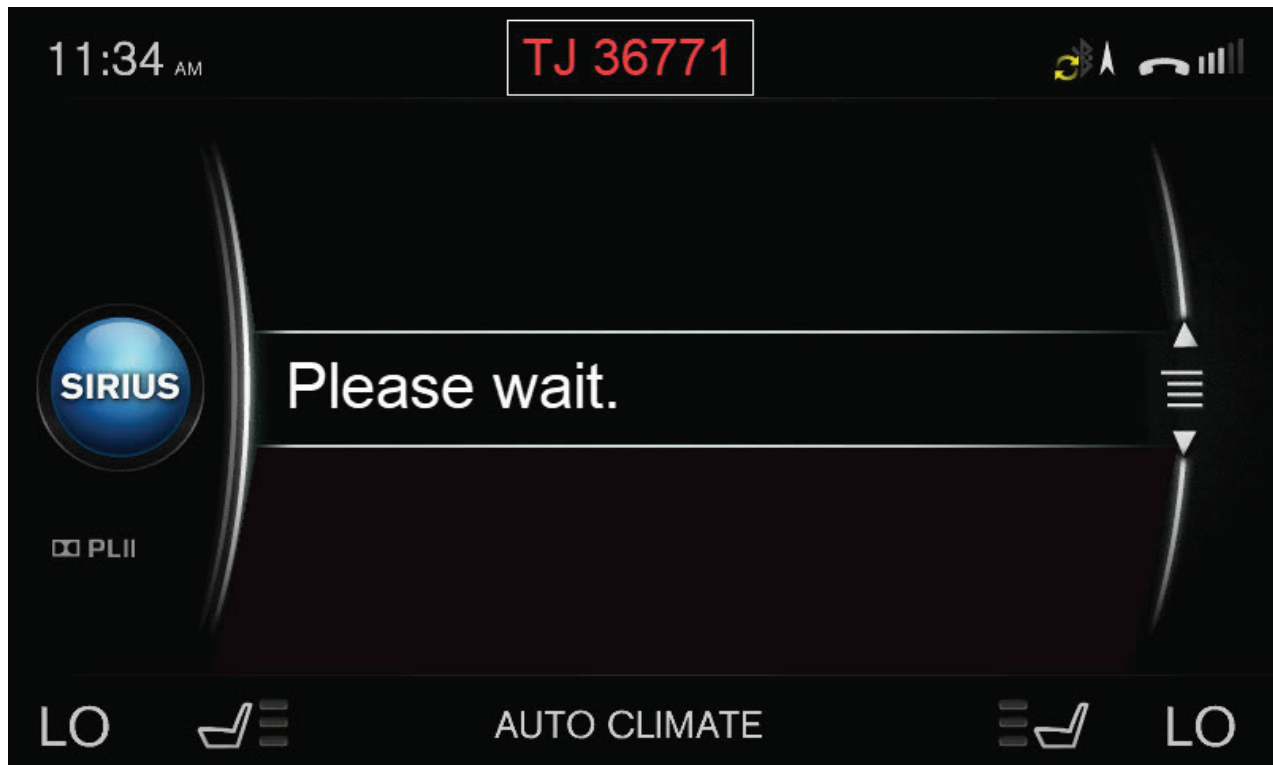
- At startup, the Sirius screen will initially say "Please wait." (attachment TJ36771_1)
- After several moments, the screen will say "Sirius unavailable" (attachment TJ36771_2)
- In the SiriusID menu/screen, the Sirius ID will be blank (attachment TJ36771_3)

*2) In the VIDA *Network* screen, check if the RDAR is *Not Responding*. If it is, power down the unit by removing RDAR (16/145) connector "C1" OR by removing fuse F1 (40 Amp) from the passenger compartment fuse panel (15/36) for 5+ minutes to recover it before proceeding.

3) Perform an update of the RDAR (Sirius Tuner Module) by downloading an RDAR upgrade with VIDA.
