**Dealer  
Service  
Bulletin**

**NO.:** 7SB007-24-01A

**AFFECTED:** 2024 Revel and Solis T36B

**SUBJECT:** EcoFlow Power Hub Pro

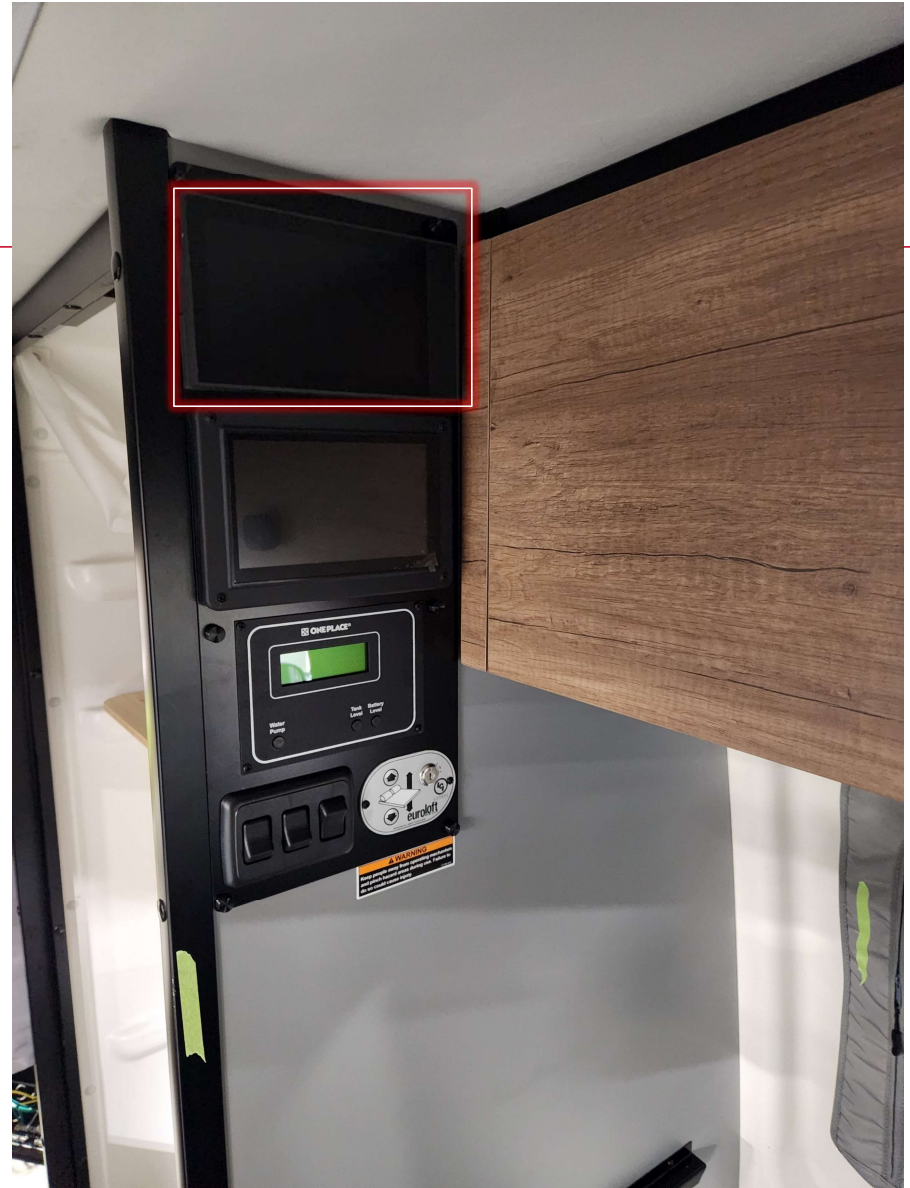
## REVEL B44E

Console screen located on the Front facing bath wall, top screen.

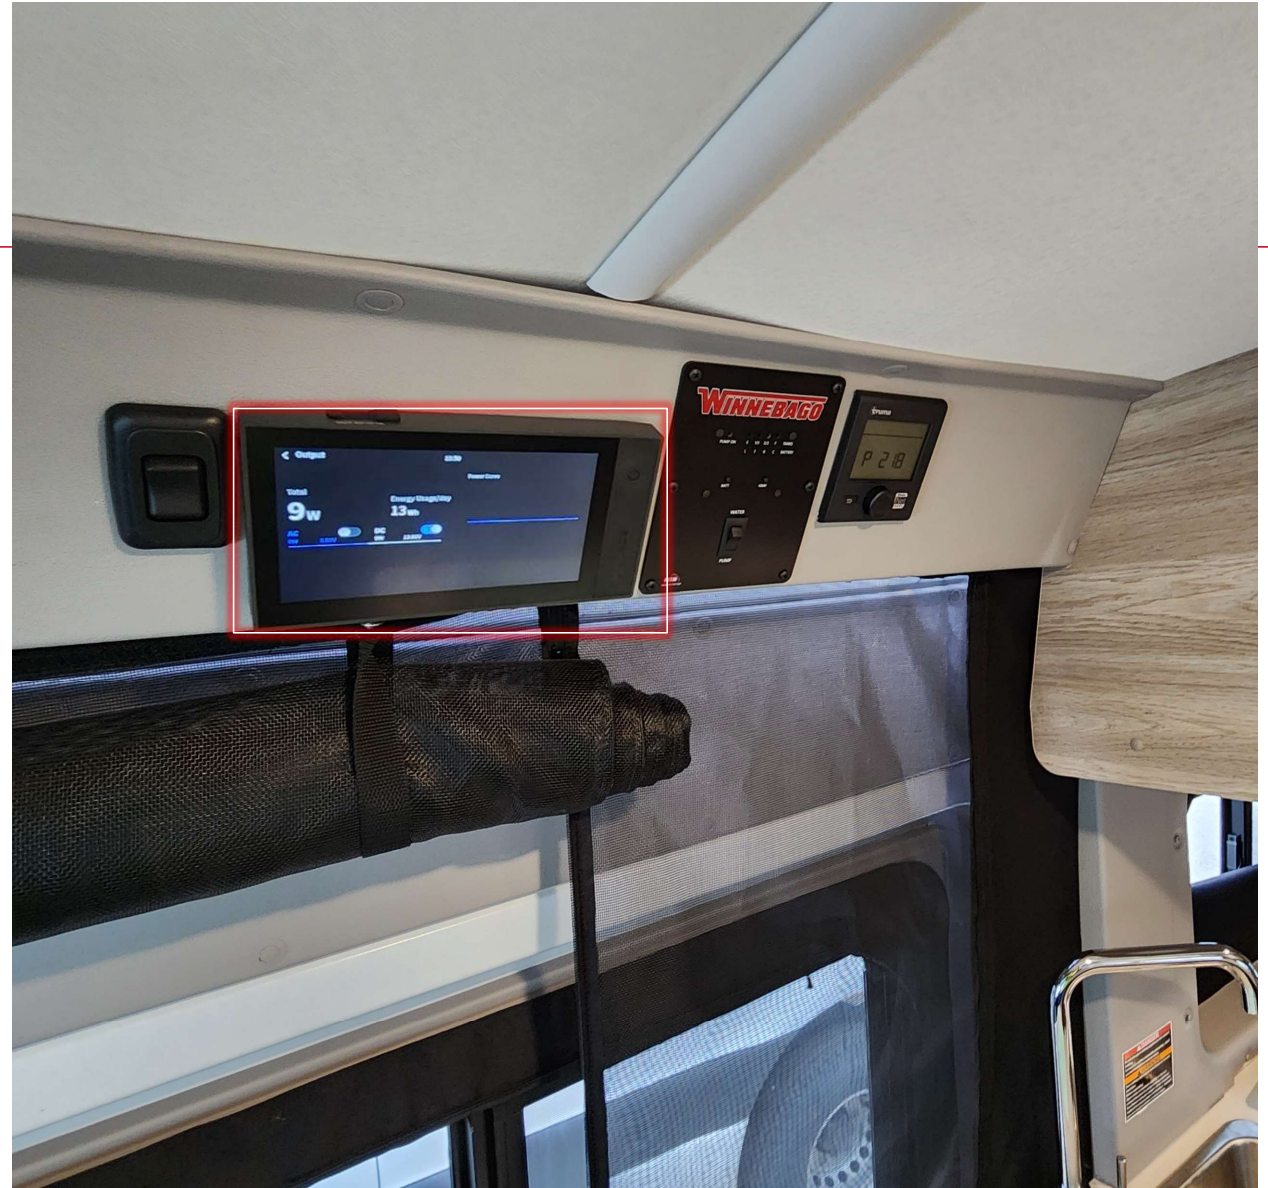
## SOLIS T36B

Console screen located on the panel above the side door.

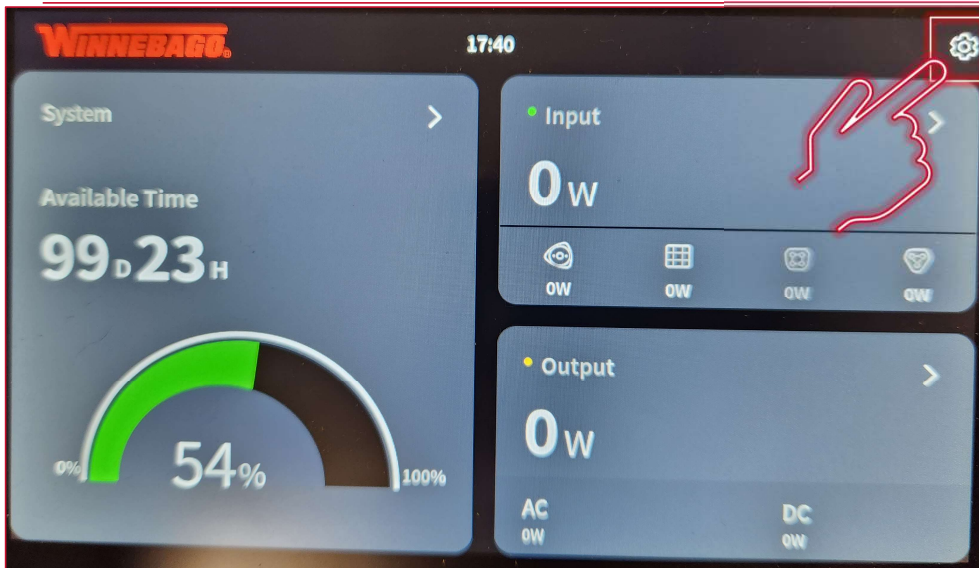
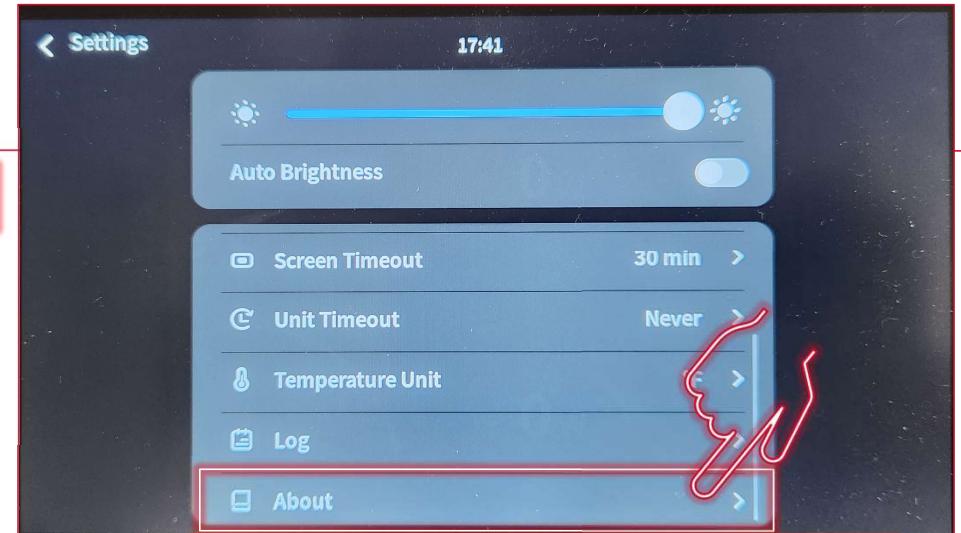
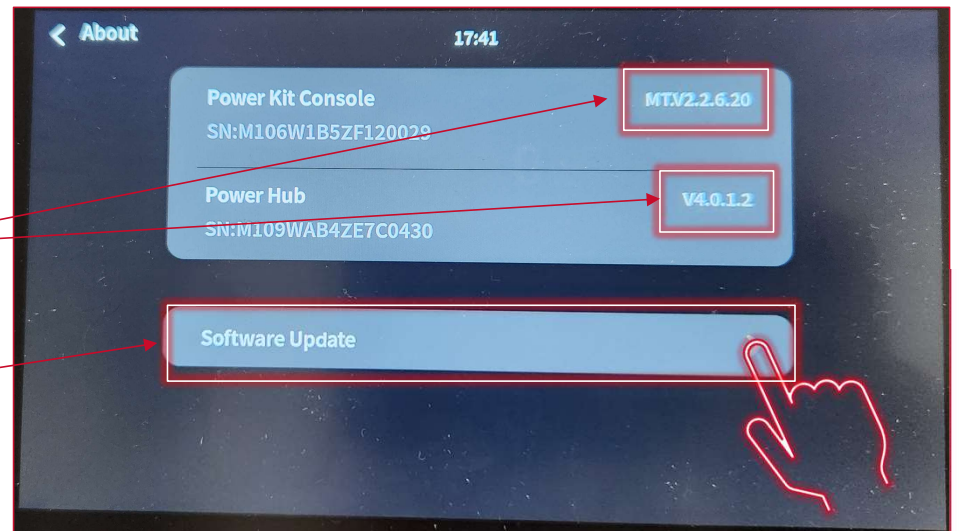
# SETTINGS -> SOFTWARE UPDATE

Check Firmware Versions here

Update Firmware here

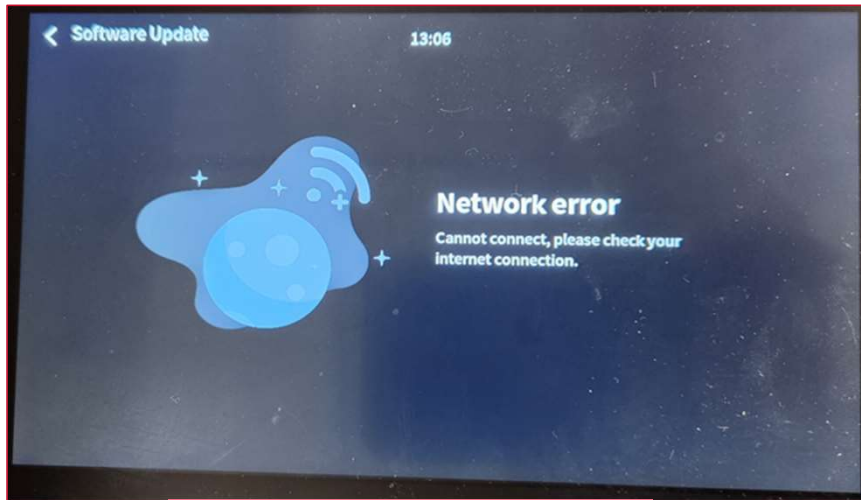
## ALTERNATIVE CASES

WiFi connection is not good.  
OR  
Try waiting a few minutes if you  
have recently connected to WiFi

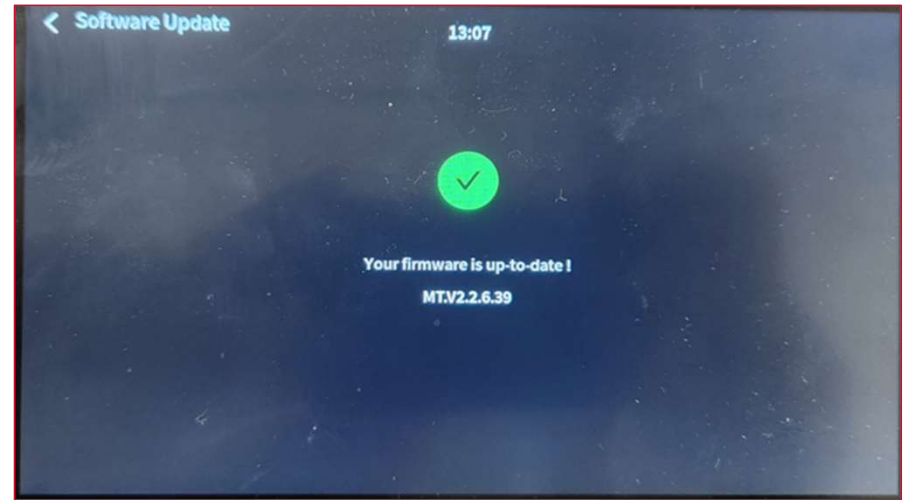
No Update is available
