Service Bulletin

Bulletin No.: 02-08-42-001J

Subject: Headlamp, Tail Lamp, License Lamp, or Fog/Driving Lamp Damage

Models: 2024 and Prior GM Passenger Cars and Trucks

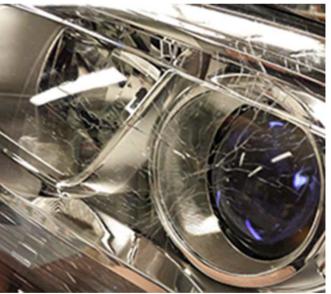
4418057

The headlamps above show glazing caused by spray-on vehicle cleaner.

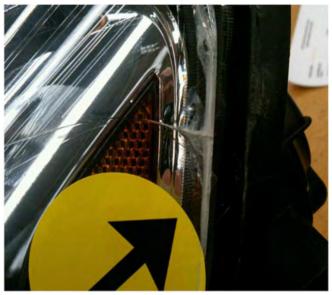
2650225

This lamp shows some effects of chemical damage. Notice the milky color along the edge and the fracture. This was caused by a solvent used to prep the body for pin striping.

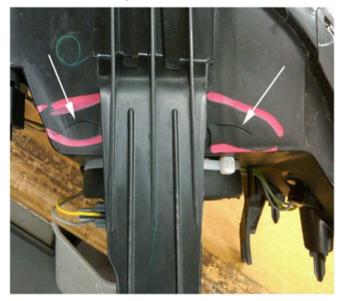
2650230

This housing is cracked across the top of the housing just below the mounting tab. Not shown is the dent at the upper edge of the lens where it impacted an object.

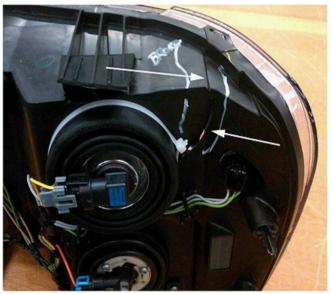
2650242

This housing shows a broken upper mounting tab and a fracture in the rear housing. This lamp had no visible marks on the lens.

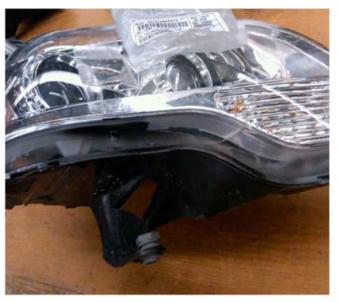
2650250

This lamp shows paint over spray along the lower edge where it would marry to the front fascia. The lower mounting tabs were also all fractured at the housing due to impact.

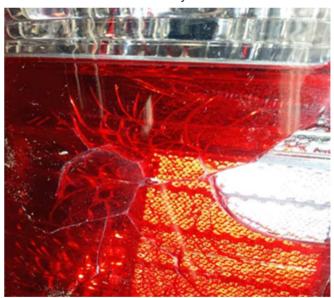
3806648

This lamp shows impact damage and internal cracking of the lens.

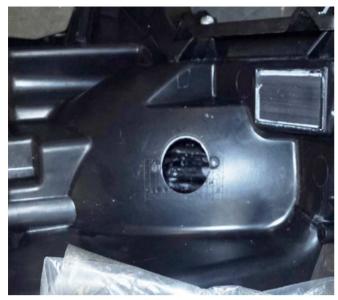
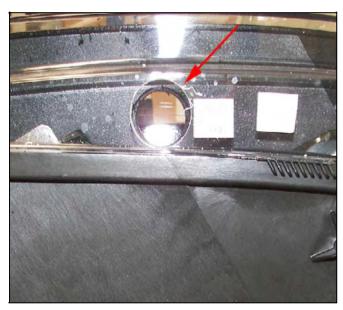
4384919

The above graphics show a hole which was drilled in the headlamp housing to accept an accessory modification and a LED insert for police applications. These parts are not covered by warranty.

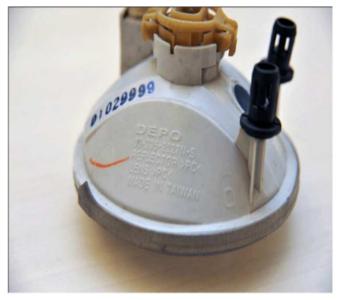
2650251

This fog lamp was returned for retaining moisture. As you can see it is marked with the Depo brand (it is also called out on the front lens).

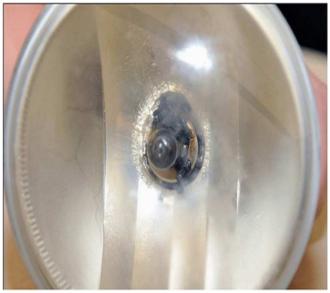
Another trend being seen is the installation of bulbs that have a higher output than the original equipment. Because the bulb output is higher, the operating temperature is also higher. This excessive heat can melt the socket, housing, or lens. Because these bulbs burn hotter and brighter, they also have a reduced service life. These bulbs are different in appearance

than the original equipment. Some have blue tint on the bulb and others are clear. If in doubt, the bulb number should match the GM service part.
