This Service Information Bulletin (Revision 5) replaces SI B11 07 23 **dated November 2023**.

The return springs on the exhaust camshaft followers may break.

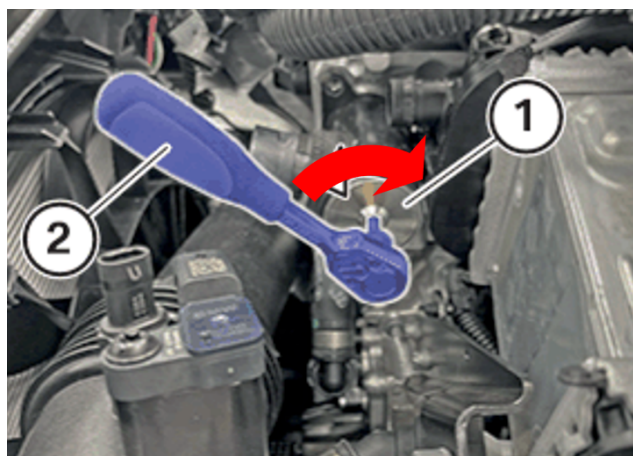
Cylinder 1 intermediate lever may interfere when trying to install the intake camshaft timing tools.

Place the VVT motor in minimum lift before installing the camshaft timing tools.

Use a 4 mm Allen socket (1) and a ratchet (2) to turn the VVT motor clockwise until it stops at the minimum lift end stop.

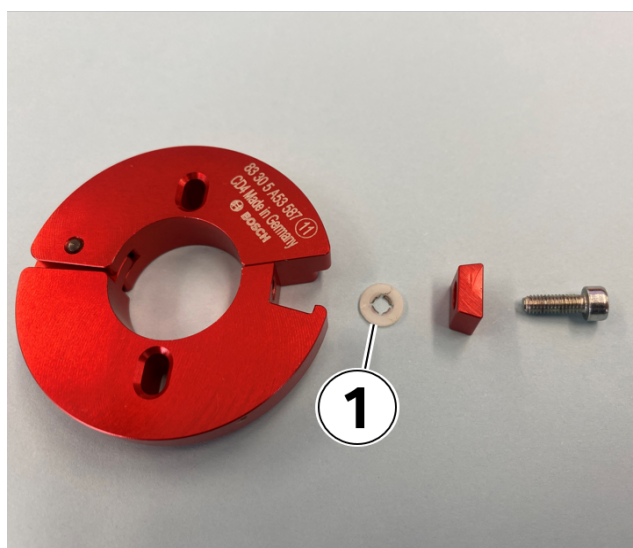
Tool 83 30 5 A53 587 may bind when removing it from both of the VANOS adjusters, the plastic washer (1) may be binding the tool and will not allow it to collapse when the screw is loosened.

Using a fine metal file, reduce the outside diameter of the plastic washer by approximately 1 mm to avoid this interference.

Removing the washer entirely could result in the screw and wedge falling into the engine, the washer avoids loosening the screw too much.

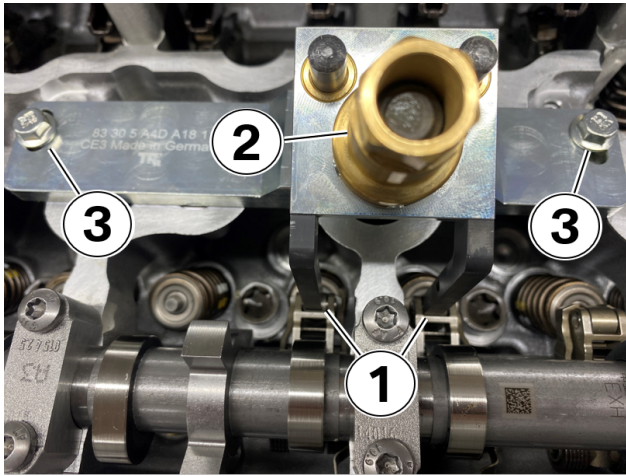
Special tool 83 30 5 A4D A18 must aligned properly with the rollers (1).

Turn the brass nut (2) to make contact with the rollers.

Tighten the screws on the base plate of the tool (3).

Finish compressing the springs with the brass nut (2).

The tool must remain installed during the entire camshaft removal and installation procedure.
