2024-01-04

This Service Information Bulletin (Revision 1) replaces SI B32 02 23 **dated August 2023**.

## MODEL

F90 (M5 Sedan)	F91 (M8 Convertible)	F92 (M8 Coupe)	F93 (M8 Gran Coupe)
F95 (X5 M Sports Activity Vehicle)	F96 (X6 M Sports Activity Coupe)	G05 (X5 Sports Activity Vehicle)	G06 (X6 Sports Activity Coupe)
G07 (X7 Sports Activity Vehicle)	G12 (7 Series Sedan)	G14 (8 Series Convertible)	G15 (8 Series Coupe)
G16 (8 Series Gran Coupe)	G30 (5 Series Sedan)	G32 (640i xDrive Gran Turismo)

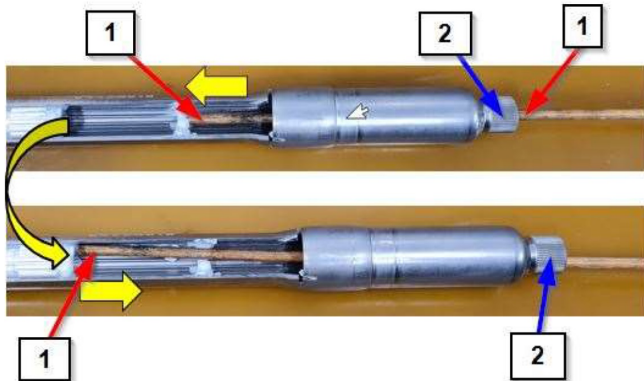
An excessively high break-away force of the spline shaft when starting the steering shaft movement causes a frictional vibration.

The high break-away force of the splined shaft (1) is caused by the inadequate distribution or the thickening of grease in certain areas of the splined shaft. Steering wheel shaft (2), steering wheel connection (3).

3. Through the opening of the steering wheel shaft (2), ensure the even distribution of grease in the internal gearing of the steering wheel shaft.

Insert a long thin object, such as a vacuum hose (1), minimum length 30cm, into the internal gearing of the steering wheel shaft and evenly distribute the grease. See attached video V32 05 23

In some cases, the grease may be located at the bottom of the shaft and will need to be pulled up to evenly distribute on the internal gearing of the steering wheel shaft.

**NOTE: Additional lubrication is not permitted**
