This Service Information Bulletin (Revision 2) replaces SI B51 10 22 **dated December 2023**.

E-Series	Model Description	Production Date
I20	iX Sports Activity Vehicle	From SOP (Start of production Nov. 2021) until 05/22/2022

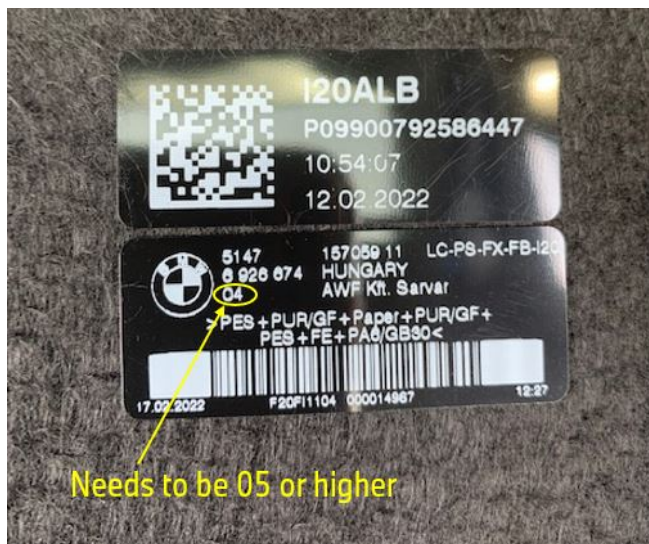
The AI (revision index) of the new part must be 06 or higher (circled).

1. Verify the customer's complaint.
2. If the noise is reproducible with the front parcel shelf installed, then the shelf will need to be replaced with part number **51 47 6 926 674**.
