2024-01-02

This Service Information Bulletin (Revision 03) replaces SI B52 06 23 **dated May 2023**.

**MODEL**

| E-Series | Model Description | Production Date |
|---|---|---|
| G06 | X6 Sports Activity Coupe | March 1, 2023 – March 7, 2023 |

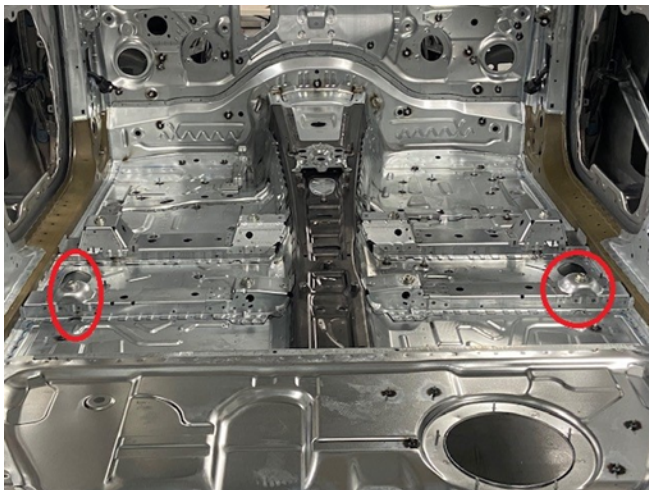
It was discovered that an indentation or crack on the driver and/or passenger seat crossmember rear outer dome (circled; viewed looking frontwards) can form.

**Note: The rear inner dome on both the driver and passenger seat crossmembers are not affected.**

A metal stamping error during production, on a small amount of the affected vehicles.

Inspect the driver's seat left rear (L/R) mounting dome as well as the front passenger's seat right rear (R/R) mounting dome for evidence of a metal crack or indentation as shown in the photos.

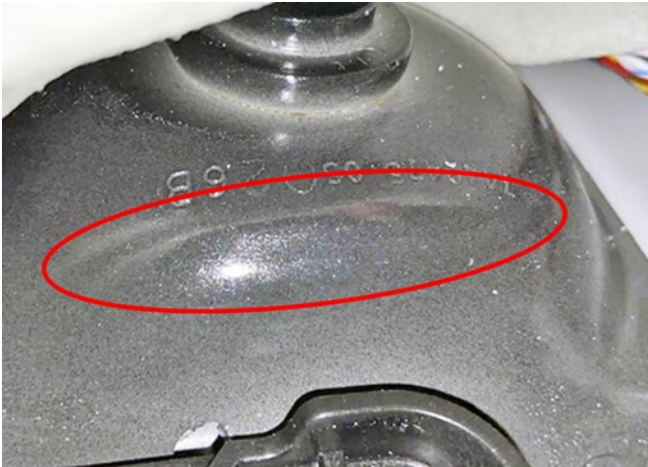
Not OK: Indent.

Go to Step 2.

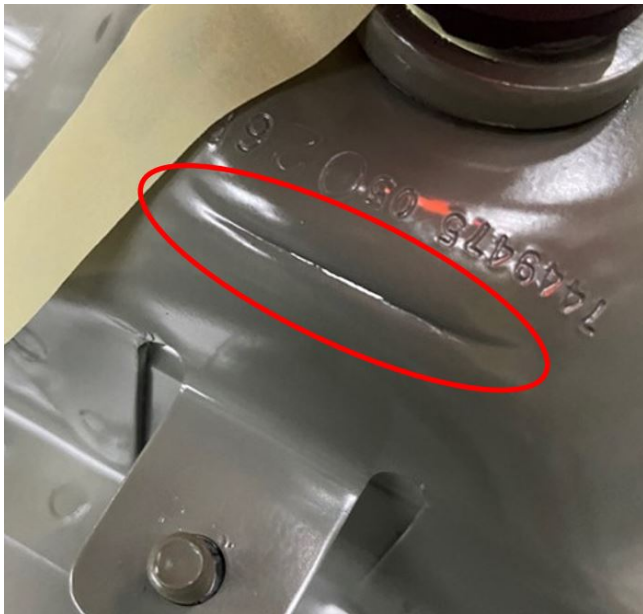
Not OK: Cracked/torn

Go to Step 2.

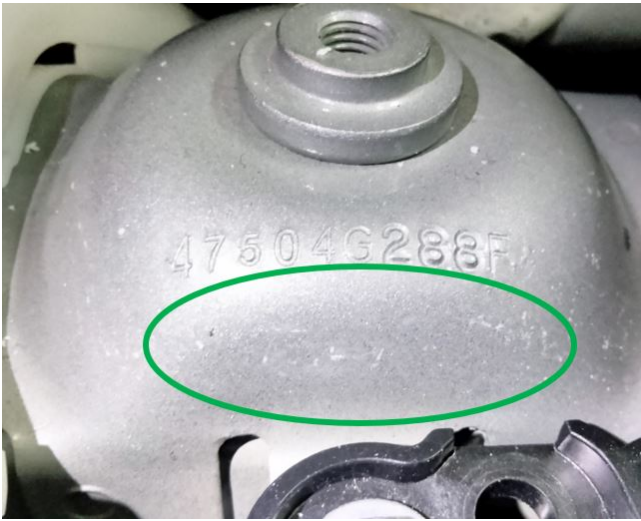
A “good” dome does not show any indications of an indent, nor of a crack/tear.

If both rear outer domes resemble this photo, go to Step 9.
