2024-01-08

This Service Information Bulletin (Revision 6) replaces SI B54 11 19 **dated March 2023**.

F95 (X5 M Sports Activity Vehicle)	F96 (X6 M Sports Activity Coupe)	F97 (X3 M Sports Activity Vehicle)	F98 (X4 M Sports Activity Coupe)
G01 (X3 Sports Activity Vehicle)	G02 (X4 Sports Activity Coupe)	X5 (Sports Activity Vehicle)	X6 (Sports Activity Coupe)
X7 (Sports Activity Vehicle)

SUNROOF DIAGNOSIS

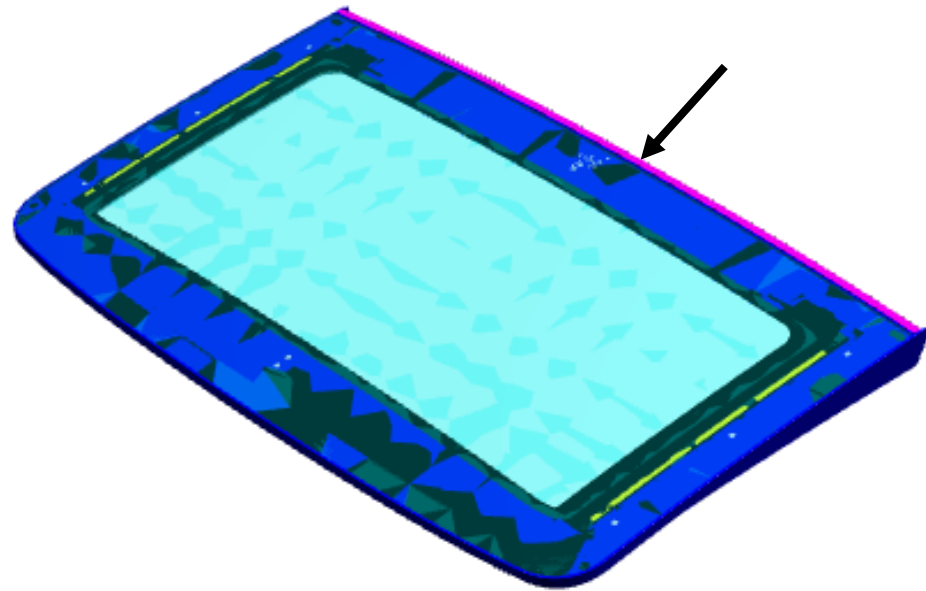
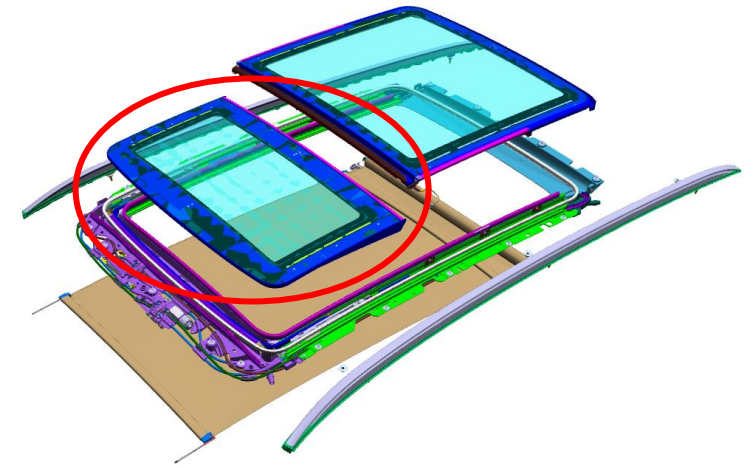
FRONT CENTER SEAL LOOSE/SHRINKING

Defect: separated

Defect: shrunken / gap

Situation: Excessive water enters through the sunroof seals.

Repair: Look for gap near end of the seal on front glass. If found, replace seal according to ISTA/AIR instructions REP 54 13 052. Also refer to B54 04 21.

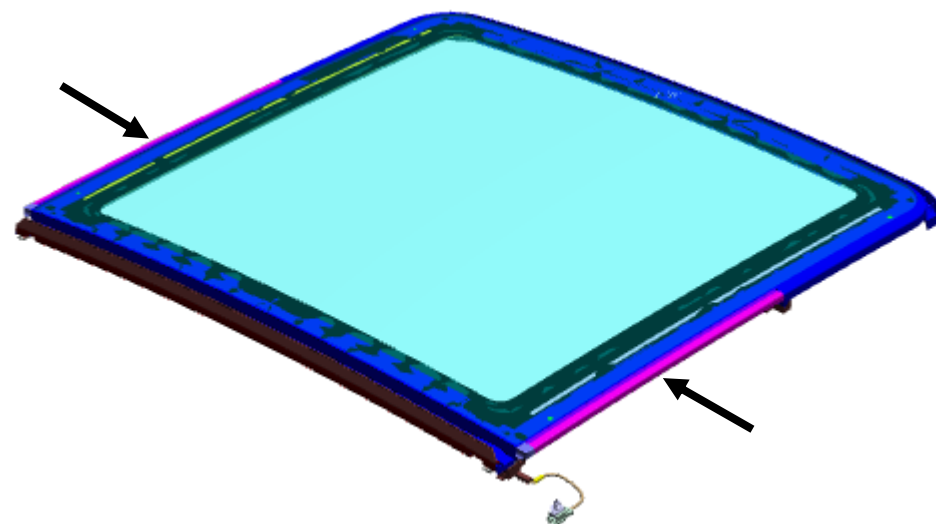
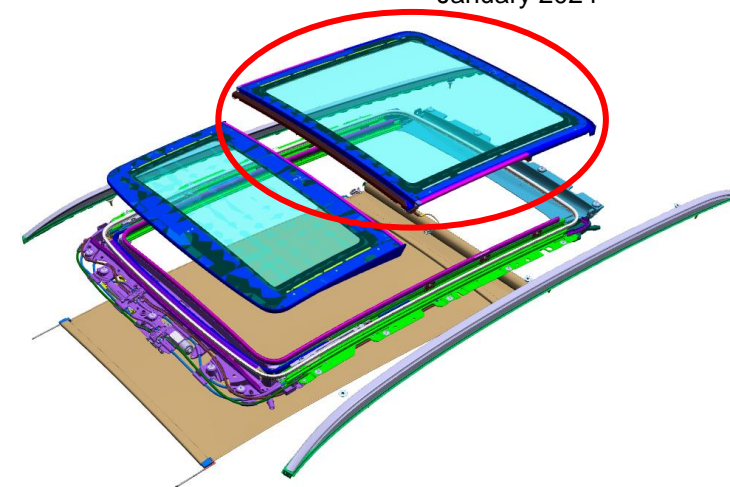
SIDE SEAL LOOSE/SHRINKING

Situation : Excessive water enters through the sunroof seals. (see pictures)

Defect: gap

Defect: twist

Defect: loose

Repair: Look for gap near ends or twist in seal. If found, replace seal according to ISTA/AIR instructions.
REP 54 13 050

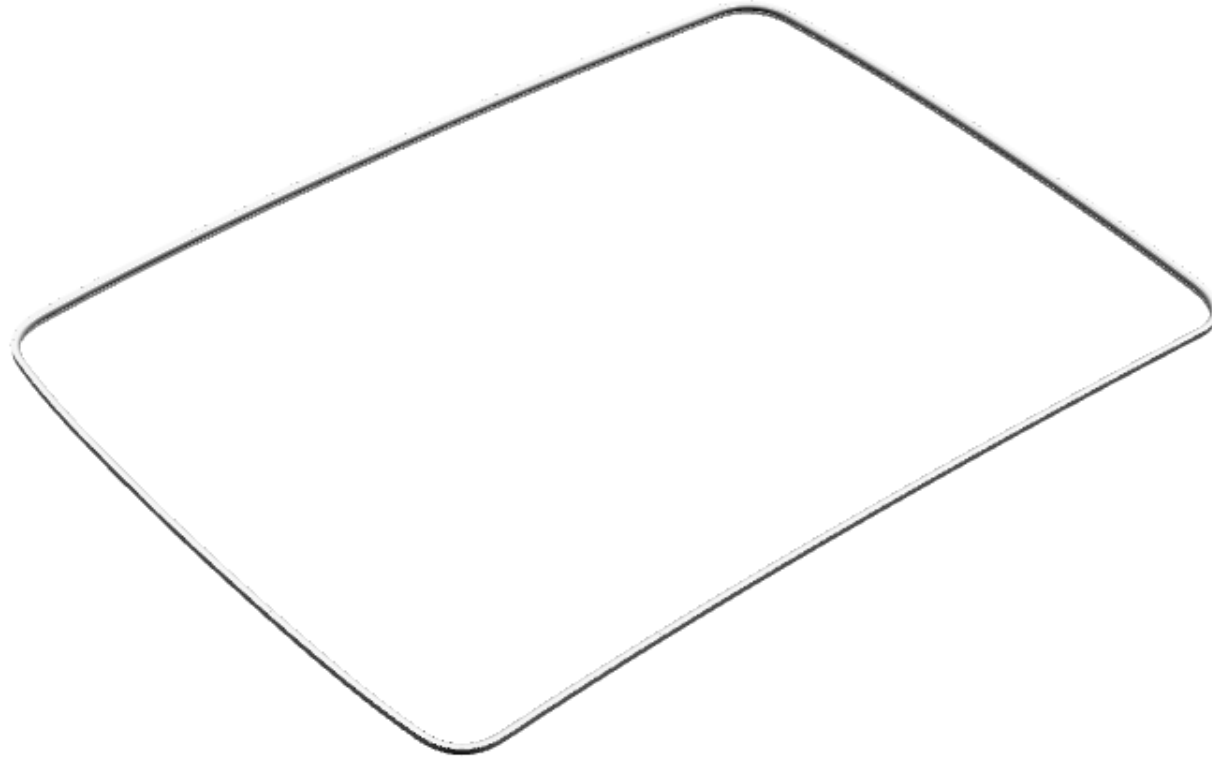
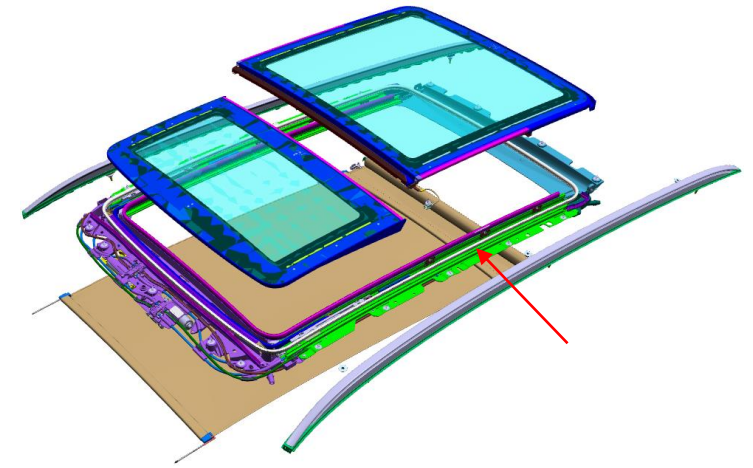
BODY SEAL NOT ATTACHED

example: gap/not flush

Situation : Excessive water enters through the sunroof seals.

Repair: Inspect the sunroof perimeter seal for defects. Replace body seal according to ISTA/AIR instructions REP 54 13 055.

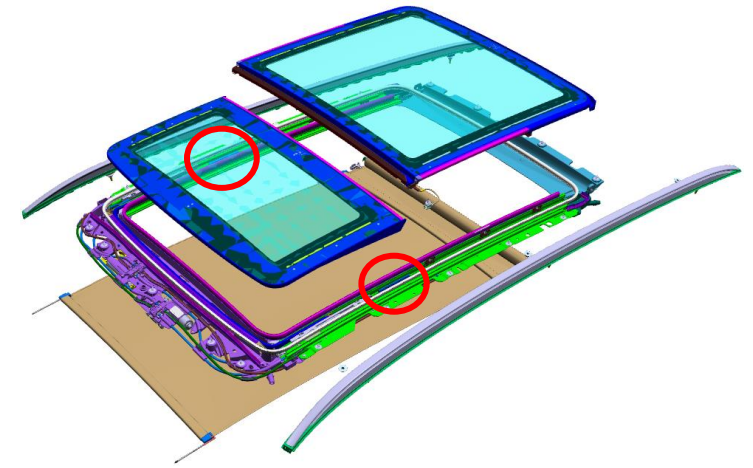
DYKO FOAM/SEAL- WATER INTRUSION INTO DRY SIDE OF CHANNEL

Solution: If there is a water leak near the middle drain channel, check position of the seal and foam.

(!) If NO foam/seal is present, the root cause of a water leak is NOT the foam/seal. Missing foam/seal will NOT CAUSE A WATER LEAK!! DO NOT REPLACE THE FFRAE FOR THIS.

Correct foam position (a)

Correct seal position (b)

Repair: Check position of the seal/ foam. Remove foam/ seal if deformed or damaged.

Part Number: 9466049-02, if new rubber seal is not available it is approved to use the foam for repair.

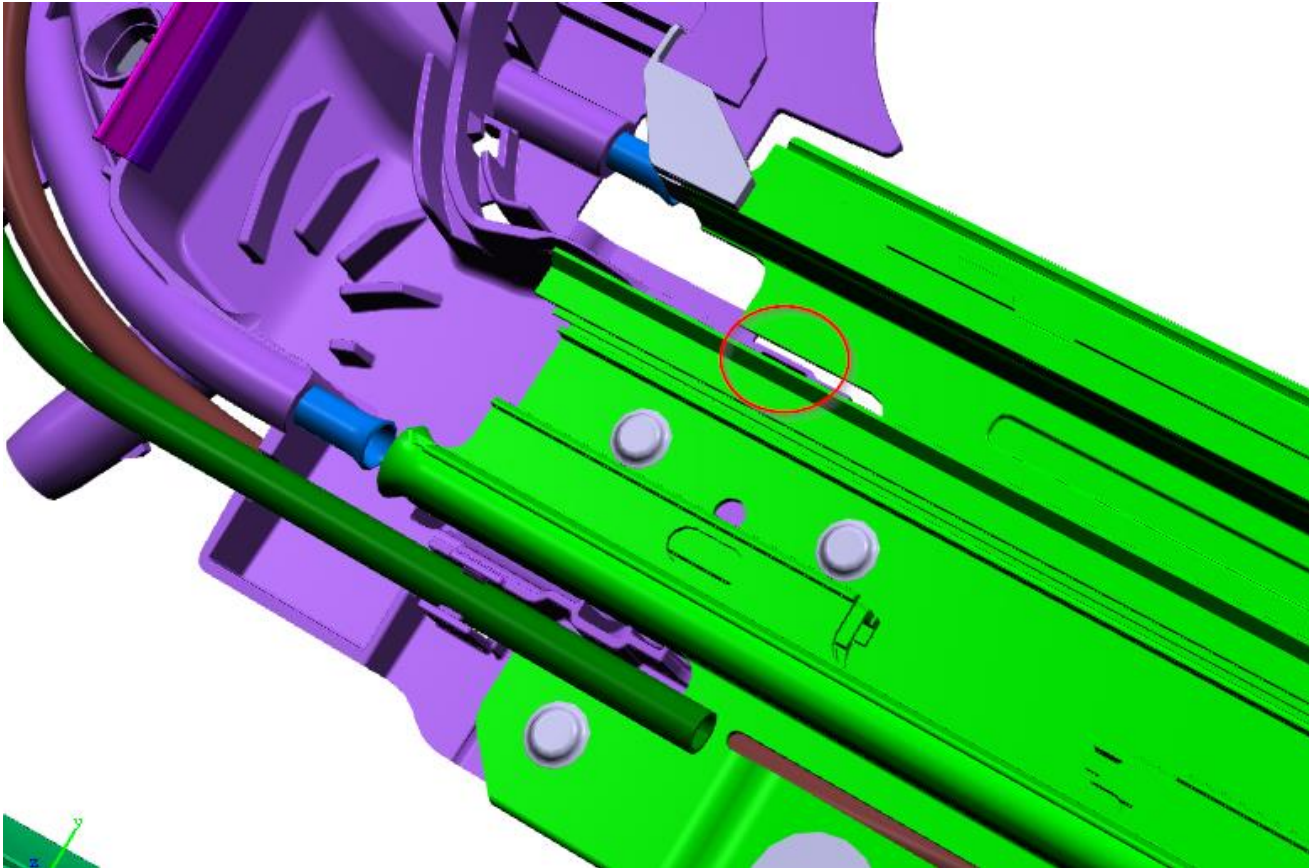
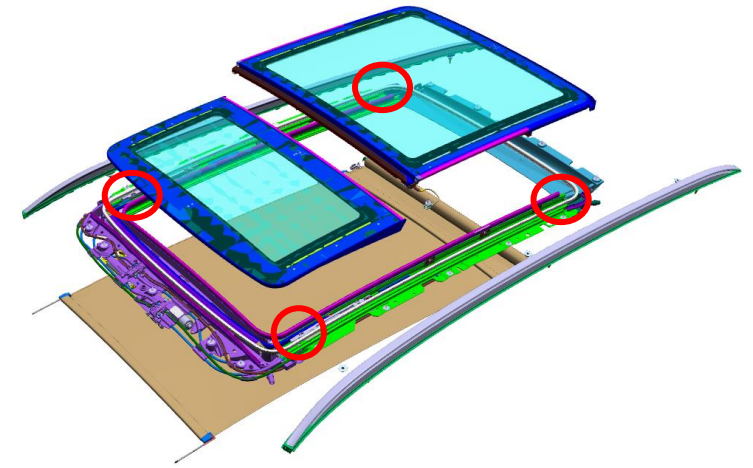
MISSING BUTYL BETWEEN SIDE GUIDES AND BEAM

Situation : There is a water leak running between front/rear beam and side guide.

Repair: There may be missing butyl sealer. ENSURE ALL OTHER WATER MANAGEMENT (SEALS, DRAINS) ARE CHECKED FIRST. ENSURE PROPER WATER TESTING PROCEDURES ARE BEING FOLLOWED (DO NOT OVERFLOW THE SEALED TRACK)

Replace frame according to ISTA/AIR instructions REP 54 13 261.

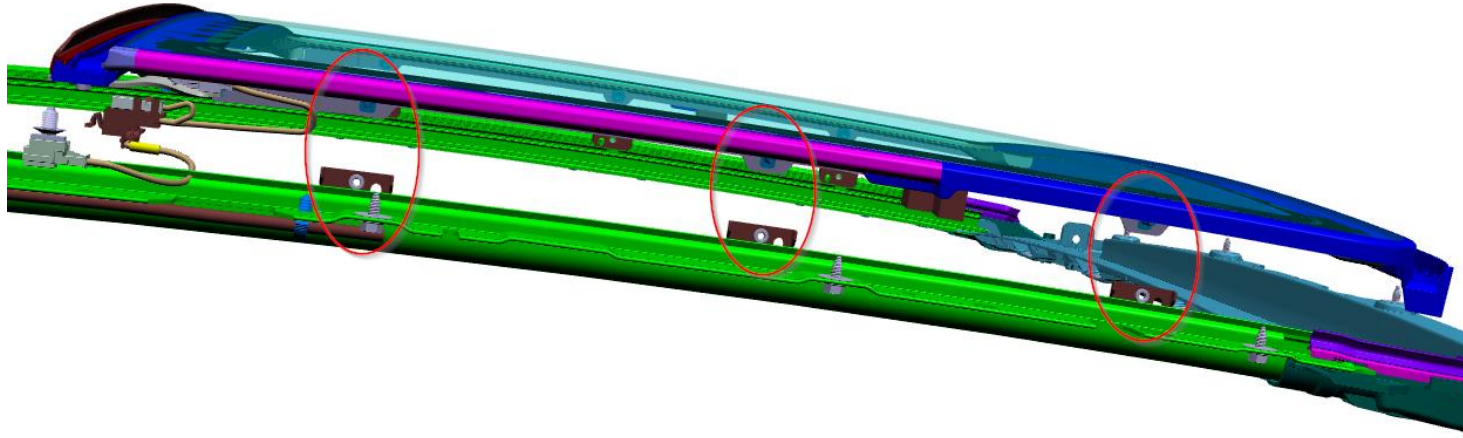
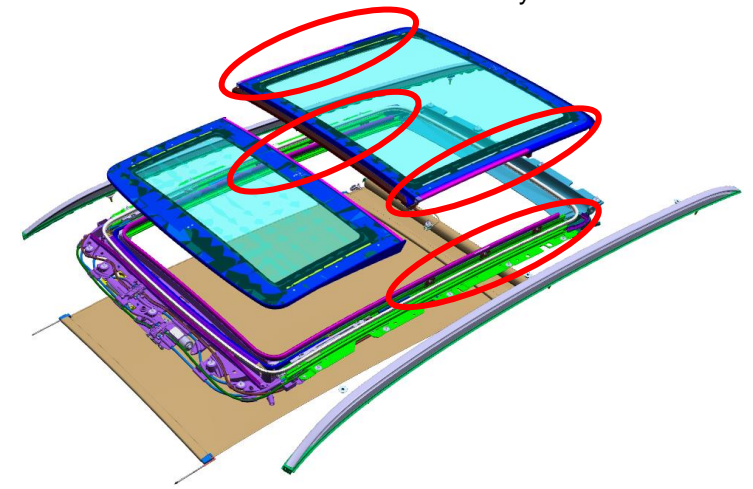
REAR GLASS NOT ALIGNED LEFT TO RIGHT (Y)

Situation: Excessive water enters a gap between the side seals and body.

Repair: Check the seals. If seals are OK, check left to right alignment of rear glass (minimal adjustment possible).

Adjust the rear sunroof glass and recheck left to right adjustment. Potential adjustment is very minor. If issue persists then replace frame according to ISTA/AIR instructions REP 54 13 261.

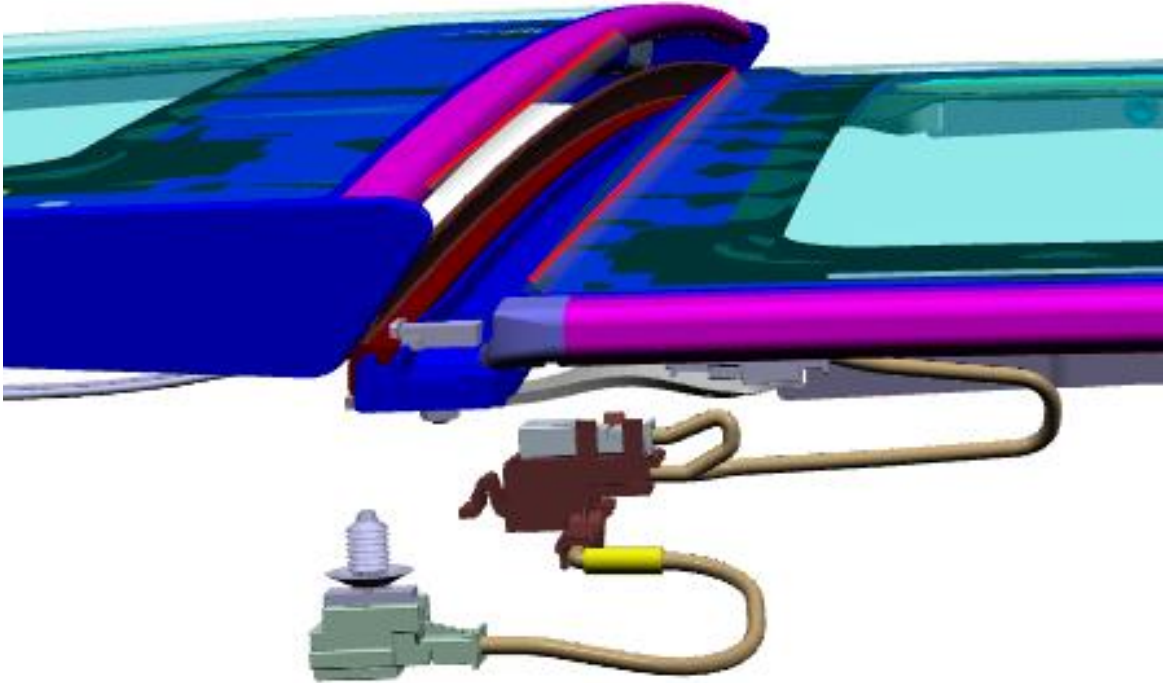
FRONT/REAR GLASS NOT ALIGNED IN X

Situation: Excess water enters the perimeter of the glass. Front and/or rear glass panels misadjusted front to rear.

Repair: Adjust both sunroof glass panels according to ISTA/AIR instructions REP 54 13 002.

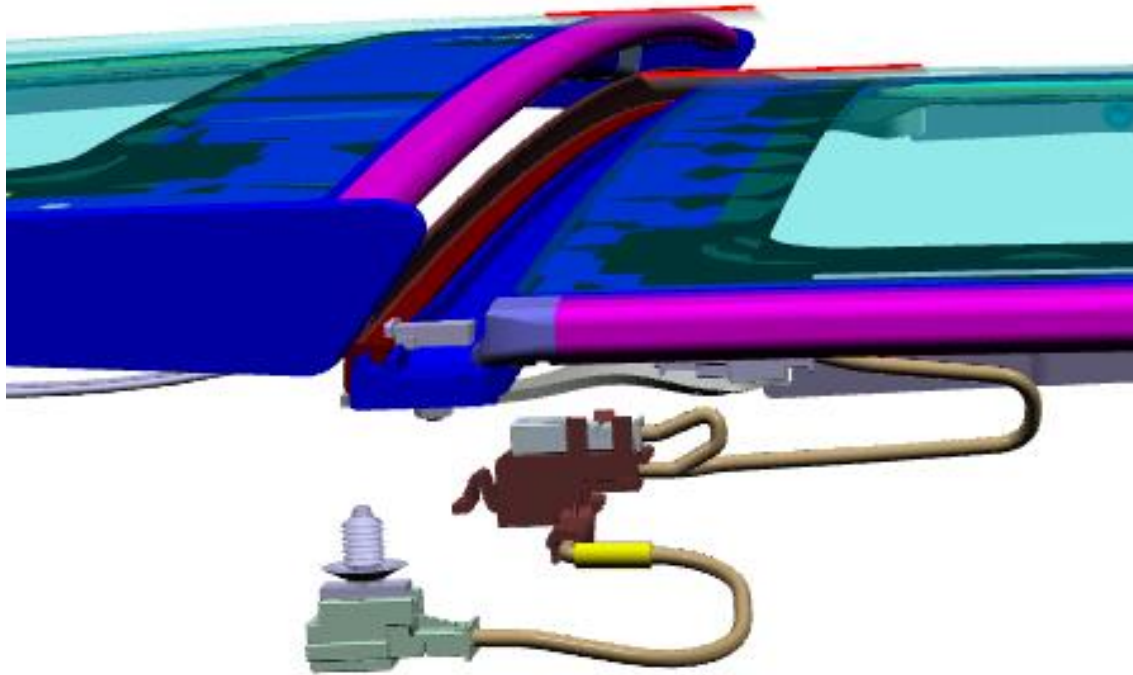
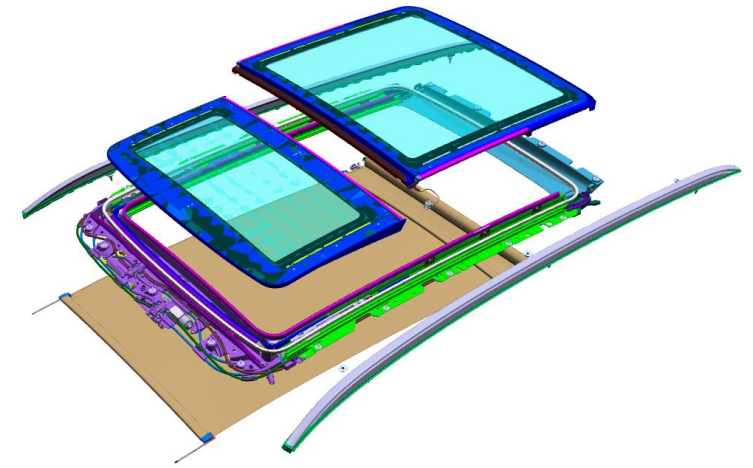
FRONT/REAR GLASS NOT ALIGNED IN Z

Situation: Excess water enters between the glass panels. Front and/or rear glass panel height misadjusted.

Repair: Adjust both sunroof glass panels according to ISTA/AIR instructions REP 54 13 002.

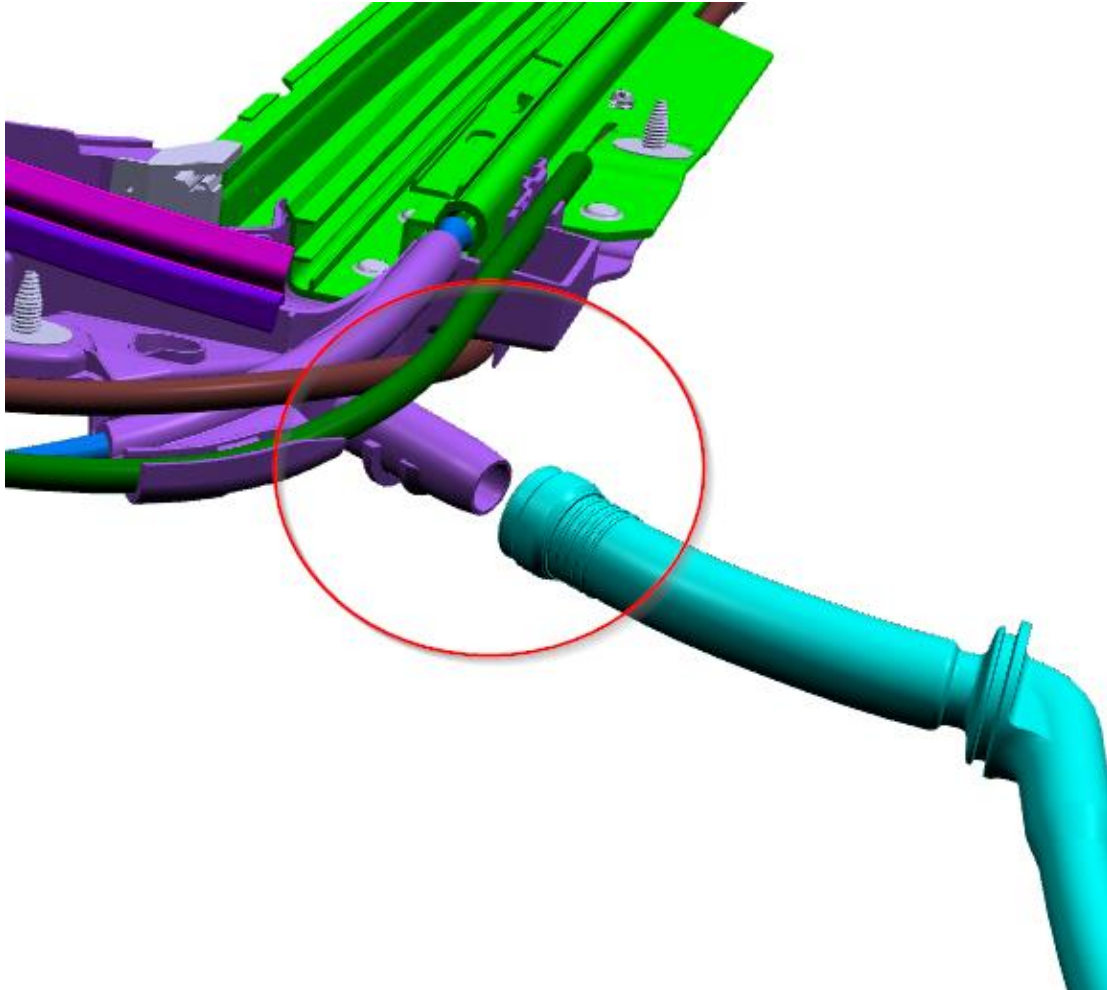
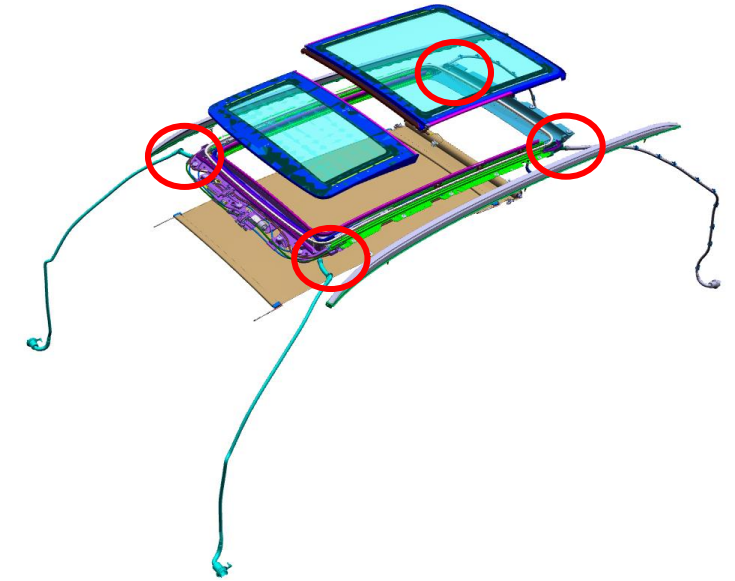
DRAIN TUBE NOT CONNECTED AT TOP

Situation: There is a water leak near the trunk area or you have a water leak near the front carpets. The drain tubes may not be properly connected at the sunroof frame (the top).

Repair: Check the drain tube connections at the sunroof. Reconnect if necessary.

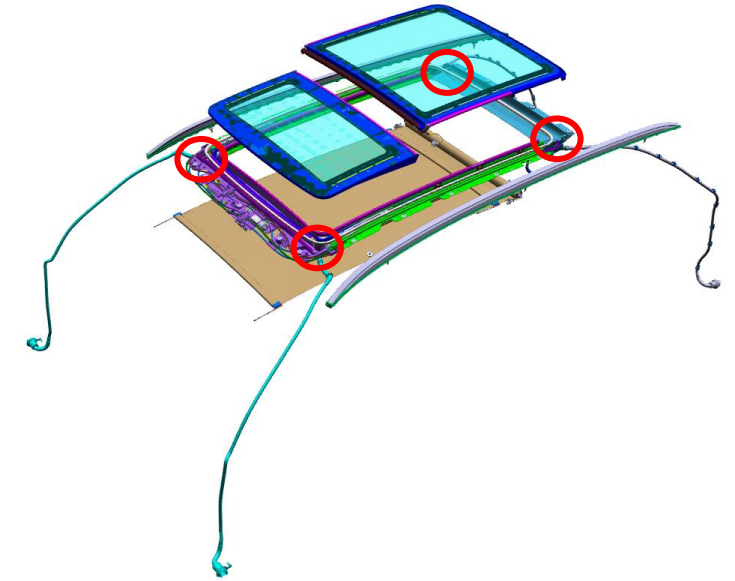
DRAIN TUBES CLOGGED (DIRT/DEBRIS)

Situation: There is a water leak onto the carpets. The drain tubes may be clogged.

Repair: Verify water flow through drain tube. Check for twist/kinks in drain hoses first. If no defect is found, gently blow air through drain tube to force debris to come out. Submit TSARA case for assistance if clog cannot be cleared.

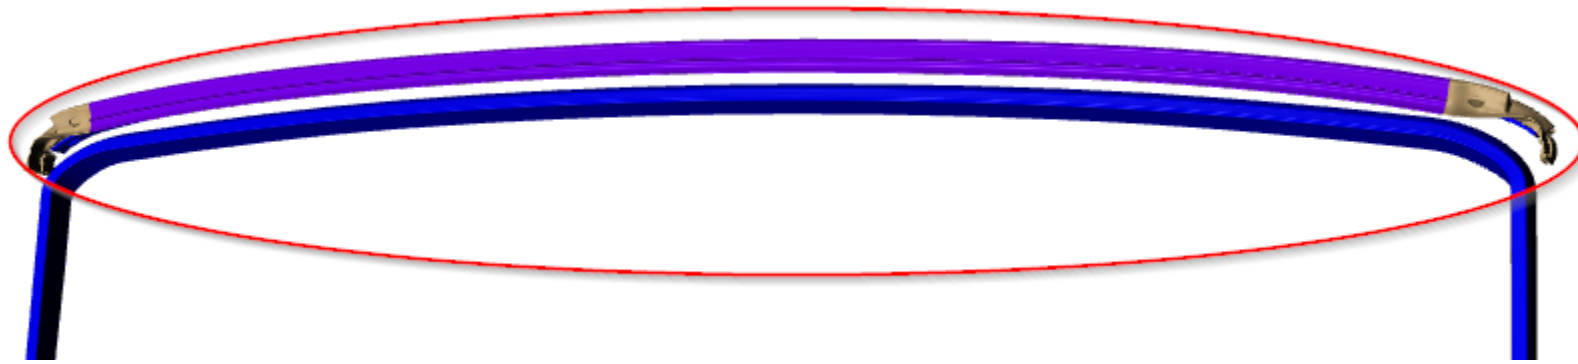
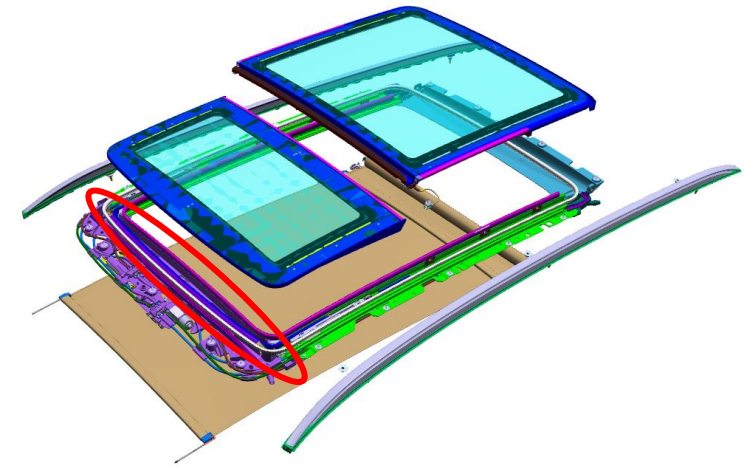
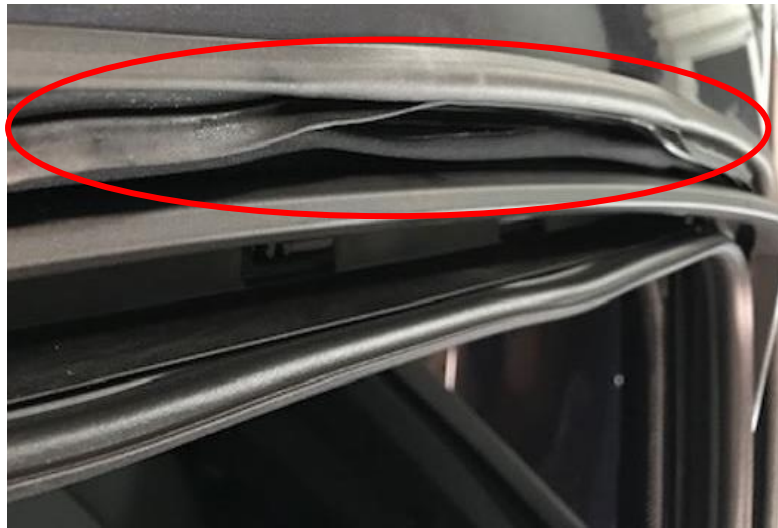
AERO ACOUSTIC SEAL NOT INSTALLED / STUCK

Situation: There is a water leak in the front. The aero-acoustic seal may be incorrectly installed or deformed.

Repair: Check if seal is properly seated and in good condition. If not, then reseal or replace the aero-acoustic seal and replace the body seal according to ISTA/AIR instructions REP 54 13 055.

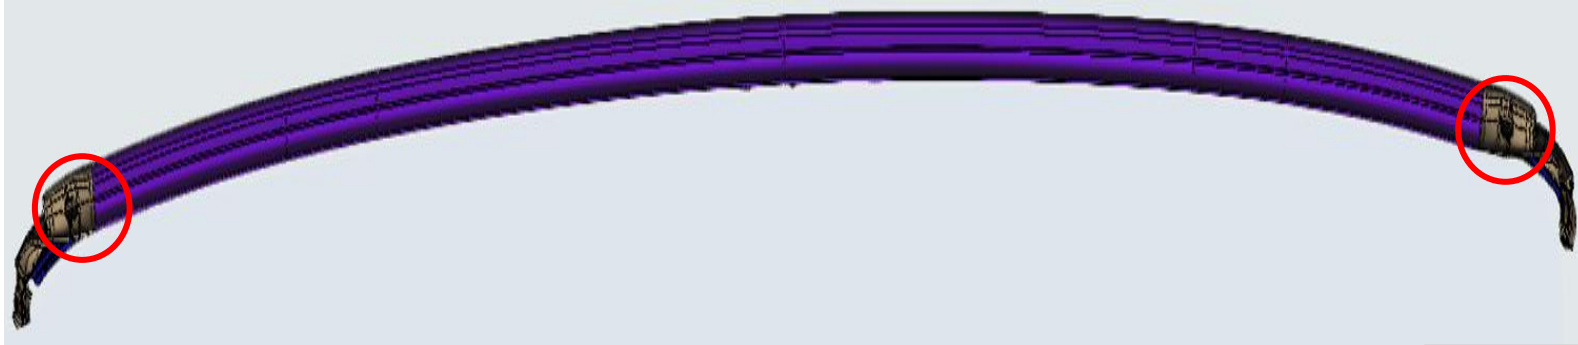
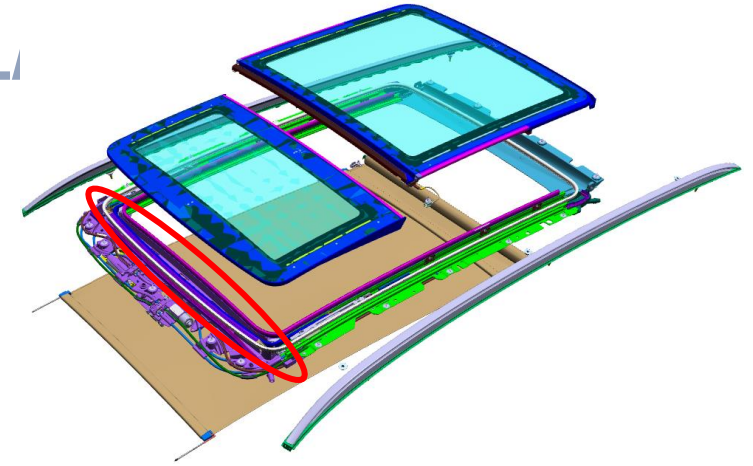
AERO ACOUSTIC SEAL VENT/ DRAIN HOLES BLOCKED/ FLASH

Solution: There is a water leak in the front. The aero-acoustic seal may have flash or blockage at the front vent/ drain holes.

Repair: Check if the seal is blocked at the front corners. If the holes are block by flash then replace the aero-acoustic seal.

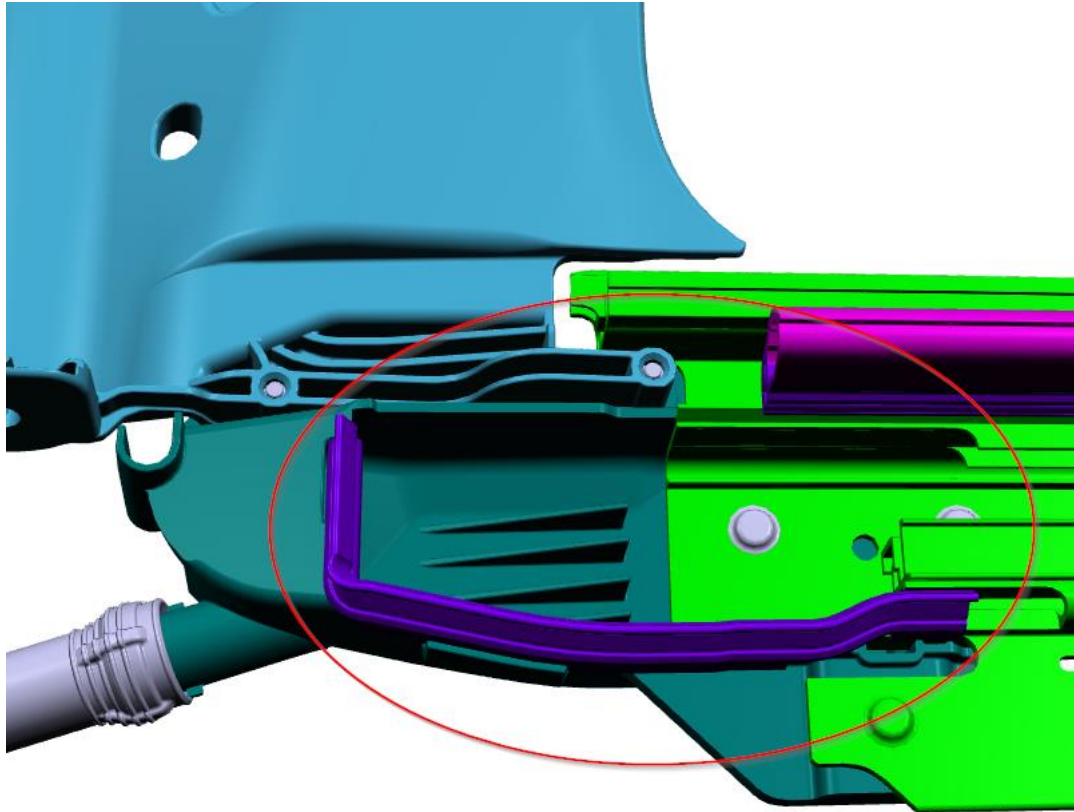
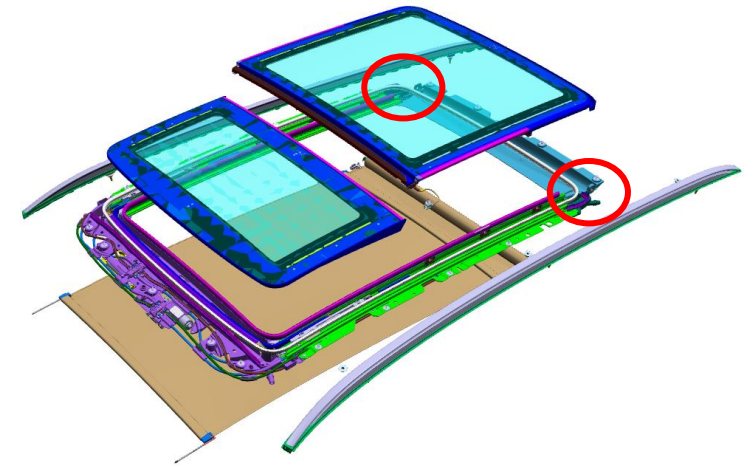
REAR BEAM DYKO SEAL NOT INSTALLED

Situation: There is water ingress in the trunk area. The rear beam seal may not be installed.

Repair: Check if seal is properly seated. Loosen bolts to lower the frame in order to properly inspect seal. If seal is completely missing then replace frame according to ISTA/AIR instructions REP 54 13 261.

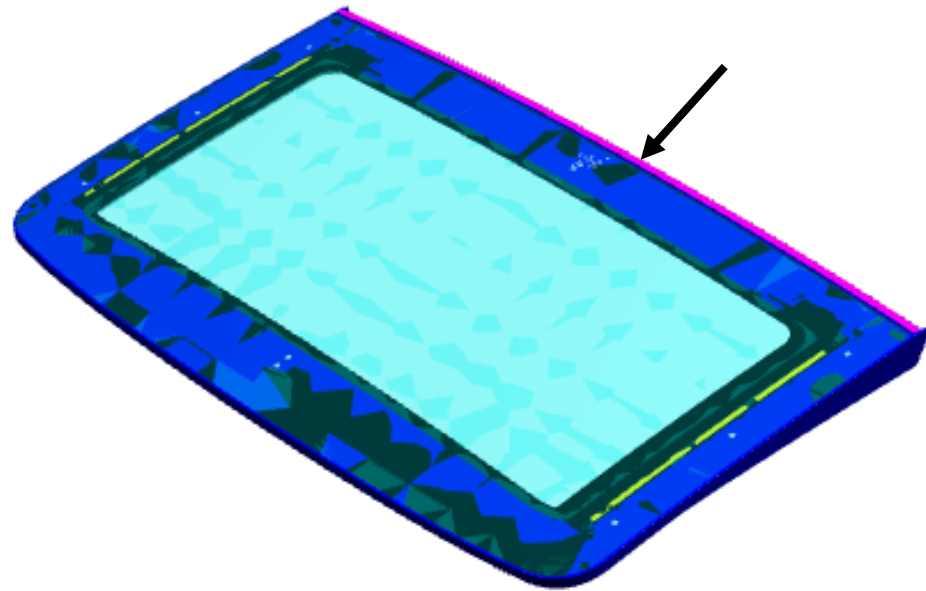
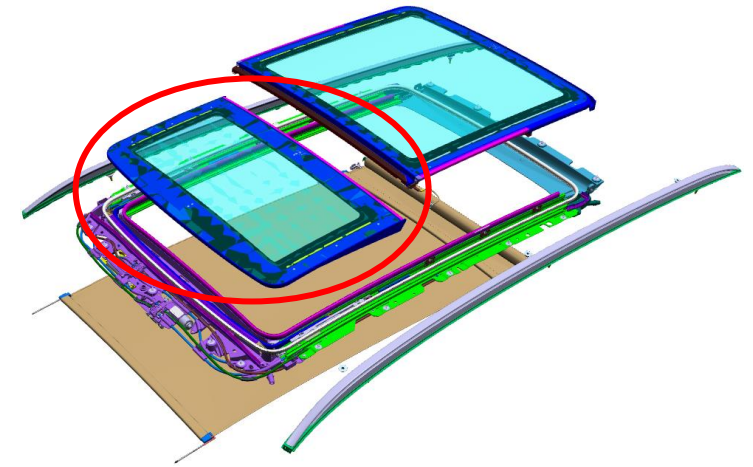
FRONT CENTER SEAL LOOSE/SHRINKING

Defect: separated

Defect: shrunken / gap

Situation: Wind noise heard at speeds of 30 Mph. A gap can be seen near the end of the seal on front glass.

Repair: Replace seal according to ISTA/AIR instructions REP 54 13 052. Refer to B54 04 21.

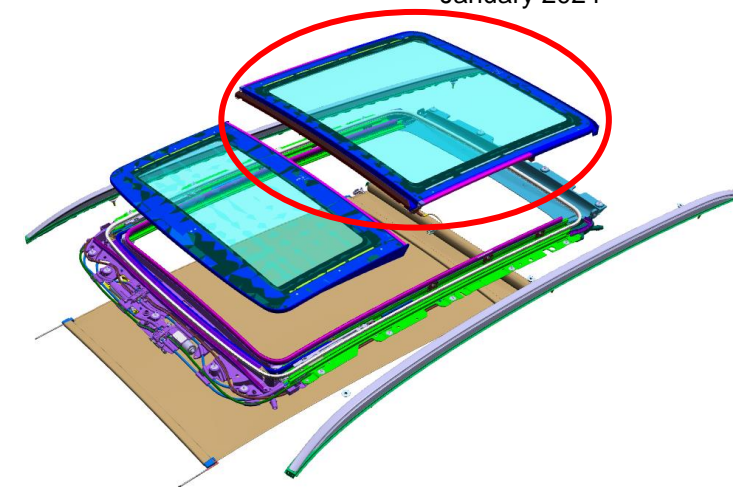
SIDE SEAL LOOSE/SHRINKING

example: gap

example: twist

example: loose

Situation: Wind noise heard at speeds of 30mph.

Repair: Look for gap near ends or twist in seal. If found, replace seal according to ISTA/AIR instructions. REP 54 13 050. If the knob or locking feature is missing on the rear glass panel replace the rear glass panel.

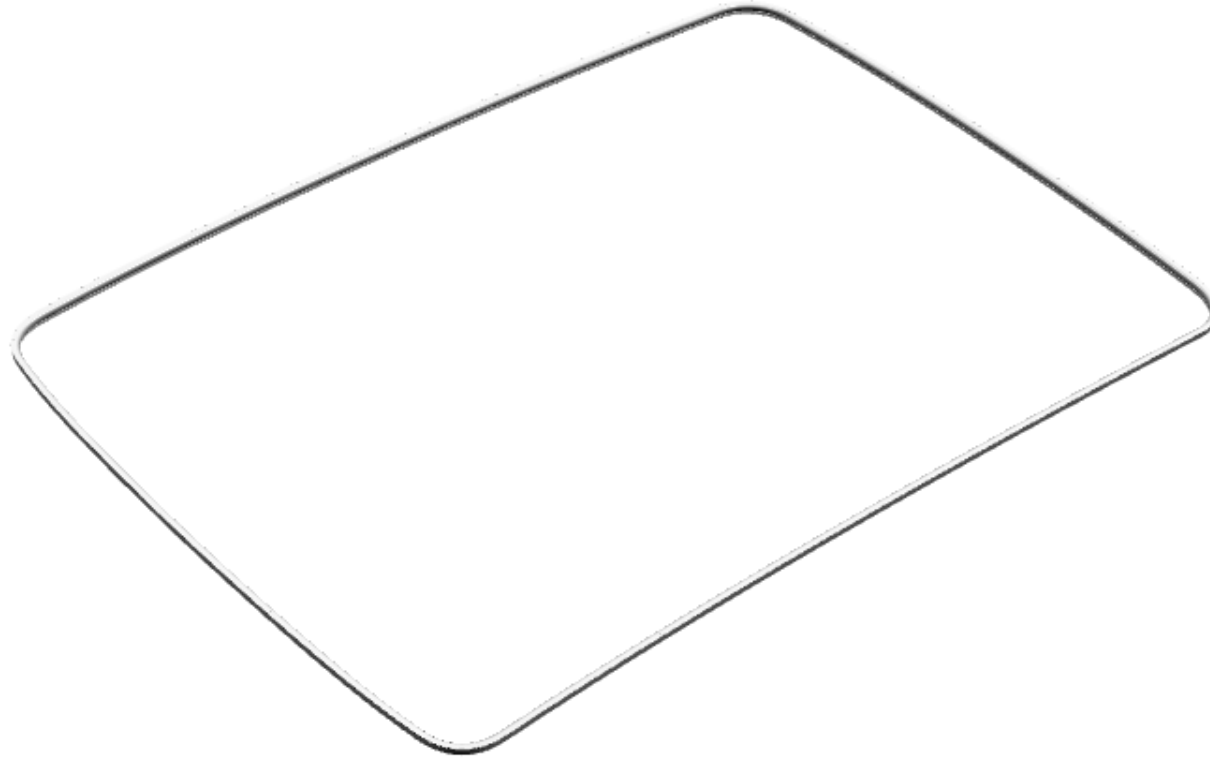
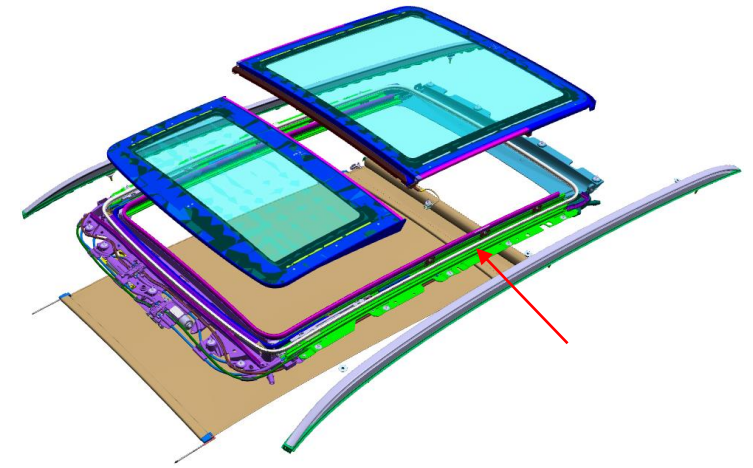
BODY SEAL NOT ATTACHED

Situation: The body seal may be detached or improperly installed.

example: gap/not flush

Repair: Check body seal to see if it is flush to vehicle.
(no loose areas/wrinkles)

If damaged, replace body seal according to ISTA/AIR instructions REP 54 13 055.

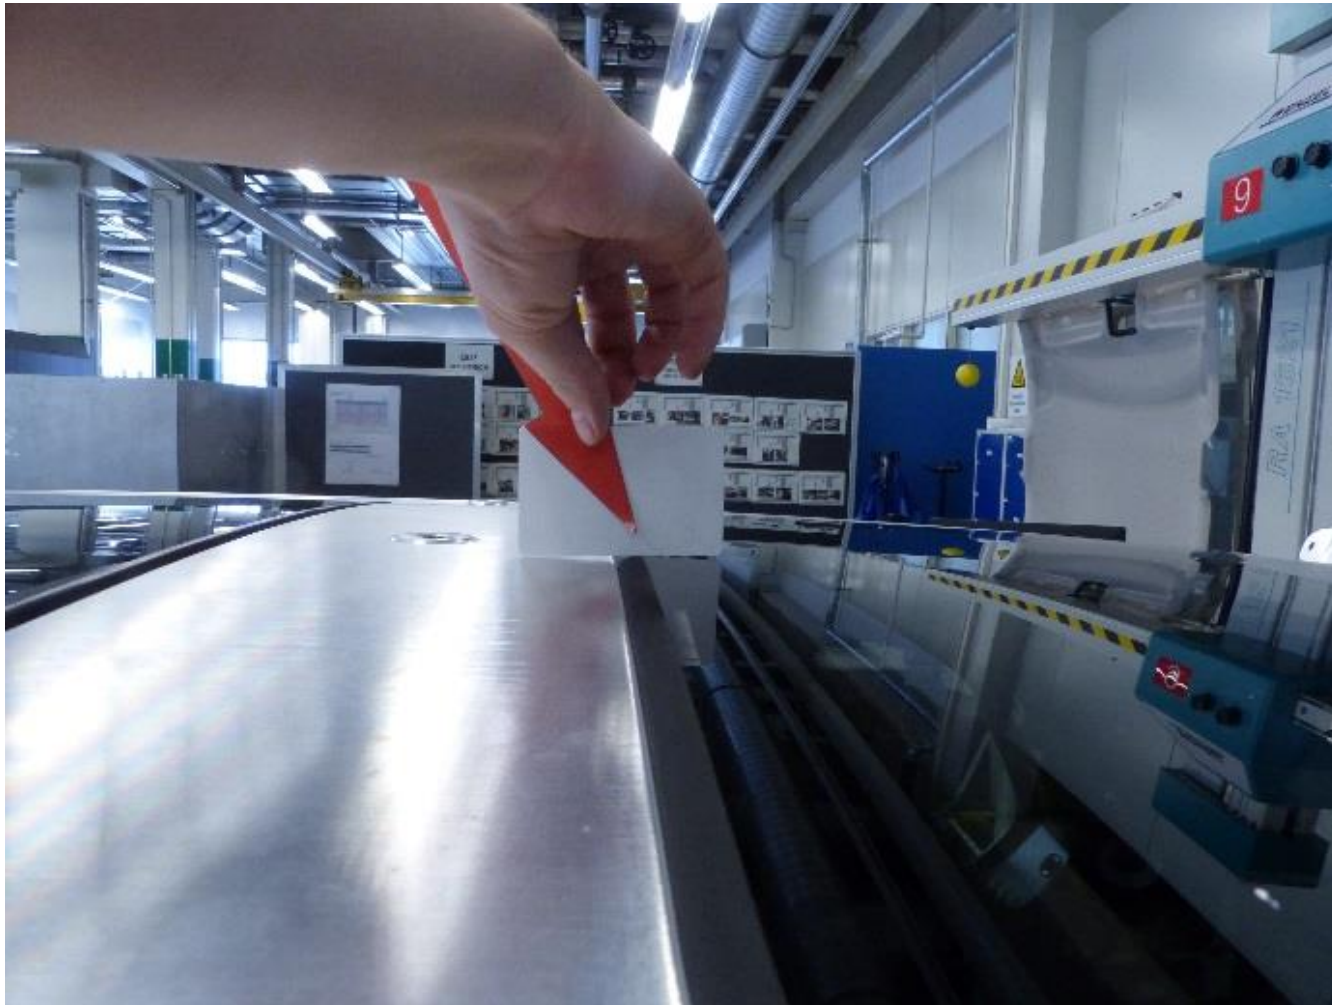
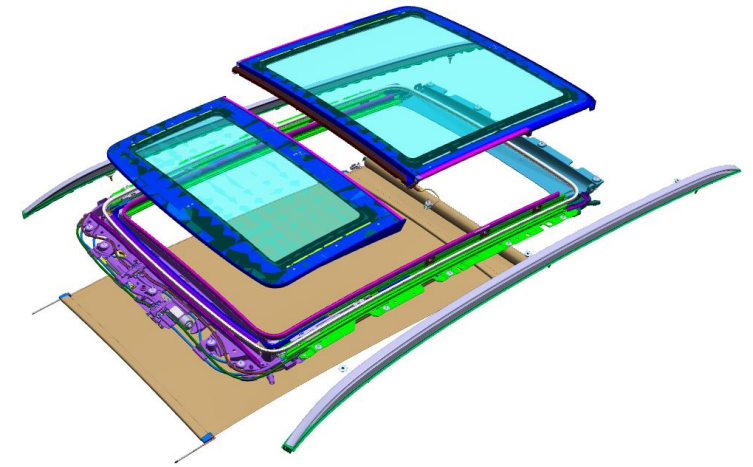
GLASS NOT FLUSH

Situation: Rushing wind noise is heard from center of the glass.

Repair: Tape can be used to isolate noise and find where glass is not flush.

Adjust both sunroof glass panels according to ISTA/AIR instructions REP 54 13 002.

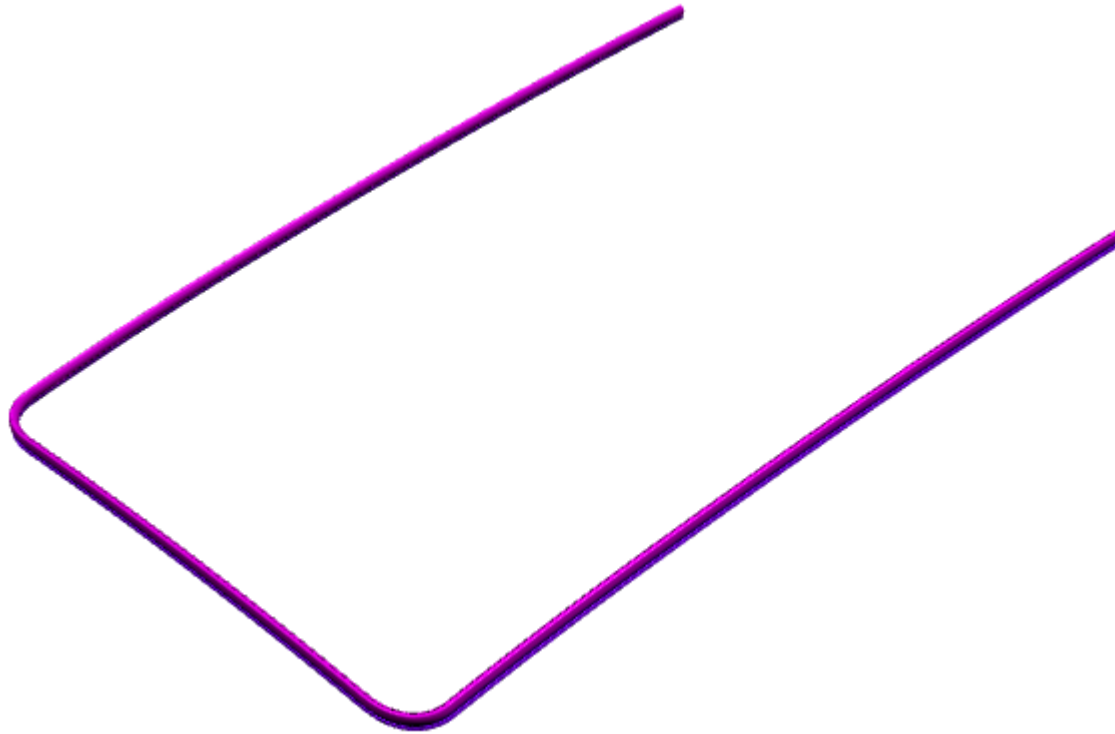
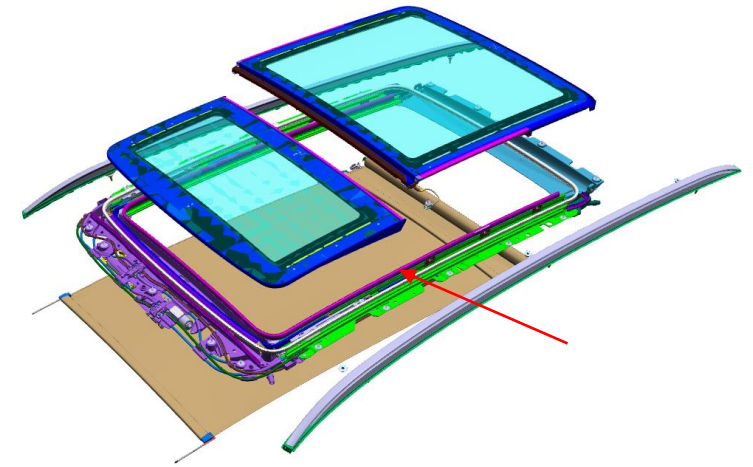
ACOUSTIC SEAL LOOSE

This seal will not cause a water leak into the vehicle and should not be replaced to solve a water leak on the panoramic roof.

Situation: Rattle or groaning noise heard while driving over rough road surfaces. Upwards pressure on the glass will stop the noise. The cause is interference between the sunroof glass and acoustic seal mounted to the sunroof frame (not the roof perimeter seal).

Repair: Slightly lower glass (within specification) to increase pressure between the glass and the seal.

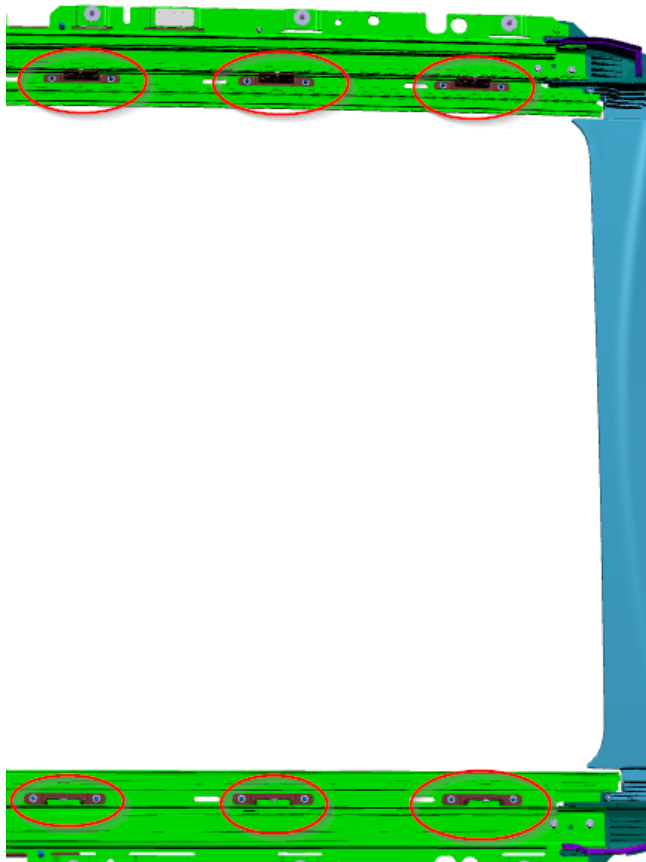
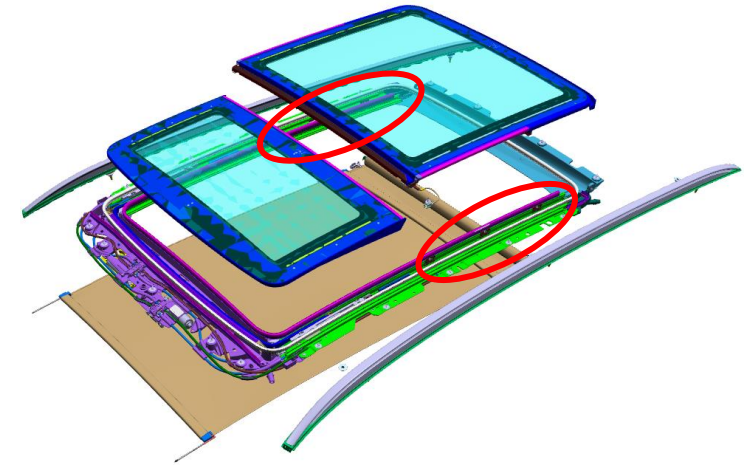
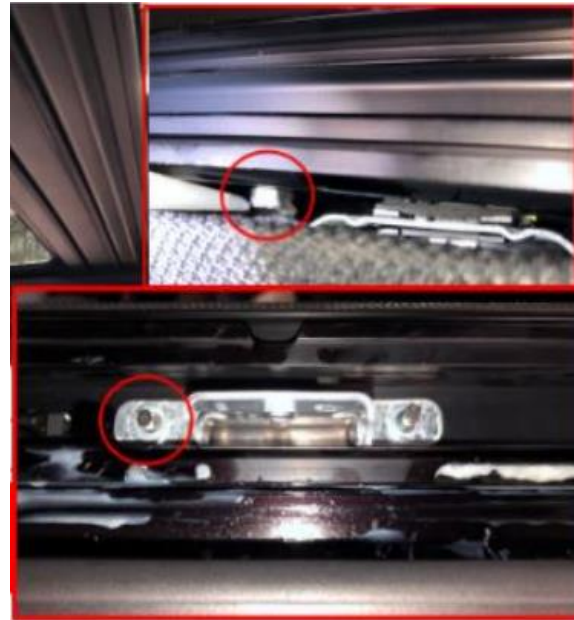
REAR GLASS BRACKET LOOSE

Situation: Metallic noise heard while driving over rough road surfaces.

Repair: Inspect bracket screws (**Bracket to frame**, not glass to bracket). Check for any cross threaded screws. If cross threaded screws are found then replace screws. Tighten loose screw(s) to 6.1Nm to fully seat. If the screws can't be tightened correctly, the frame would need replacement.

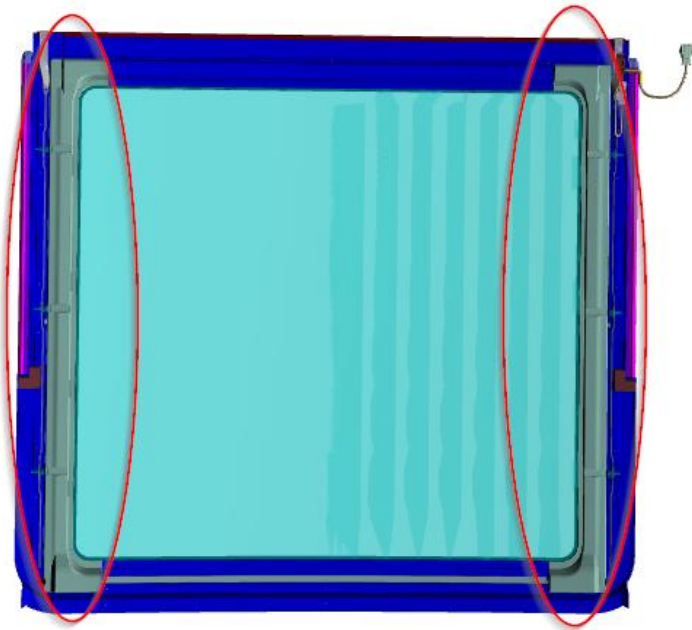
AMBIENT LIGHT COVERS LOOSE

Situation: Rattle is heard from plastic cover tapping on glass panel (front or rear glass) when driving on rough road surfaces.

This situation only affects vehicles with SA407 (Panoramic Sky Lounge LED Roof)

Repair: Attempt to insulate with felt tape is visually appropriate. Replace glass panel according to ISTA/AIR instructions REP 54 13 250 if insulation is not possible.
