2024-01-08

This Service Information Bulletin (Revision 6) replaces SI B54 11 19 **dated March 2023**.

F95 (X5 M Sports Activity Vehicle)	F96 (X6 M Sports Activity Coupe)	F97 (X3 M Sports Activity Vehicle)	F98 (X4 M Sports Activity Coupe)
G01 (X3 Sports Activity Vehicle)	G02 (X4 Sports Activity Coupe)	X5 (Sports Activity Vehicle)	X6 (Sports Activity Coupe)
X7 (Sports Activity Vehicle)

SUNROOF DIAGNOSIS

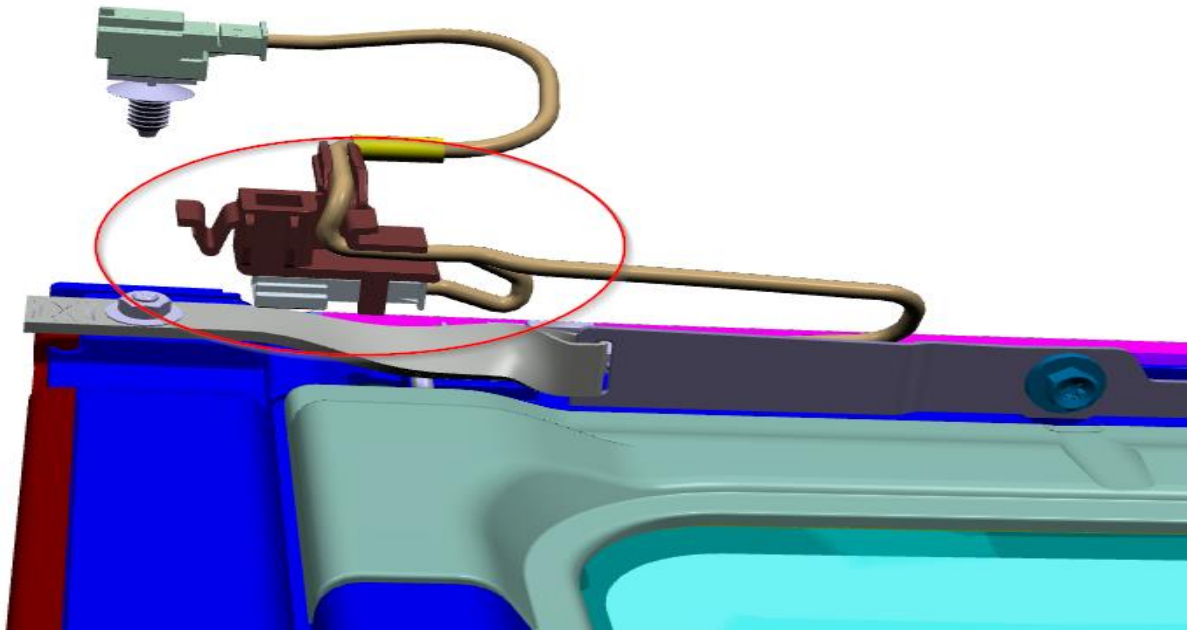
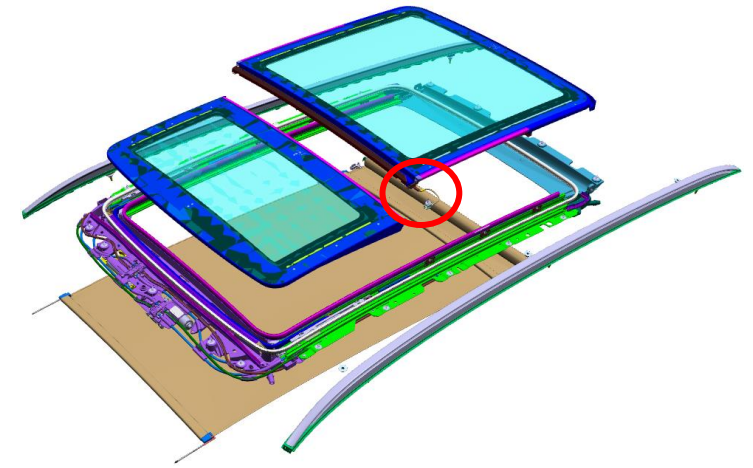
AMBIENT LIGHT CLIP LOOSE/NOT INSTALLED

Clip loose with prongs attached to connector

Clip attached to panel with a press fit rib on the back into a slot on the panel. Glass supplier glues the rib with cyanoacrylate glue.

Situation: A loose clip for the ambient light harness is tapping on the glass or contacting the sunroof mechanism. Only affects vehicle with SA407 (Panoramic Sky Lounge LED Roof).

Repair: Correctly install the harness clip.

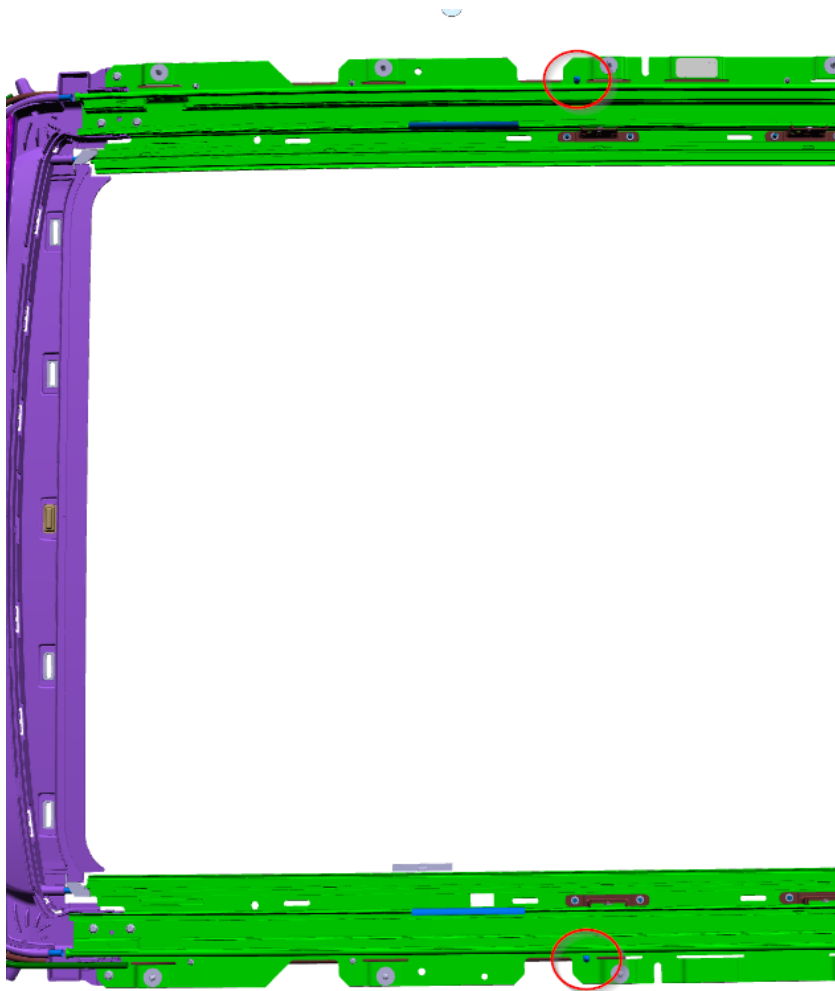
CABLE TUBE CLIP NOT INSTALLED

Situation: There is humming / crackling sound when opening the sunshade or plastic rattling while driving on rough roads.

Repair: Engage/set clip correctly. If tube is damaged and noise persists then replace cassette according to repair instructions.

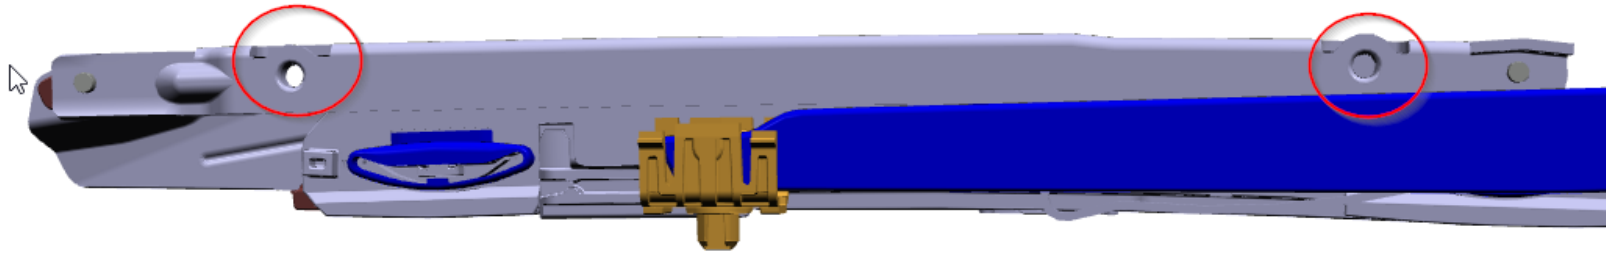
EXTRA SCREW

Situation: A metallic “rolling” noise is heard during acceleration/deceleration. An extra screw may have fallen into the track during production. The screw is not missing from any location.

Repair: Remove the extra screw. Additional repairs are not necessary, all other screws are correctly installed.

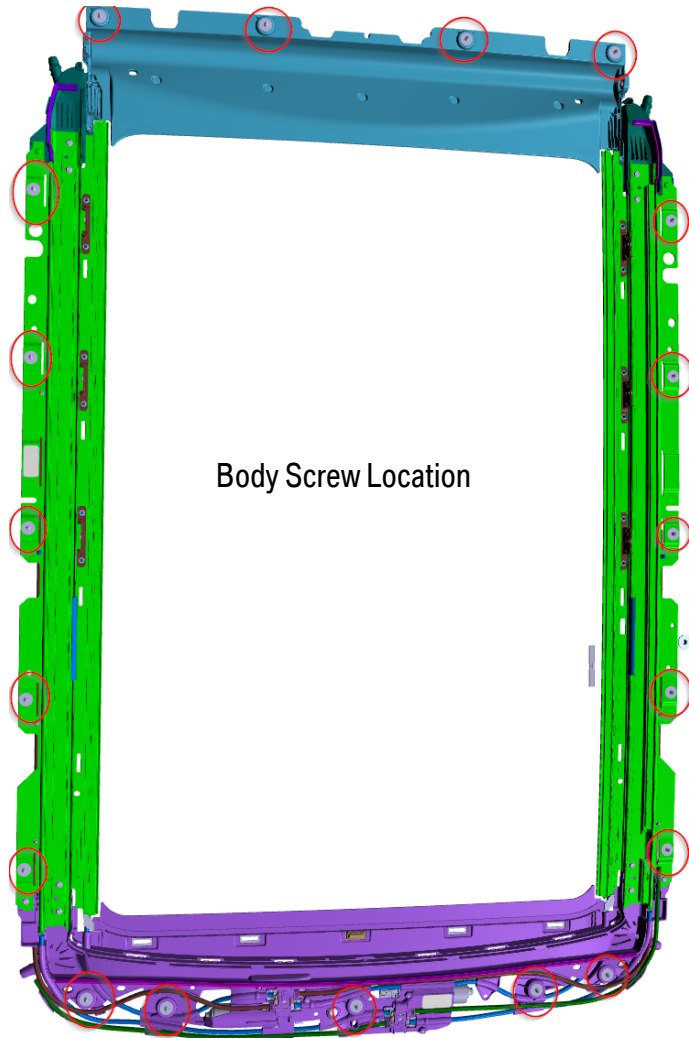
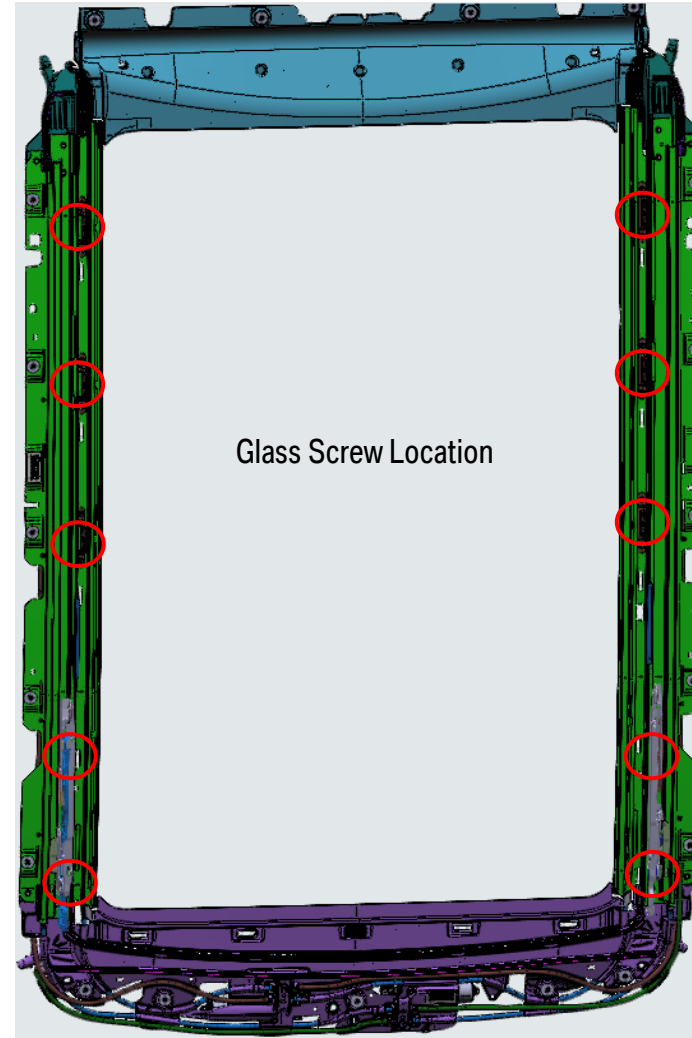
LOOSE FRAME TO BODY SCREW/ FRAME TO GLASS SCREW

Situation: Rattling noise is heard from the roof area. One or more sunroof frame screws may be loose.

Repair: Inspect screws for signs of cross-threading. Replace screws if damaged. Retorque frame screws correctly according to ISTA/AIR repair instructions to 5.4nm. Retorque glass panel screws to 4.5nm. Note: Ensure headliner clips are engaged and not broken.

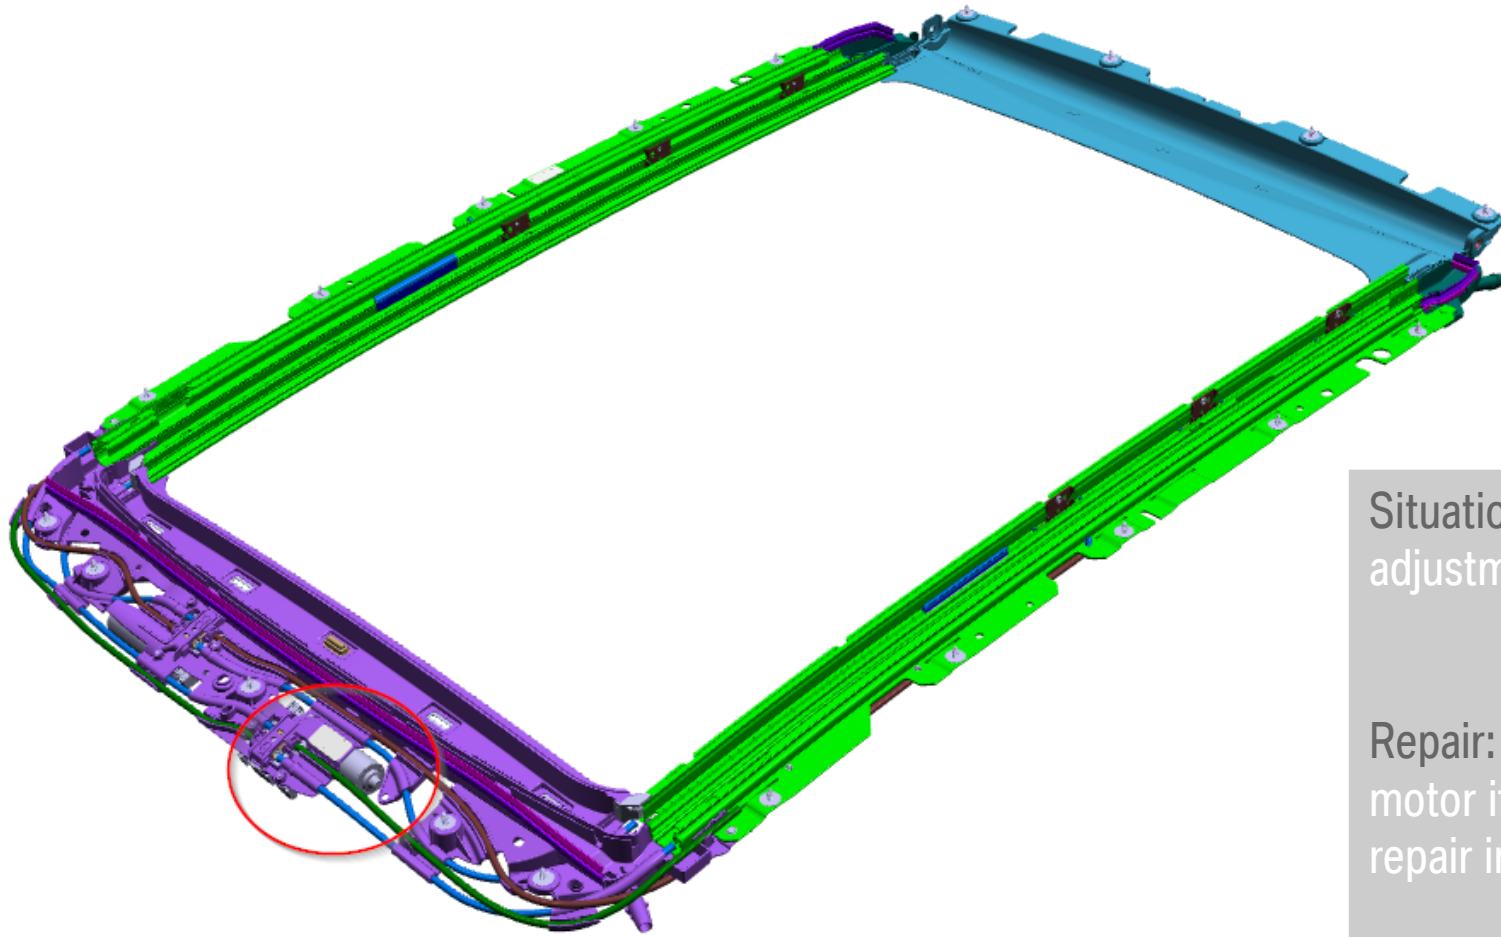
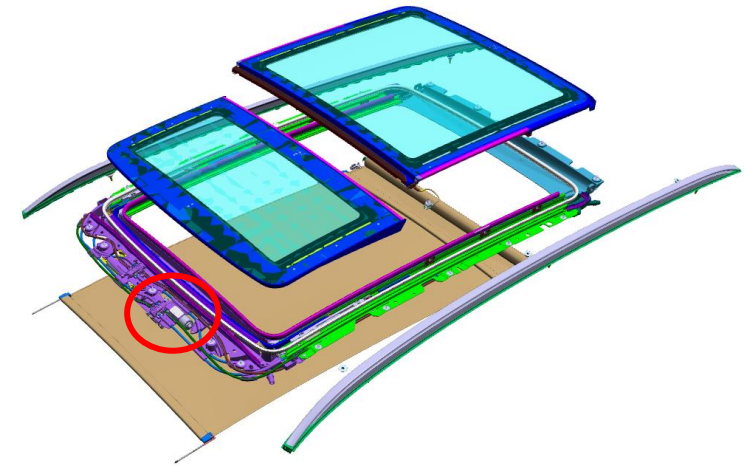
MOTOR NOISE

Situation: An oscillation noise is present from the adjustment motor when the shade or glass is moving.

Repair: Swap/replace the motor and retest. Replace the motor if found to be the cause according to ISTA/AIR repair instruction REP 67 61 580.

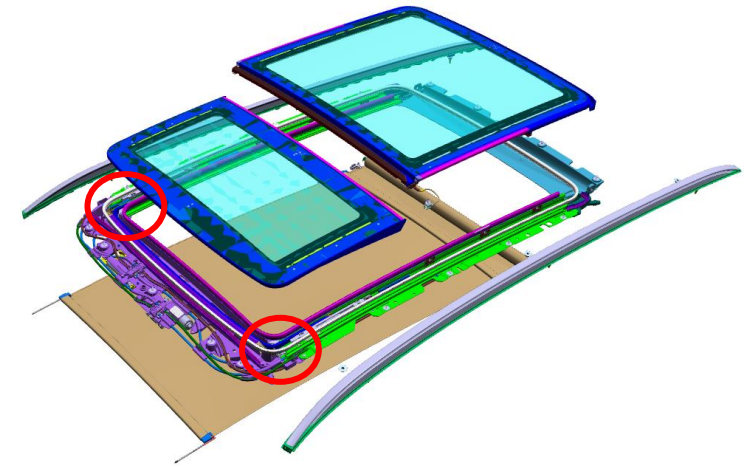
CABLE RATCHETING

Defect: misaligned or burr

Situation: A quiet oscillating/chattering noise is present when moving only the sunshade.

Repair: Inspect the sunroof frame for misalignment or a burr on the cable guide as shown. If damage is found, replace the frame according to ISTA/AIR instructions REP 54 13 261.

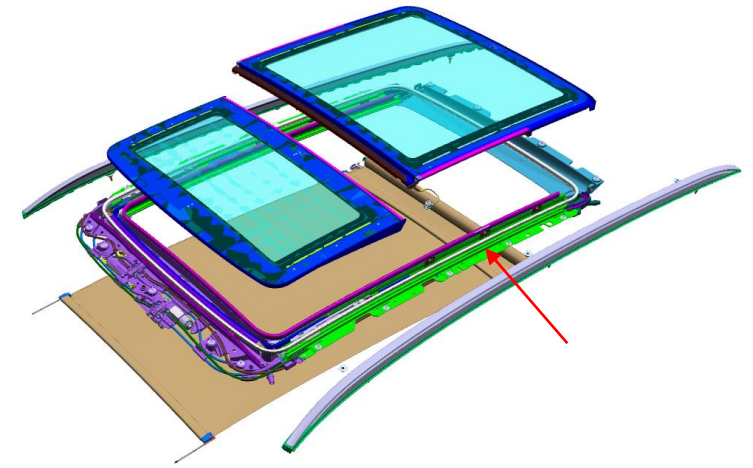
GUIDE RAIL NOT ENOUGH LUBRICATION

Situation: A squealing or chattering noise is heard when moving the sunshade. Typically on Alcantara (suede) equipped vehicles.

Repair: Clean and lubricate the sunroof guides. If noise persists then replace sunshade according to ISTA/AIR instructions REP 54 13 548.

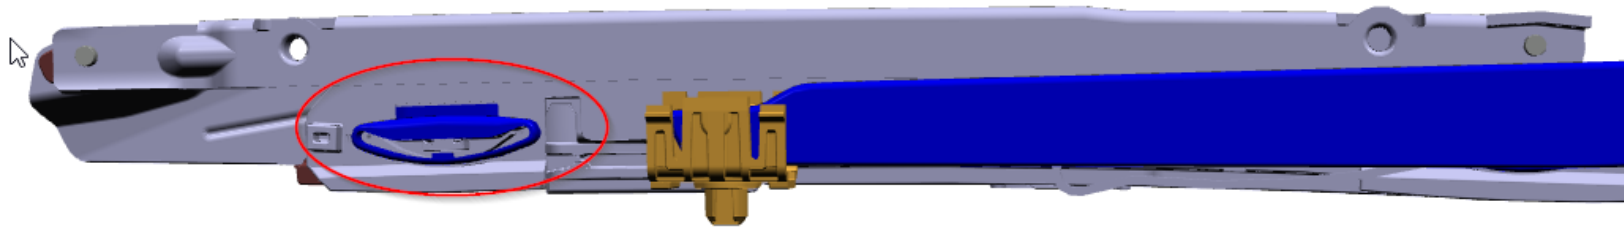
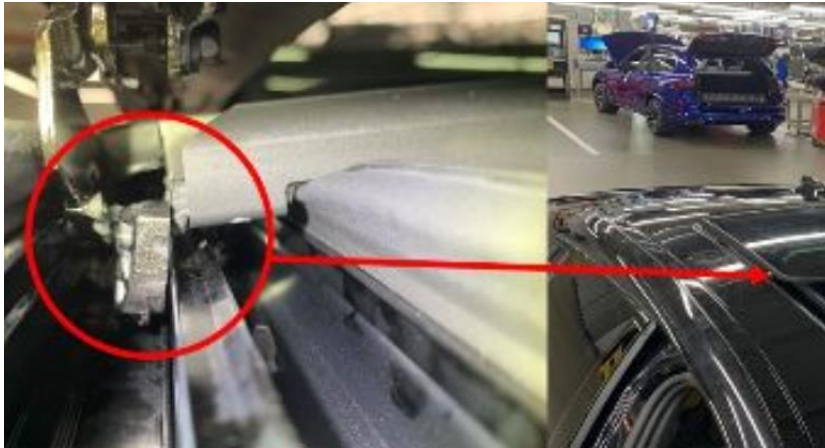
GUIDE SHOE NOT INSTALLED CORRECTLY

Situation: A rubbing/tapping noise heard when glass is moved.

Repair: Replace mechanism according to ISTA/AIR instructions REP 54 13 515.

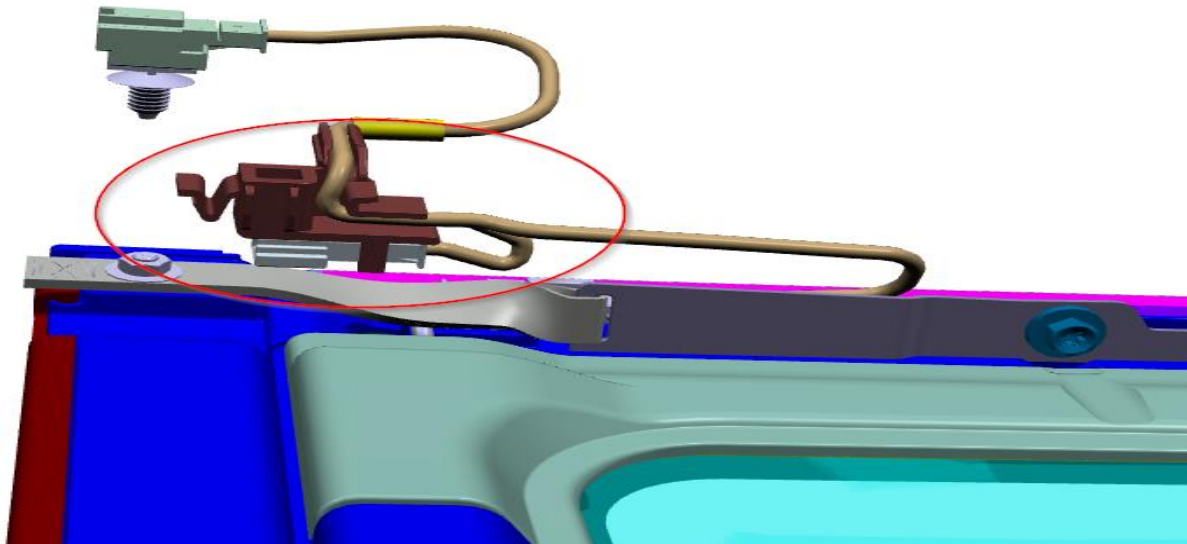
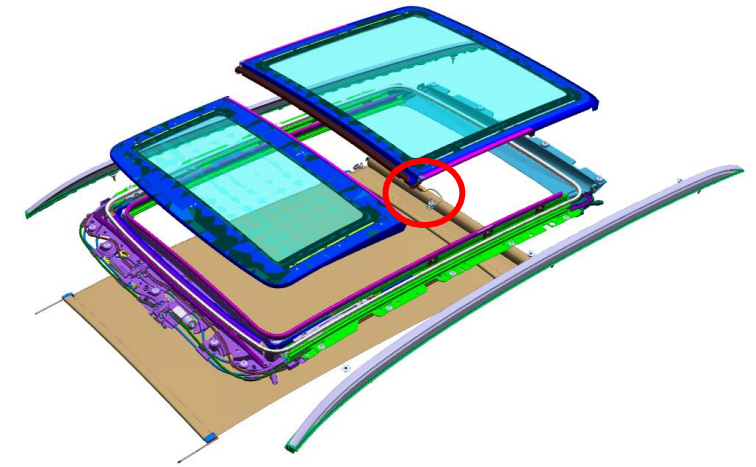
AMBIENT LIGHT CLIP LOOSE/NOT INSTALLED

Situation: A loose clip for the ambient light harness is tapping on the glass or contacting the sunroof mechanism. Only affects vehicle with SA407 (Panoramic Sky Lounge LED Roof).

Clip loose with prongs attached to connector

Clip attached to panel with a press fit rib on the back into a slot on the panel. Glass supplier glues the rib with cyanoacrylate glue.

Repair: Correctly install the harness clip.

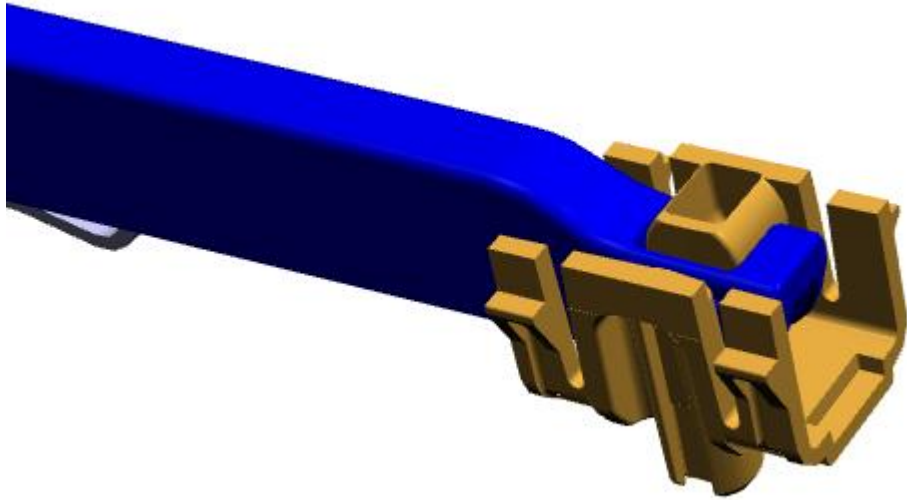
WIND DEFLECTOR PIVOT POINT LOOSE/BROKEN

Situation: A creaking noise is present while the wind deflector raises/lowers. Sunroof may reverse due to anti-trap when closing.

Repair: Replace pivot point and wind deflector according to ISTA/AIR instructions REP 54 13 090

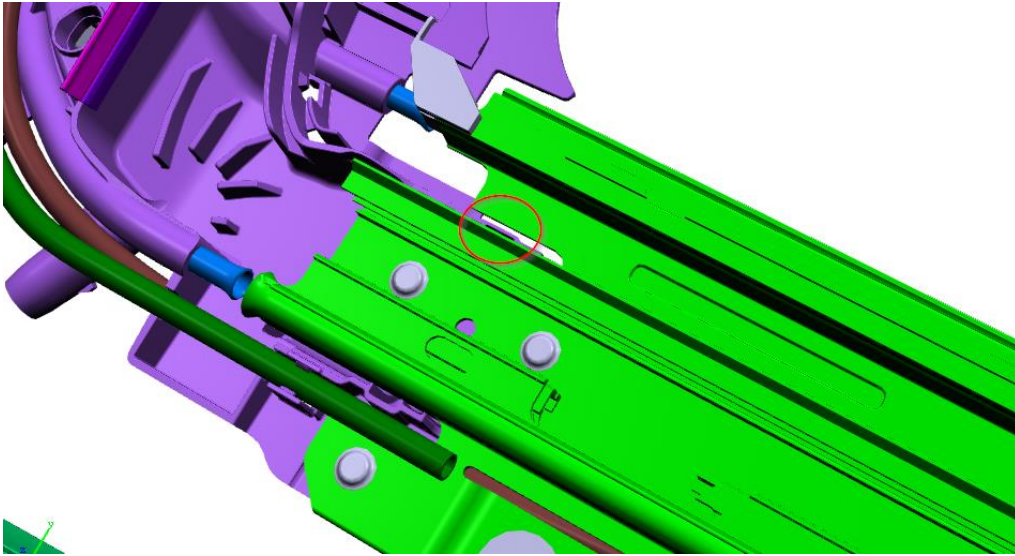
WIND DEFLECTOR EXCESS BUTYL

Picture of NOK (Before adjustment)

Picture of OK (After adjustment)

Situation: A popping noise is heard when the wind deflector raises/lowers.

Repair: Remove excess butyl to allow the wind deflector to move freely.

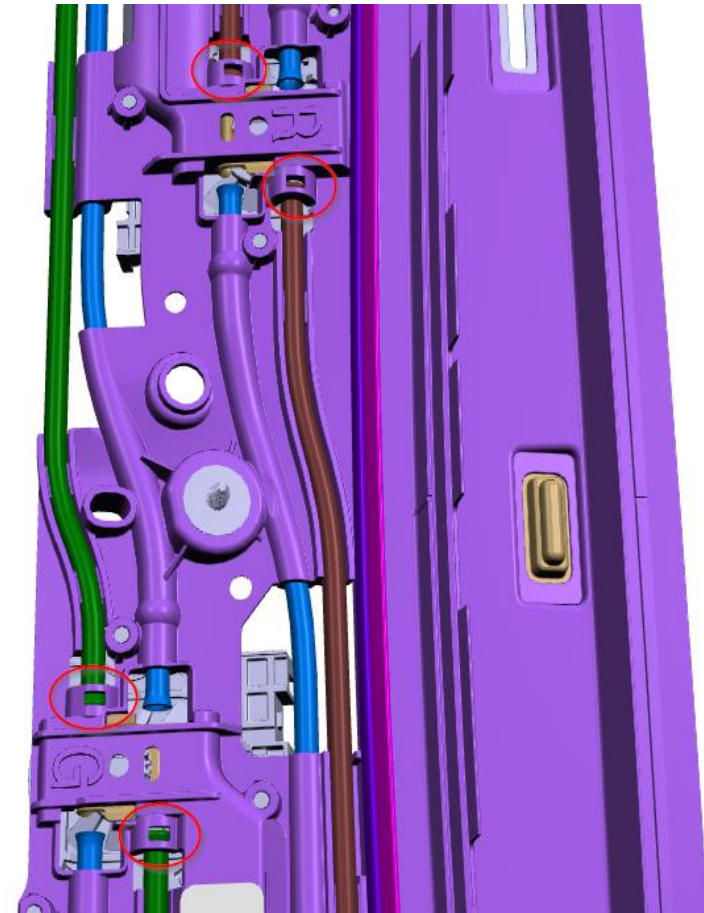
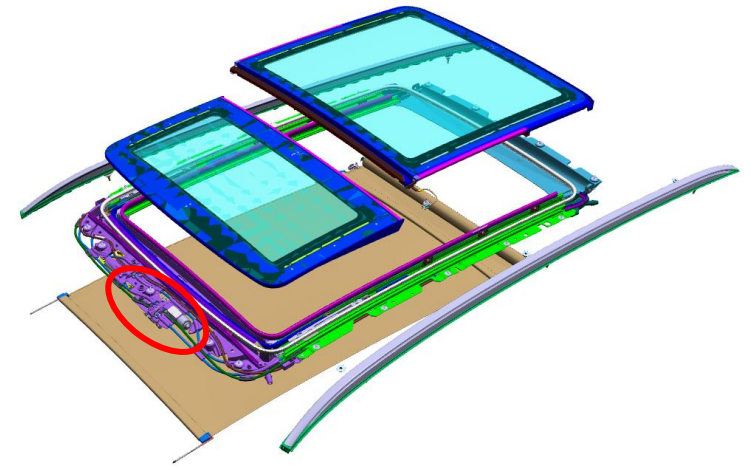
RELIEF CABLE TUBE NOT INSTALLED

Bead not visible in window

Situation: A humming / crackling noise is present when opening the glass or sunshade.

Repair: Replace frame according to ISTA/AIR instructions REP 54 13 261.

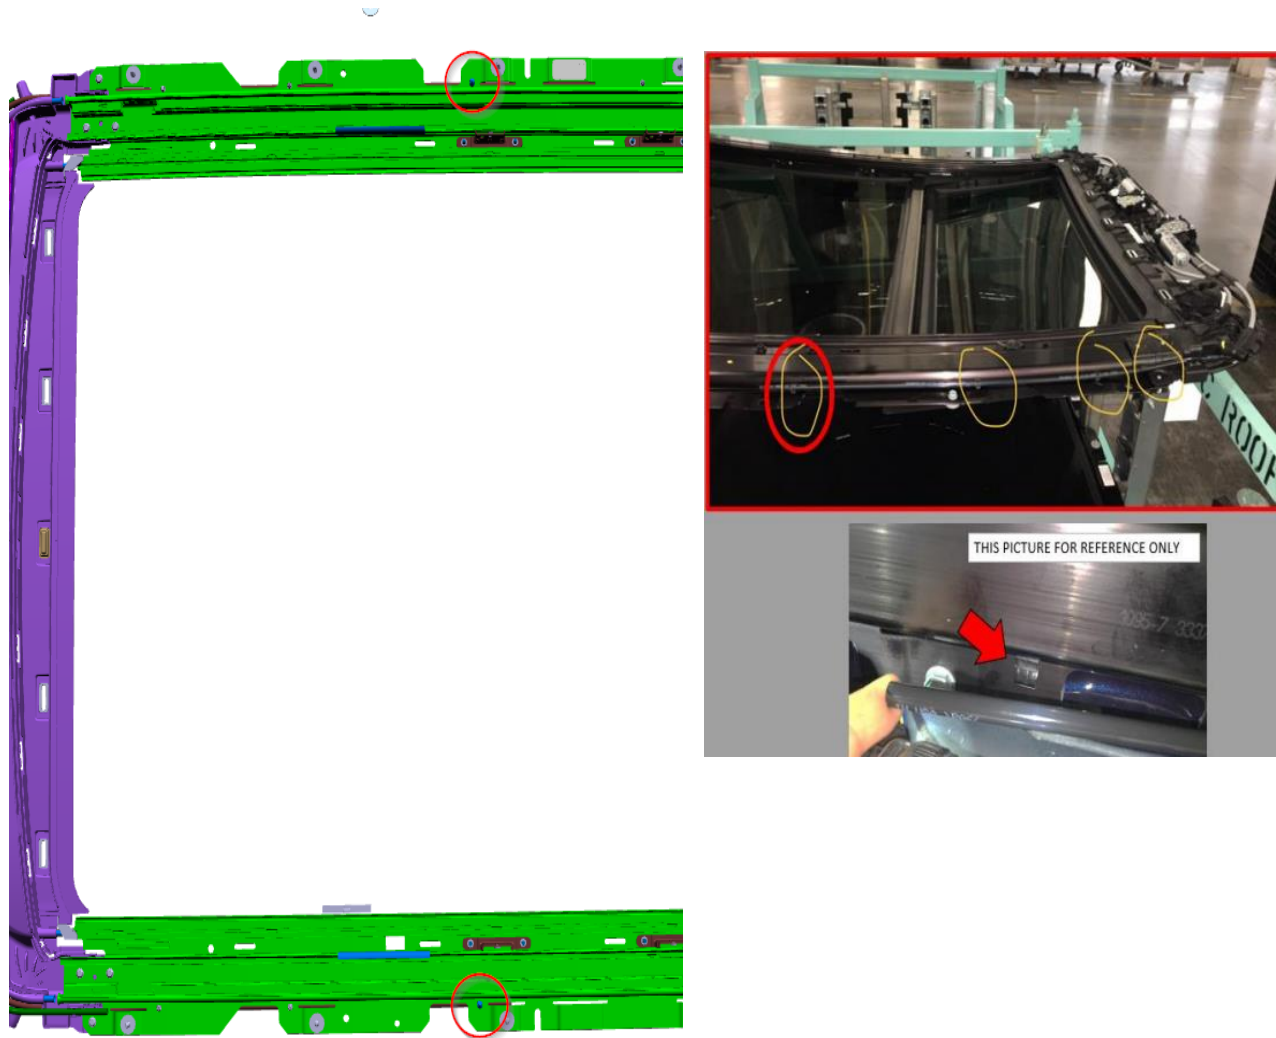
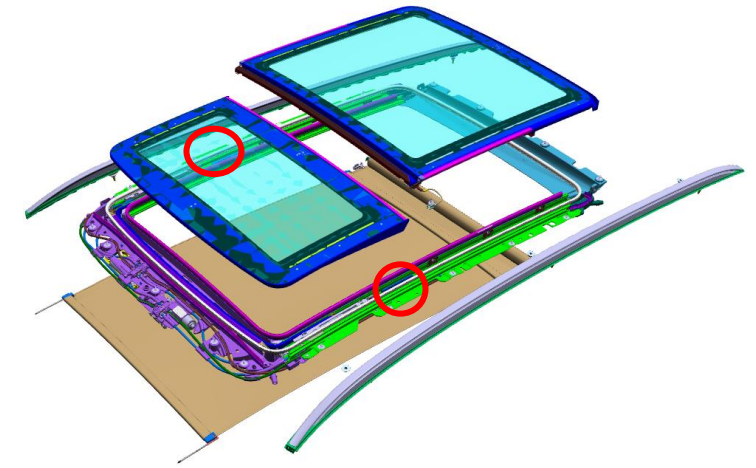
CABLE TUBE CLIP NOT INSTALLED

Situation: A humming / crackling noise is present when opening the sunshade or, a plastic rattling noise is heard while driving on rough road surfaces.

Repair: Reinstall the guide tube clip into the frame. If tube is damaged and noise persists then replace the frame according to ISTA/AIR instructions REP 54 13 261.

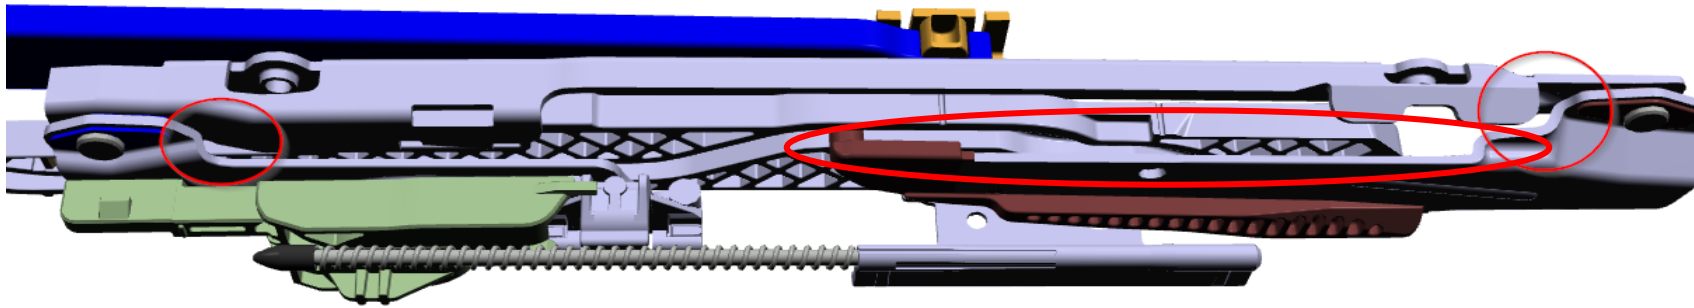
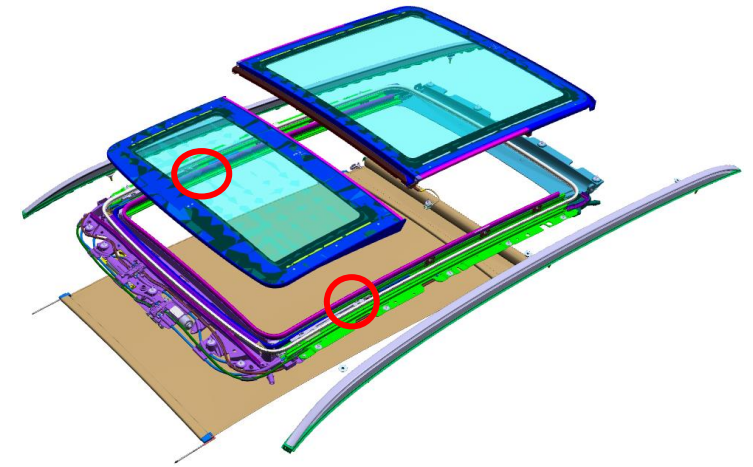
MECHANIC ARM BURR

Situation: A clicking sound is present when the glass is opened to vent.

Repair: Inspect the pivot area for a burr and remove it if found. If the burr can't be found or it can't be repaired, replace the sunroof mechanisms according to ISTA/AIR instructions REP 54 13 515.
