E-Series	Model Description
G60	5 Series Sedan, i5 Sedan
G70	7 Series Sedan, i7 Sedan

When driving over rough surfaces, a low-frequency rattling noise can be heard inside the vehicle's cabin. The noise typically sounds as though it is coming from the front right footwell area.

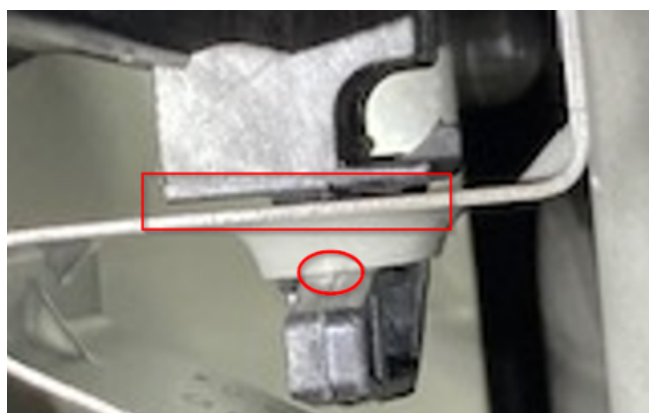
The washer fluid reservoir mounting hook has too much play, which allows the reservoir to vibrate and cause a noise.

1. Inspect the washer fluid reservoir for play or looseness, check the mounting points or areas where contact may occur.
2. Confirm the source of the noise is the washer fluid reservoir.

Replace the washer fluid reservoir.

3. If the noise is determined to originate from the reservoir, replace it with the improved part listed below. Follow the repair instructions **“Replacing the washer fluid reservoir for the washer system 61 71 065 | REP-REP-P-6171065-G60/G70 - V.1”**.

4. After performing the washer fluid reservoir installation, check for leaks; and test the functionality of the system.
