# Service Bulletin

Bulletin No.: 23-NA-004  
Date: January, 2024

Subject: Front Door Panel Separating

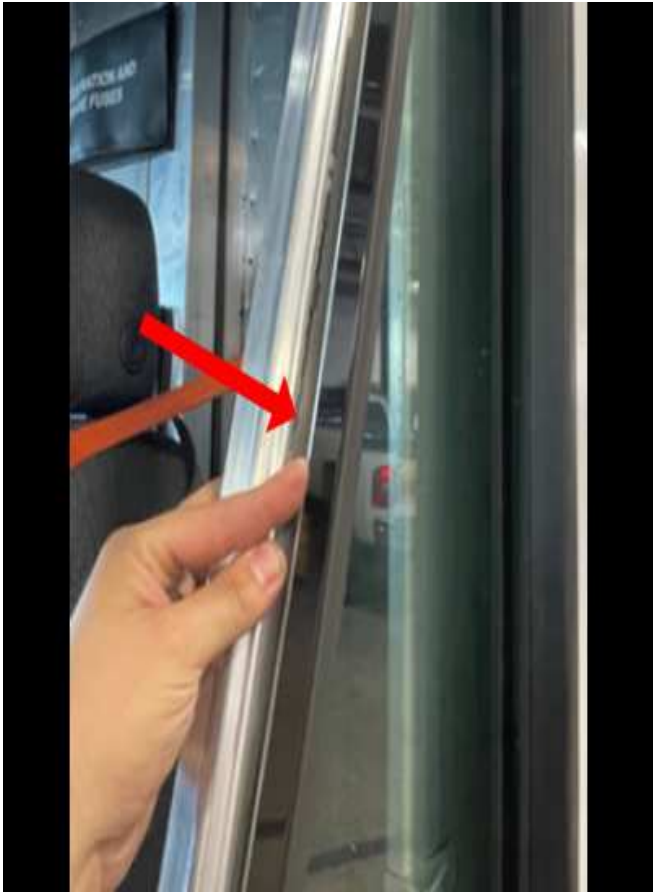
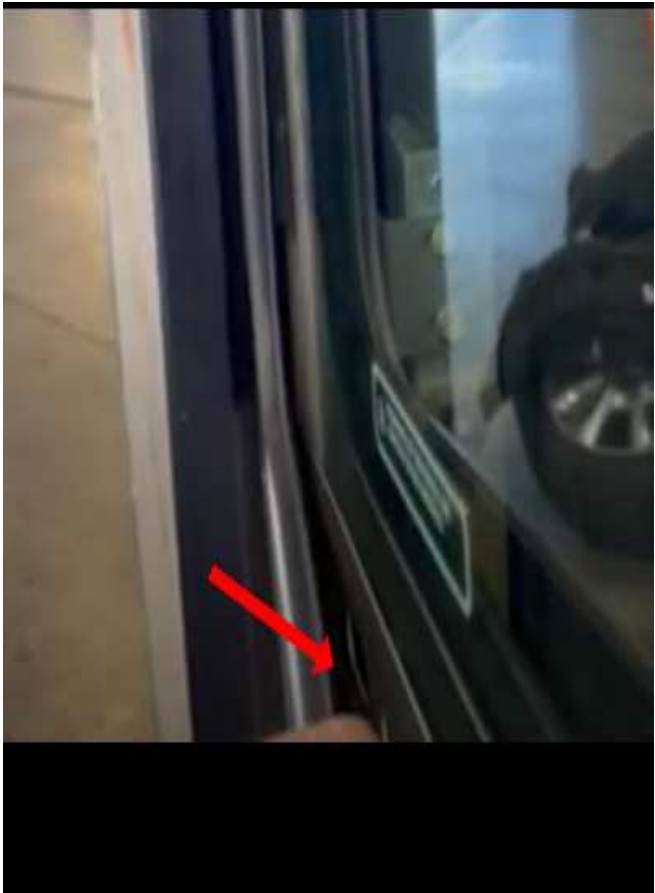
| Condition | <p>Some customers may comment that the front (inner or outer) side door panel is separating from the door frame.</p> <p>6252115</p> |

| Cause | The causes of the condition may be due to the loss of adhesion of the bonding tape that secures the outer panel to the door frame. |

| Correction | Upon verifying that the door can be repaired in a manner that will provide the proper appearance and function, Dealers are to resecure the inner and outer door panels using additional fasteners per the steps in the service procedure below. If the damage to the door is determined to be not repairable, the complete door assembly must be replaced per the PN's listed in the GM EPC. |

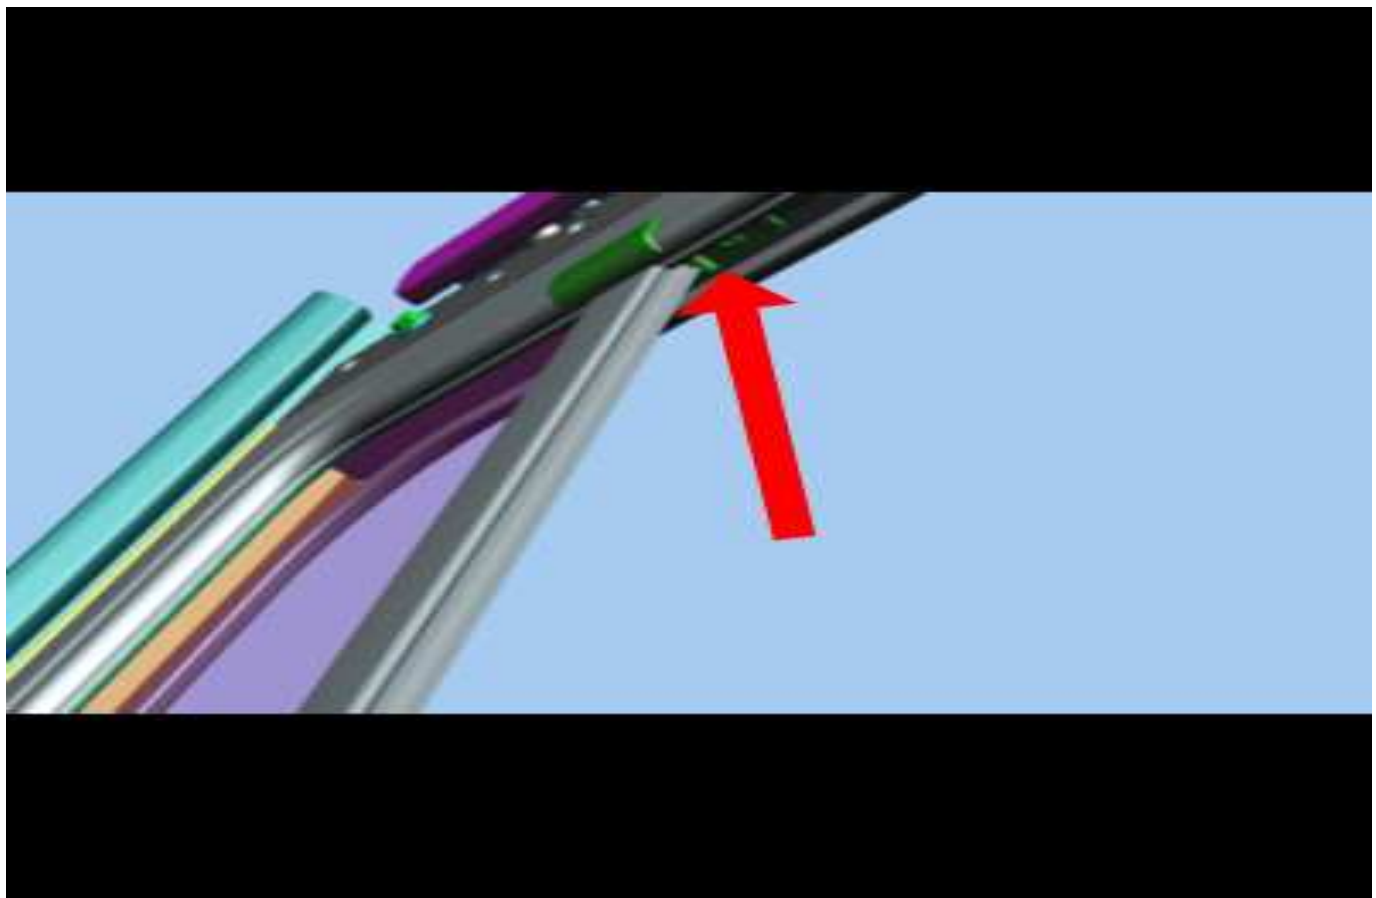
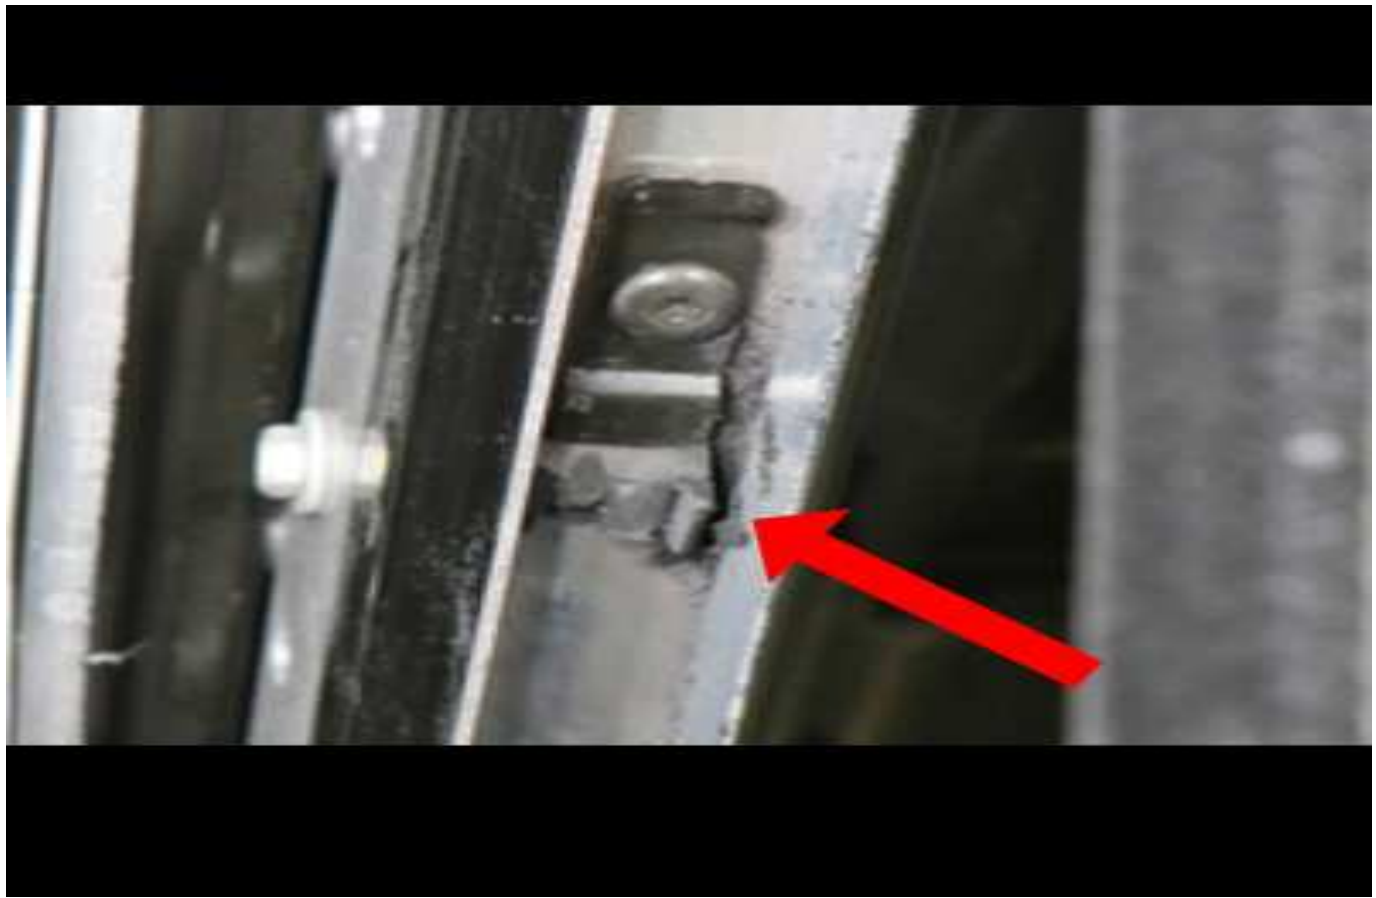
1. Disengage the inner and outer upper weatherstrips at the front side door stationary window and inspect the upper bracket for signs of breakage or damage.

- If the bracket shows any signs of breakage or damage, replace the front side door stationary window. Refer to *Front Side Door Stationary Window Replacement in the Service Manual*.
