# Technical Service Bulletin

## 40 Visual complaint - grease emerging from swivel joint

40 24 71 2068702/3 January 12, 2024. Supersedes Technical Service Bulletin Group 40 number 23-65 dated June 29, 2023 for reasons listed below.

Model(s)	Year	VIN Range	Vehicle-Specific Equipment
e-tron GT, and RS e-tron GT	2022 – 2023	All	Not Applicable

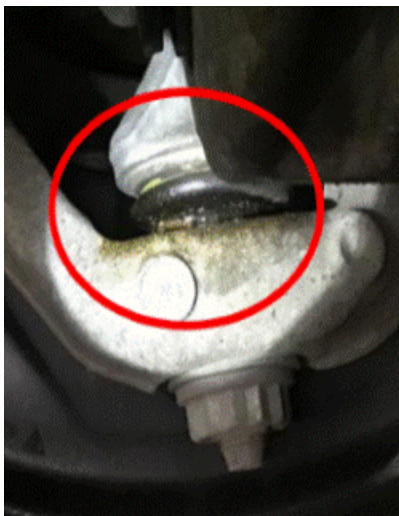
When inspecting the underbody of the vehicle, you notice grease emerging from the sleeve of the swivel joint on the lower suspension link on the left and/or right side (Figure 1).

*Figure 1: Grease emerging from swivel joint.*

When the individual suspension components (wheel bearing housing, suspension link, etc.) are assembled, grease may emerge from the sleeve when the components are bent/moved. The sleeve only forms a seal once the wheel bearing housing has been bolted on.

The grease becomes liquid due to heat conditions, making it appear as though the sleeve is leaking.

- **Do not replace any components.**
- Clean the affected area and check the sleeve for damage. It is not necessary to reapply grease to the sleeve.
- Release the vehicle.
