# Technical Service Bulletin

## 90 Flickering lines in Audi virtual cockpit

90 24 72 2072065/2 January 22, 2024. Supersedes Technical Service Bulletin Group 90 number 23-57 dated November 20, 2023 for reasons listed below.

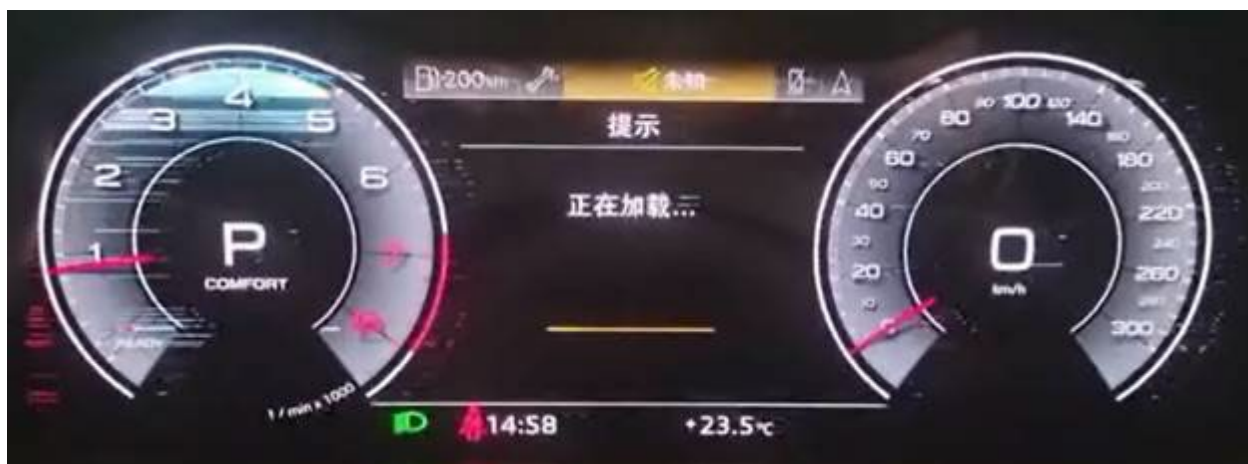
**Customer states:** The Audi virtual cockpit displays flickering horizontal, vertical or diagonal lines (Figures 1-2).

Figure 1: This is an example of horizontal lines in the virtual cockpit.

Hardware issue in the Audi virtual cockpit.

1. In your warranty claim notes document the production date of the instrument cluster. To do so:
  - a. Using ODIS: Right click diagnostic address 17>>Identification>>Production date
2. Replace the Audi Virtual Cockpit -J285- according to the instructions of the ELSA repair manual.

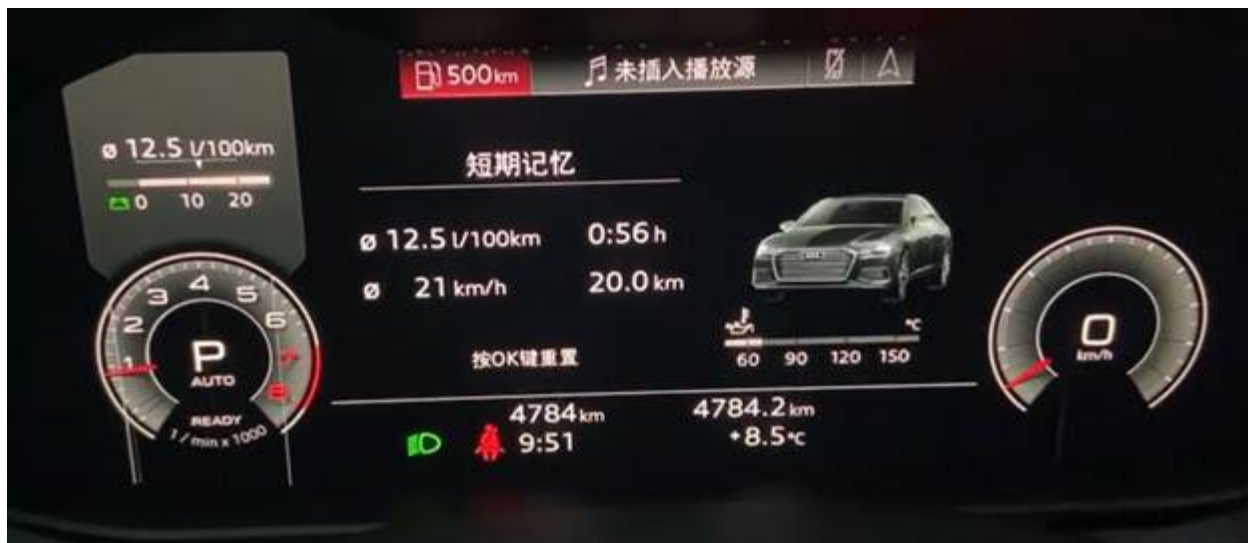
Figure 2: This is an example of vertical lines in the virtual cockpit.
