Technical Service Bulletin

91 Audi connect: Remote locking/unlocking not possible

91 24 58 2071297/2 January 19, 2024. Supersedes Technical Service Bulletin Group 91 number 23-27 dated August 24, 2023 for reasons listed below.

| Model(s) | Year | VIN Range | Vehicle-Specific Equipment |
|---|---|---|---|
| Q3 | 2019 – 2024 | All | Not Applicable |

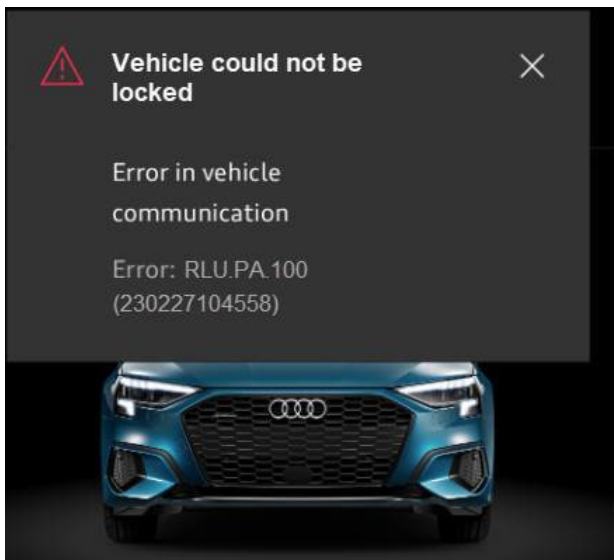
- RLU.PA.100 (iOS - Figure 1).

Figure 1: Message for iOS devices

There is a functional issue in the onboard supply control unit (address word 0009).

If the customer description and message above are present, reset the electronic central electrics module -J519- (address word 0009).

1. Perform the guided function “Replace control module”
2. When prompted whether the data should be carried over from the old control unit, select “no”.
3. Continue in test plan as normal.

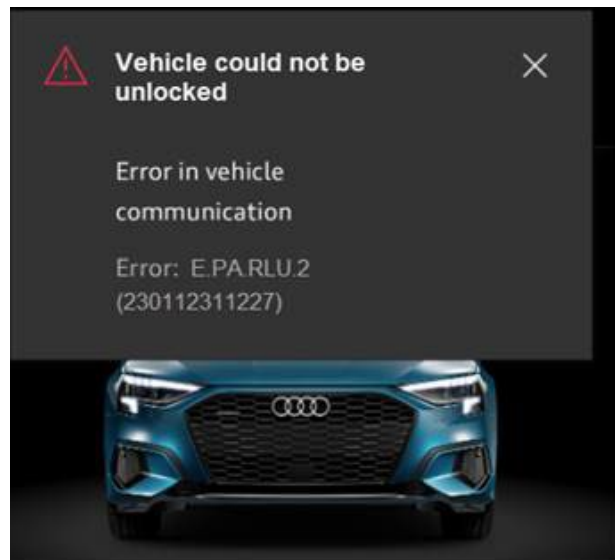
- E.PA.RLU.2 (Android - Figure 2).

Figure 2: Message for Android devices
