# Technical Service Bulletin

## 91 PSS: ConBox: Bluetooth inop / grayed out, Audi connect features inop, antenna malfunction, SOS malfunction

91 24 59 2071693/2 January 22, 2024. Supersedes Technical Service Bulletin Group 91 number 23-32 dated October 9, 2023 for reasons listed below.

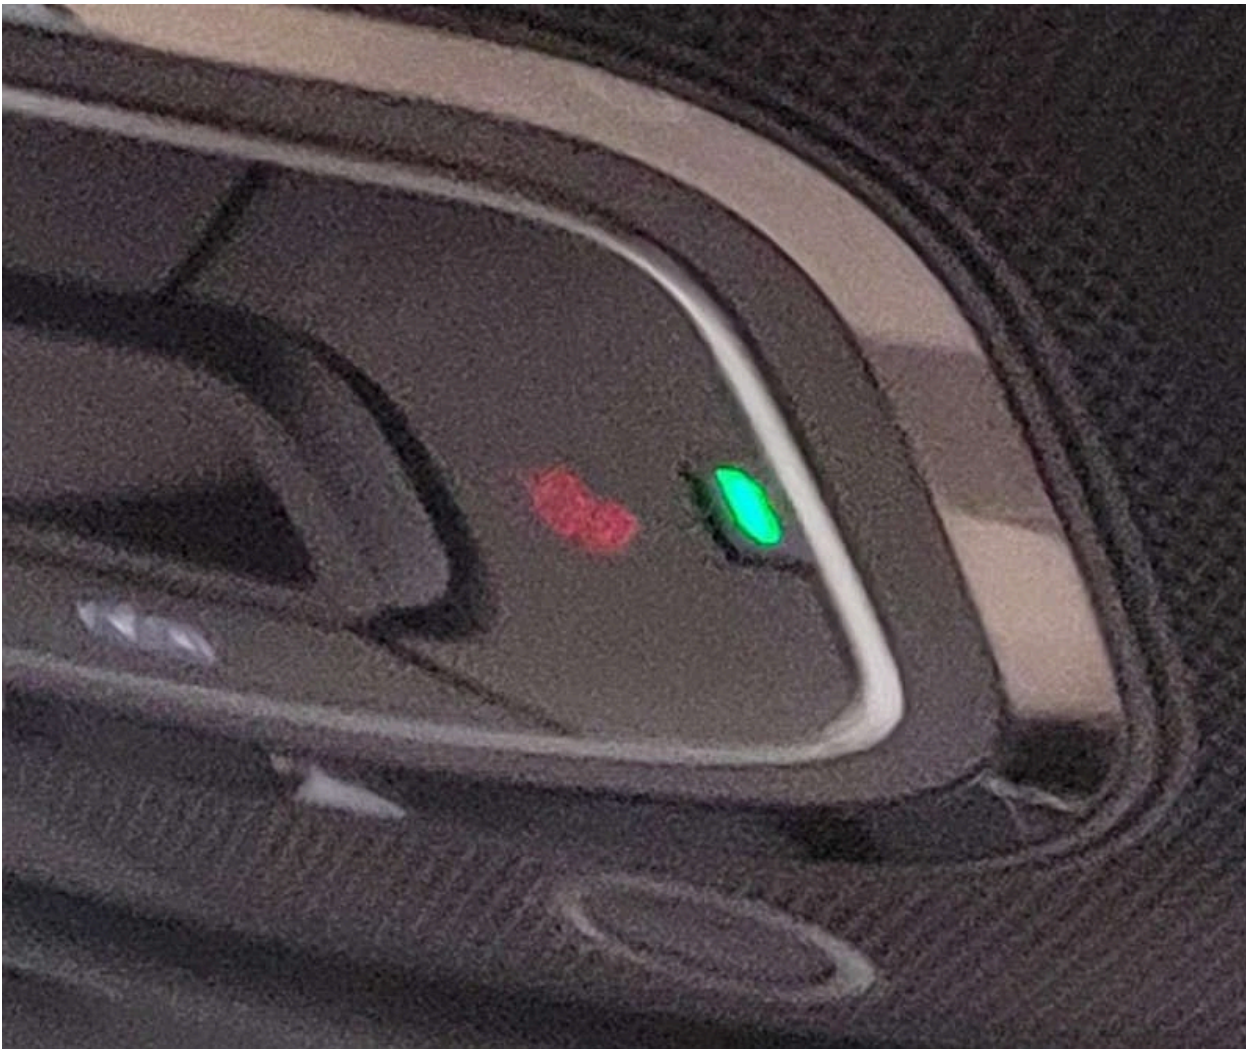
The e-Call LED in the roof module remains illuminated green at all times (see Figure 3).

*Figure 3: e-Call LED illuminated green.*

If the e-Call LED is not illuminated, or illuminated red, and no other DTCs then listed in this TSB, or only “ghost faults” (marked as unauthorized in the GFF log) are present, it is likely that the issue is due to a connectivity or backend issue, not a hardware issue. In these cases, this TSB does not apply. Please do not replace parts solely because of ghost faults.
