Technical Service Bulletin

97 MIL on: DTC U064100 or U064000 for fuel tank breather - 2.0 ltr. TFSI EA888

97 24 05 2069123/2 January 18, 2024. Supersedes Technical Service Bulletin Group 97 number 23-90 dated January 17, 2023 for reasons listed below.

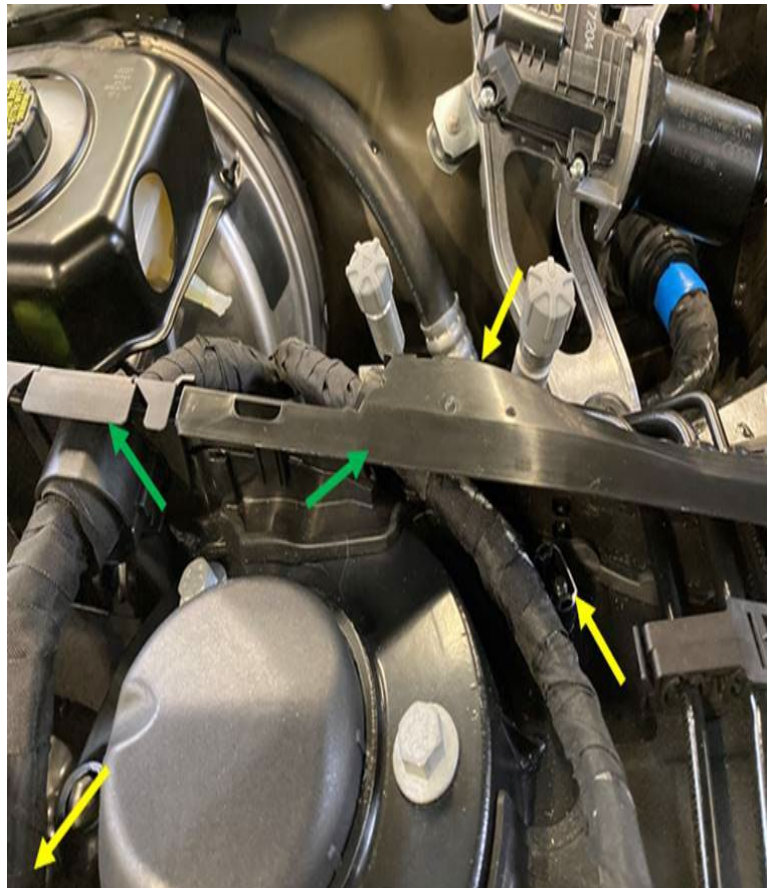
Figure 1: Plenum chamber covers (green arrows).

1. Remove plenum chamber covers (green arrows, Figure 1)

Release wiring harness securing clips (yellow arrows, Figure 1).

Using a seam ripper, expose the wiring harness as shown in Figure 2.

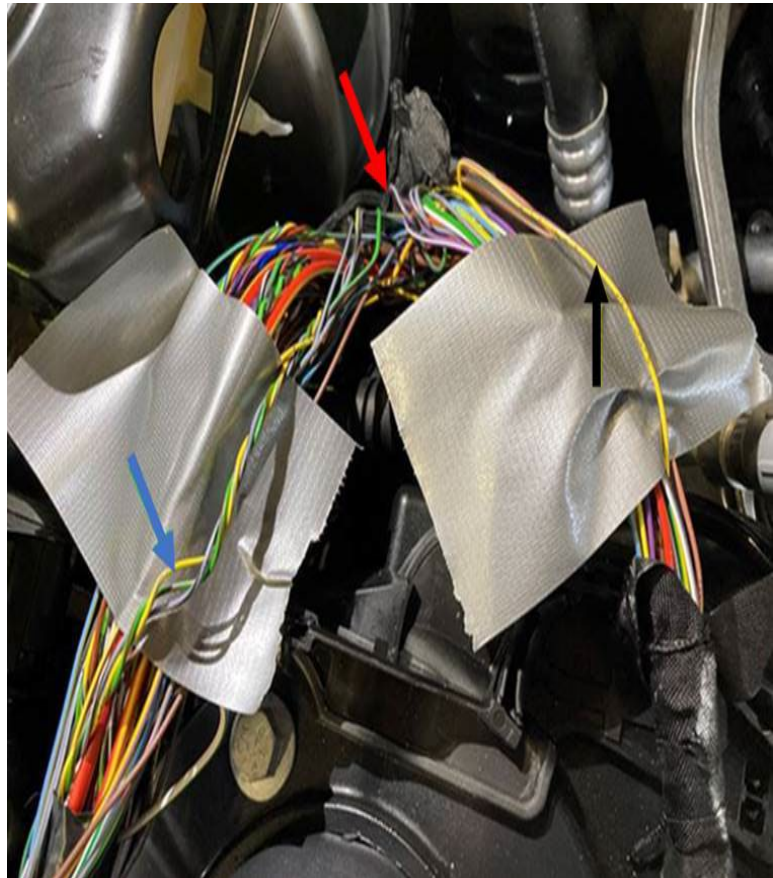
Figure 2: Wires isolated for modification.

2. Isolate the yellow/grey wire (triple twisted wire; blue arrow, figure 2) in the left bundle.

Isolate the yellow/purple wire in the right bundle (black arrow, Figure 2).

Cut the yellow/grey wire at the blue arrow and unravel it in the direction of the plenum chamber up to the red arrow.

Cut the yellow/purple wire at the black arrow.

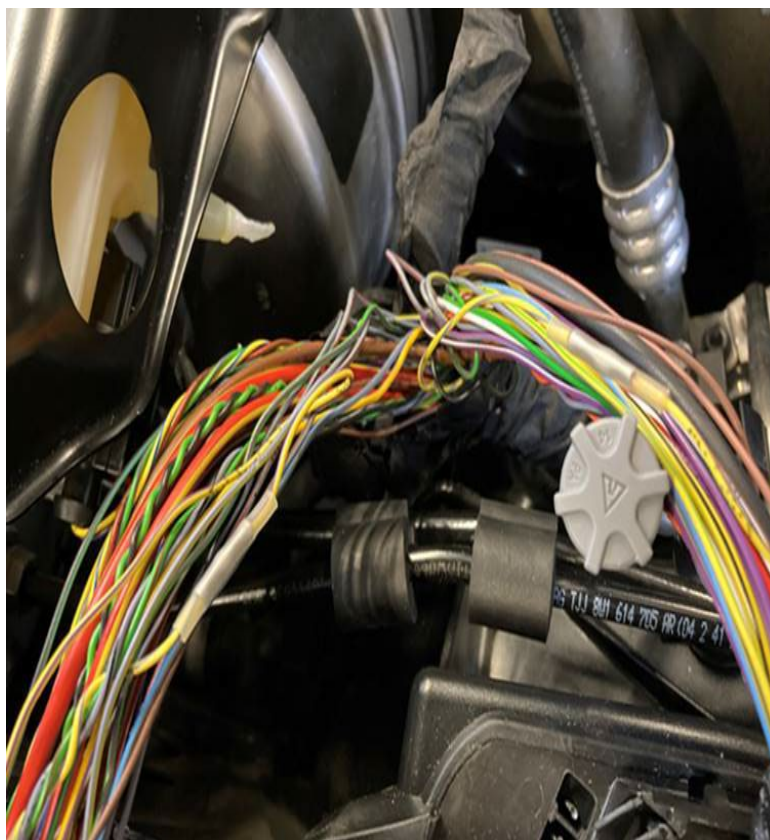
Figure 3: wire modification complete.

3. Using wire harness repair set **VAS 1978 B**, perform the following:

Connect the untwisted yellow/grey wire (plenum chamber side) from the left bundle to the yellow/purple wire in the right bundle (engine side).

Connect the remaining yellow/purple wire (plenum side) to the yellow/grey wire (engine side).
