SIB 41 05 23

2024-01-22

SERVICE ACTION: CHECKING THE GAPS ON THE TAILLAMPS

E-Series	Model Description	Production Date
U11	X1 Sports Activity Vehicle	August 2, 2022 – August 31, 2023

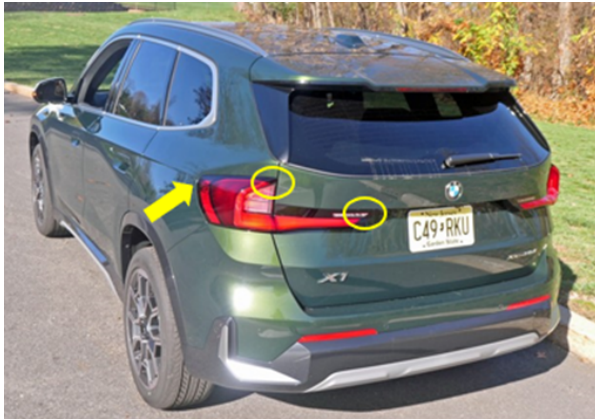
Contact between the taillamps and the tailgate/side panel(s) can occur. This can cause paint abrasion, and over time corrosion can form on the body of the vehicle/tailgate.

Note: This can occur on either one or both sides of the vehicle.

Measure the gaps between the taillamps' housing and the tailgate/side panels. If the gap is too small, the taillamp(s) must be removed and the specific area of the tailgate/side panel(s) will need to be inspected for corrosion.

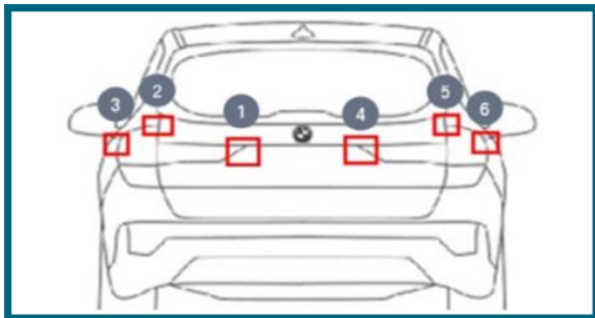
Chafe mark 1, or
Chafe marks 2, 3, or
Chafe marks 4, 5, 6

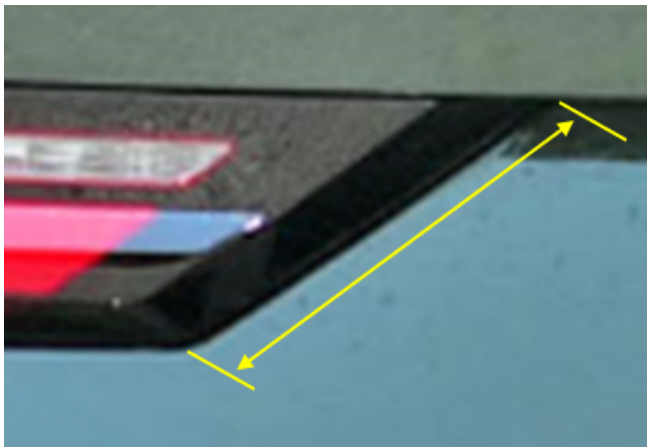
1. Inspect the inner taillamp(s) housing on the tailgate for correct gap.

The gap is to be checked at the diagonal area of the taillamps as shown in the photo.

Note: Check both inner taillamps' gap.

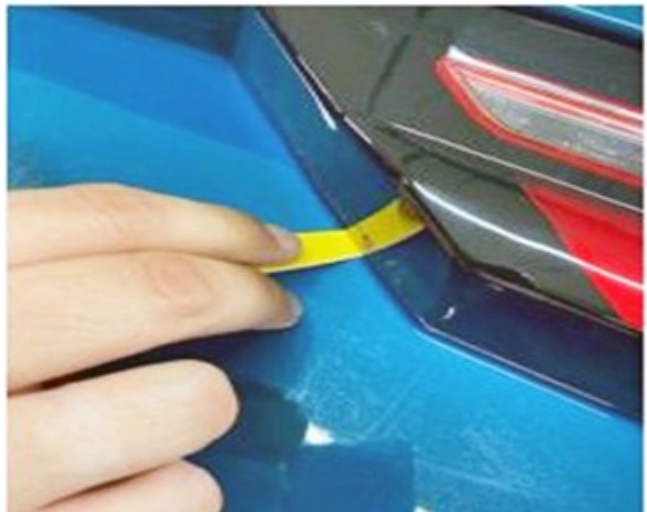
Attempt to insert a small strip of writing paper between the diagonal part of the taillamps housing and tailgate.

If the paper **CAN** be inserted in the gap between the inner taillamps housing and tailgate, the taillamp(s) is OK.

If the paper **CANNOT** be inserted in the gap between the inner taillamp(s) housing and tailgate, continue to step 2.

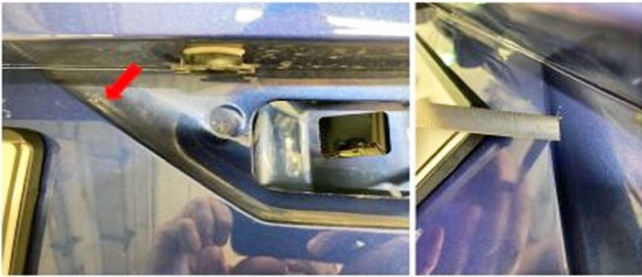
3. Clean off the tailgate paint using R2 cleaner. Inspect for any paint abrasion. The critical area is 5mm inward from the top edge as shown in the photo.

4. (A). If there is NO abrasion of the clear coat or the base color, or if there is only minor abrasion which dulls the clear coat, NO paint touch-up is needed. Continue to step 5.

(B). If the clear coat or base color is abraded so that the primer is visible: Touch up the area with the matching touch-up paint stick. Continue to step 5 afterwards.

(C). If the paint is not only damaged/abraded but there is bubble formation under the paint (lifting) or even rust formation, the damaged area must be repaired, and the entire tailgate repainted. After the repainting, continue to step 5.

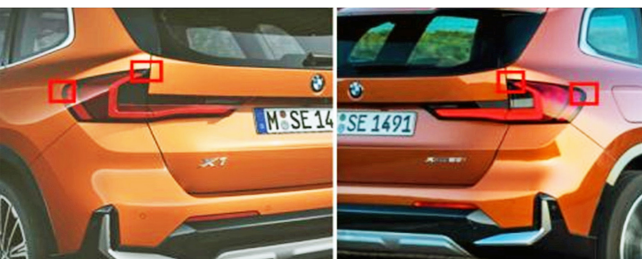
7. Check the outer taillamps in the areas shown in the photo.

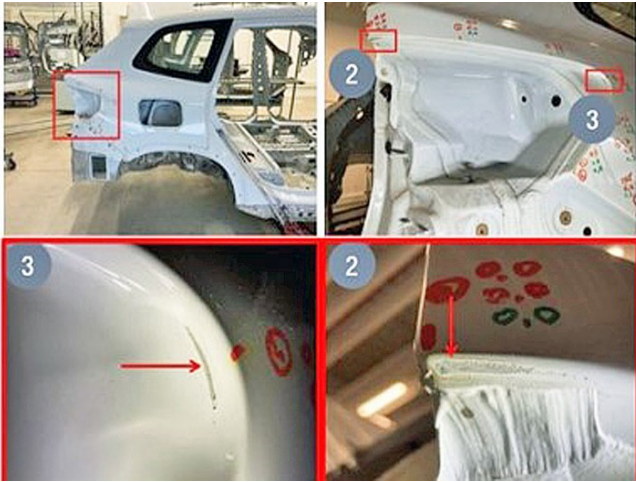
9. The right side shown with the body partially stripped for clarity. The specific areas to be checked are in the red boxes as shown in the photo.

If the paper **CAN** be inserted in the gap between the outer taillamps housing and the side panel(s), the taillamp is OK.

If the paper **CANNOT** be inserted in the gap between the outer taillamps housing and the side panel(s), continue to step 10.

10. Remove the outer taillamp(s) that is contacting the side panel(s) following the repair instructions listed in ISTA/AIR 63 21 275/277 and/or 63 21 283

11. Clean the side panel(s) paint where the outer taillamp sits using R2 cleaner. Inspect for any paint abrasion.

- (A). If there is NO abrasion of the clear coat or the base color, or if there is only minor abrasion which dulls the clear coat, no paint touch-up is needed.
- (B). If the clear coat or base color is abraded so that the primer is visible: Touch up the area with the matching touch-up paint stick. Continue to step 12.
- (C). If the paint is not only damaged/abraded but there is bubble formation under the paint (lifting) or even rust formation, the damaged area must be repaired, and the entire side panel repainted.

12. Install taillamp(s). Adjust the gap to the side panel to 1.1 mm.
