SIB 01 05 20

2024-01-23

N47/N57 DIESEL ENGINE EGR COOLER EXT LTD WTY (ELW) 10 YRS WITHOUT MILEAGE LIMIT

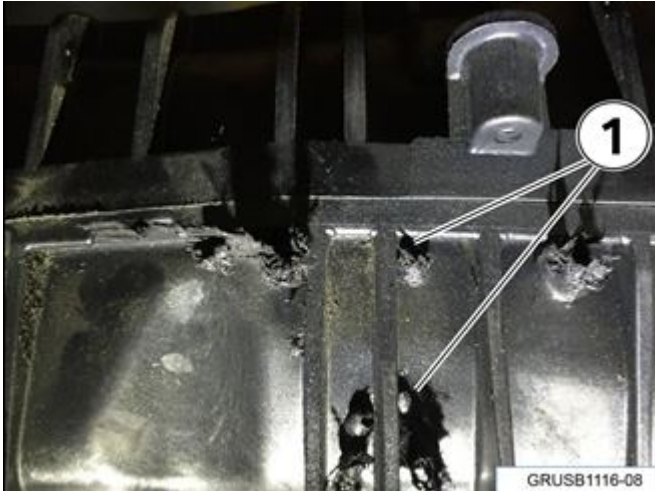
1. Remove the engine cover and inspect the intake manifold and venturi pipe to the throttle for holes or cracks.

Are there visible signs, on the intake manifold and venturi pipe, of overheating, similar to the illustration (1)?

- YES – go to step 4.
- NO – continue with step 2.

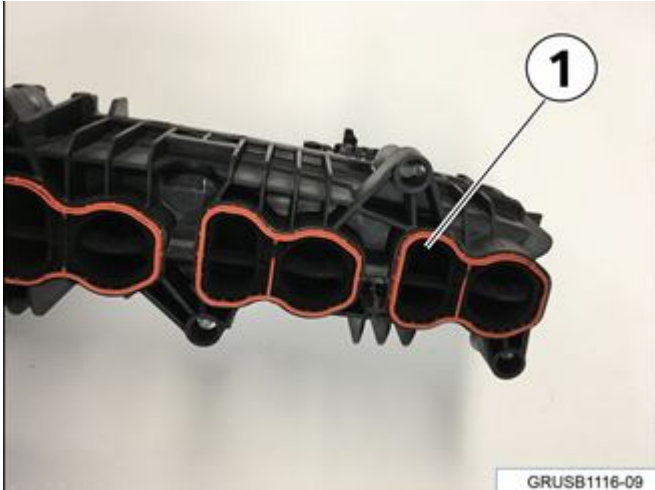
6. Check all swirl flaps for damage or melted/missing parts (1).
Are any swirl flaps damaged?
 YES- Continue to step 7.
 NO - Go to step 8.

Note: N57T is pictured, N47T is similar.

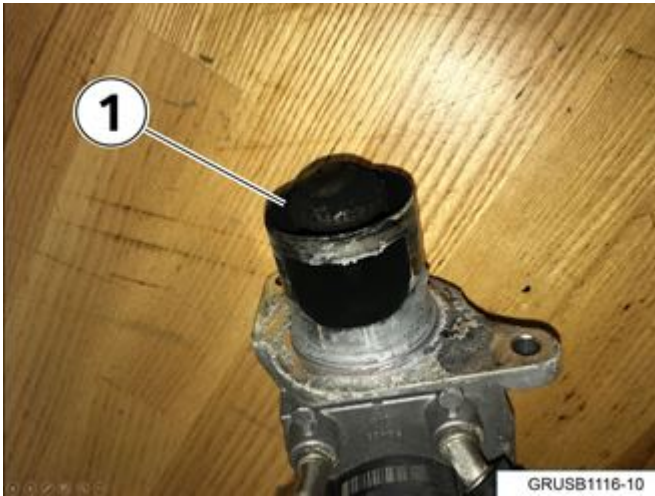
8. Remove the EGR valve and check for jamming (valve is normally sprung closed).
Is the EGR valve jammed or stuck open?
 YES- continue to step 10.
 NO – go to Step 9.

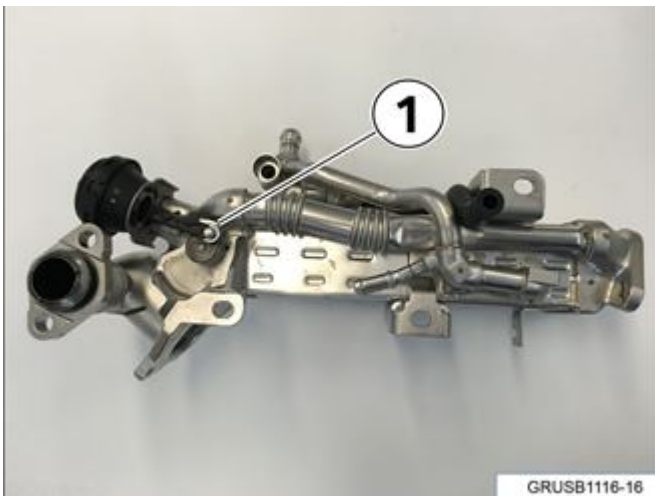
9. Check the bypass flap on the EGR cooler.
Is the flap binding?
 YES- Replace the cooler (with EGR valve).
 NO – Reinstall the EGR valve and continue to Step 11.

10. If the EGR valve is stuck open, check the valve for debris holding the valve open.
Is there debris jamming the valve open?
- YES (debris) - Replace the EGR cooler (with new EGR valve).
 - NO (open, but no debris) - Continue to Step 11.

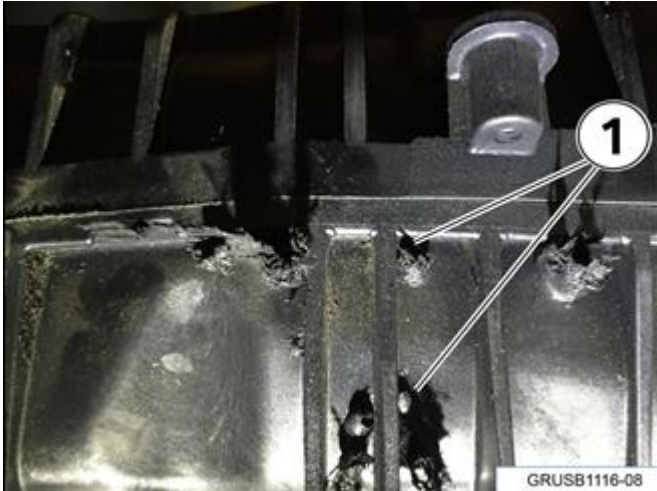
1. Remove the engine cover and inspect the intake manifold and venturi pipe to the throttle for holes or cracks.

Are there visible signs, on the intake manifold and venturi pipe, of overheating, similar to the illustration (1)?

- YES – go to step 5.
- NO – continue with step 2.

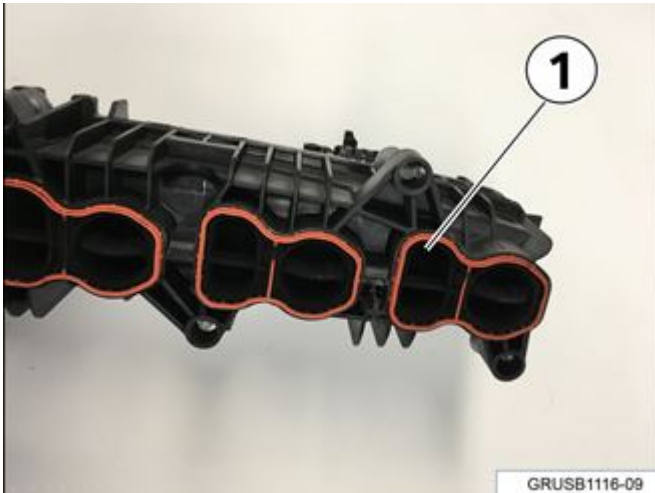
6. Check all swirl flaps for damage or melting/missing parts (1).

Are any swirl flaps damaged?

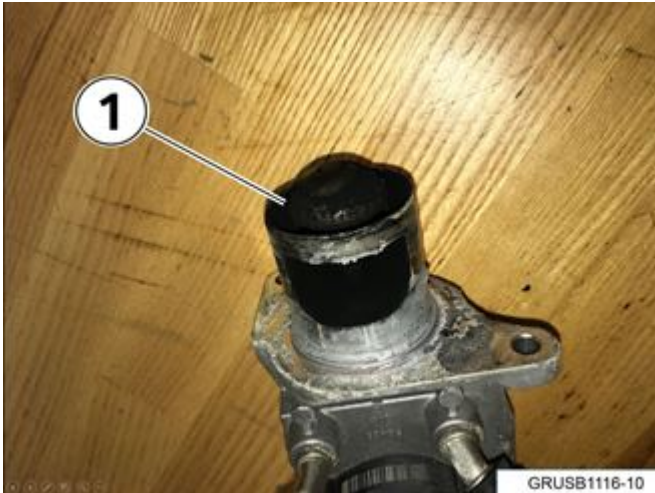
8. Remove the EGR valve and check for jamming (1) (valve is normally sprung closed).

Is the EGR valve jammed or stuck open?

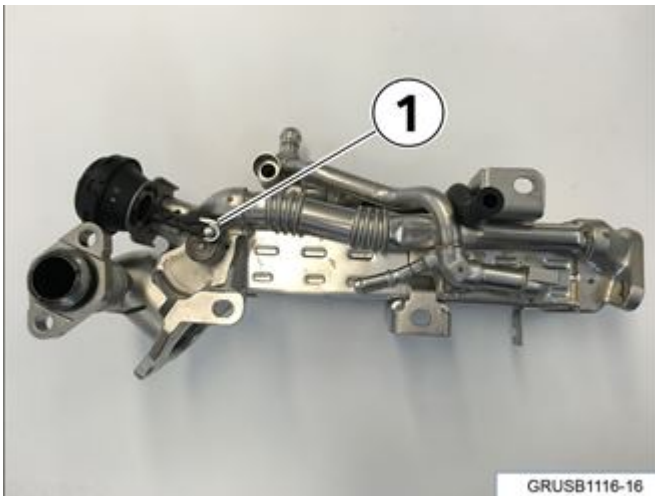
9. Check the bypass flap on the EGR cooler.

Is the flap binding?

YES- Replace the cooler (with EGR valve).

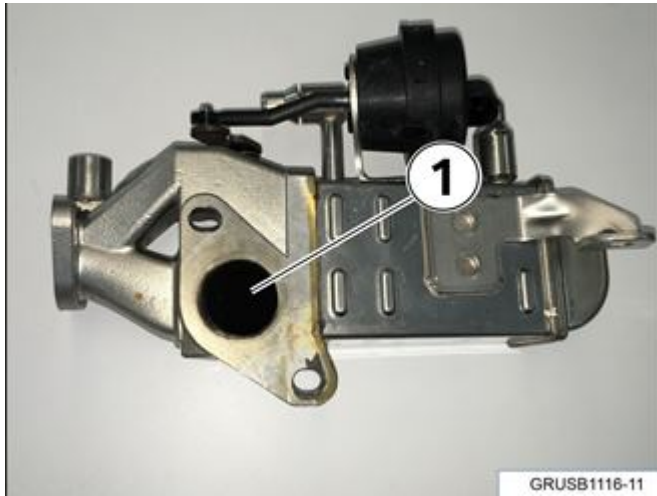
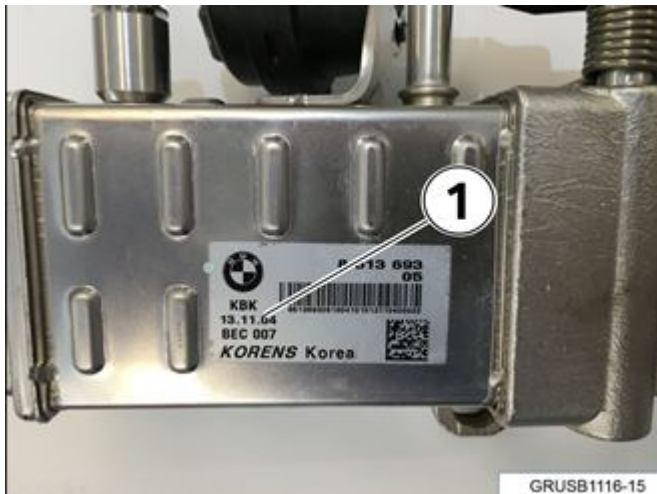
12. Inspect the cooler by-pass flap (1).

Is the flap intact?

YES- Check the production date of the cooler (1). If the production date is before 15.02.20 (**YY.MM.DD or February 20, 2015**) replace the cooler. If the production date is newer – reinstall the cooler.

NO (flap missing or damaged) – Replace the cooler and continue to step 13.
