Technical Journal Title Wireless Phone Charger (WPC) - no/unstable charging		Ref. No. TJ 36693.2.1	
Issuer (Dept.) Technical Service		Issue Date 1/26/24	Status Date 1/30/24
Car Market United States and Canada	Partner 3 US 7510 Volvo Car USA	Function Group 3942	
Function Description Mobile telephone		Page Page 1 of 4

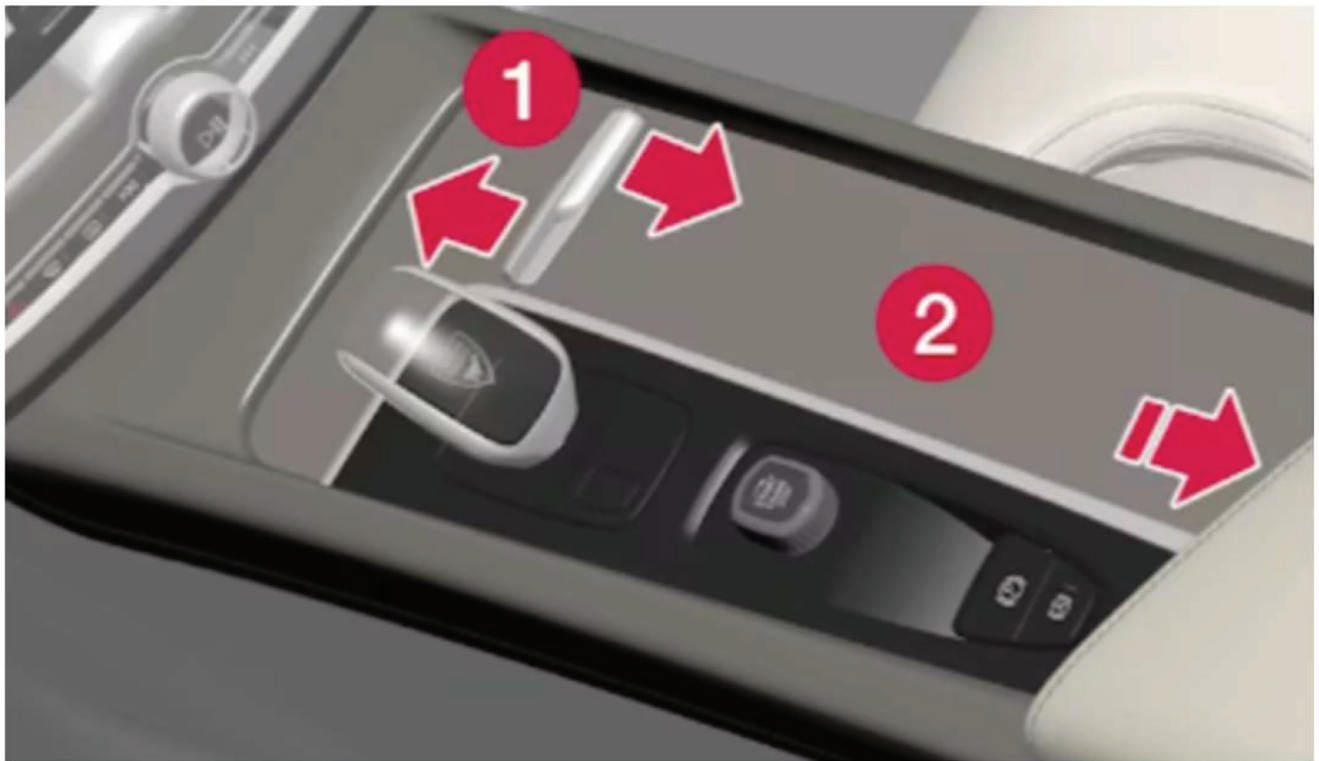
TJ 36693

- When performing PDS SWDL on MY24 cars with a WPC, hardware part no. 32359823, it is crucial that no phone or other external metallic object is placed on top of, or near (up to 60mm), the WPC. The car radio must also be off. For SPA cars, open the blinds/hatches in the tunnel console (see attachment).
- If this was not followed during the PDS SWDL, then the WPC will be incorrectly calibrated, resulting in no charging or unstable charging performance. To solve this issue, recalibrate the WPC by performing the following sequence:

1. Make sure that the blind/hatch in the tunnel console is open and that there are no phones or other external metallic objects placed on top of, or near (up to 60mm), the WPC.
2. Download “WPC FIX”.
 S90/V90/V90CC: WPC fix: SP 32319453
 S90L: WPC fix: SP 32319472
 XC60/XC90: WPC fix: SP 32301792
 S60/V60/V60CC: WPC fix: SP 32319494
3. Download WPC reload.
4. Confirm that WPC charging function is OK
