Model series X294 EQE SUV - Driver's voice is difficult to understand/perceive when making telephone calls

Topic number	LI82.70-P-077433
Version	1
Function group	82.70 - Telephone, Voice-control-system(VCS)
Date	1/30/24
Validity	Vehicles of model series X294
Reason for change

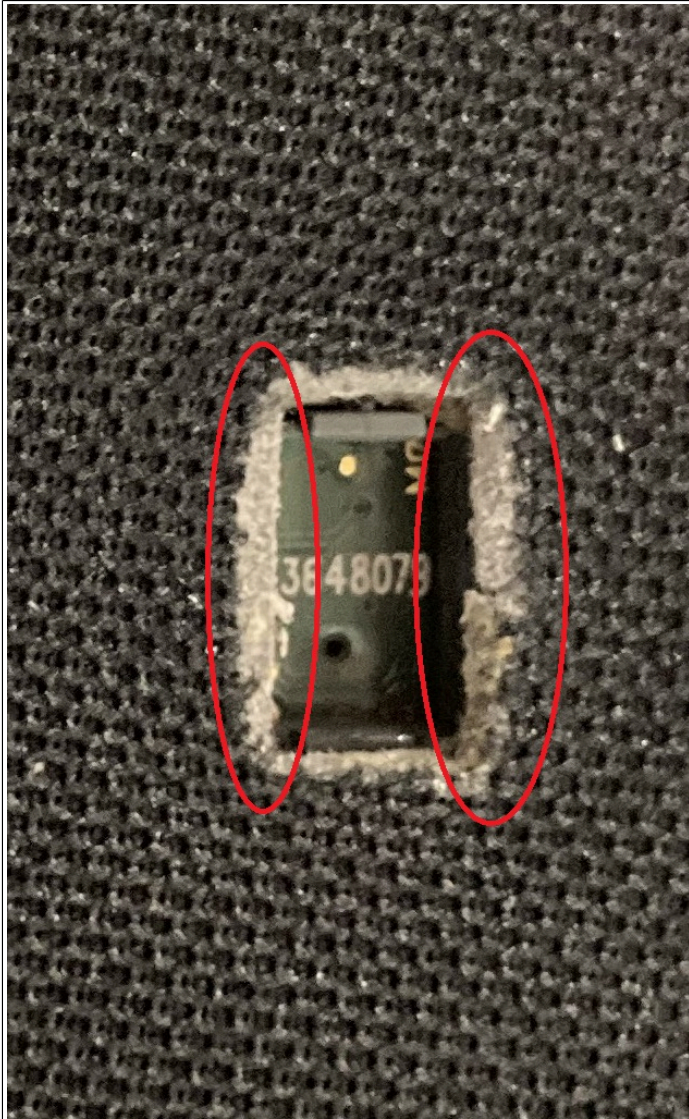
During a phone call, the called party has difficulty understanding/cannot understand the driver, or interference/background noises are audible to the called party during a call. It becomes increasingly difficult to understand as the speed rises.

- A. Seating of the microphones in the headliner. Side edges are covered by the textile cover (see picture "1")
- B. Assembly of microphones (B25/20 or B25/21) in the headliner.
- C. Dirt inside the microphone housing

Attachments	
File	Description
1.jpg	Cutout for microphone does not correspond to the specification; the side edges of the microphone are concealed.

1. Press finger on rear of microphone (on adhesive tape)
 2. Remove microphone cap from the front
 3. Eliminate protruding material residues of the microphone cutout at the headliner, e.g. with a soldering iron. The microphone must be seated in the headliner as shown in picture "2".
 4. Push microphone from behind until it is firmly pressed into the headliner
 5. Maintain pressure and press/clip cap into microphone from the front.
- Note: The cover cap must be clearly heard and felt to engage.
6. This procedure must be carried out on both microphones (B25/20 and B25/21)

Note: It is recommended to replace the cover caps.

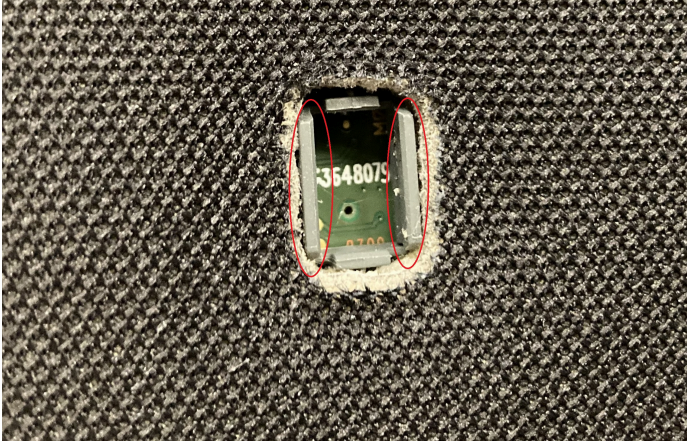
Attachments	
File	Description
2.jpg

Cutout for microphone corresponds to the specification; the side edges of the microphone are visible.
