Subject: SQUEAKING NOISE FROM REAR OF VEHICLE WHEN DRIVING ON BUMPY ROADS AND TURNING	Bulletin No.: 02-001/24
	Last Issued : 01/30/2024

2024 CX-90 with VINS lower than JM3KK*****152396 (produced before December 2, 2023)

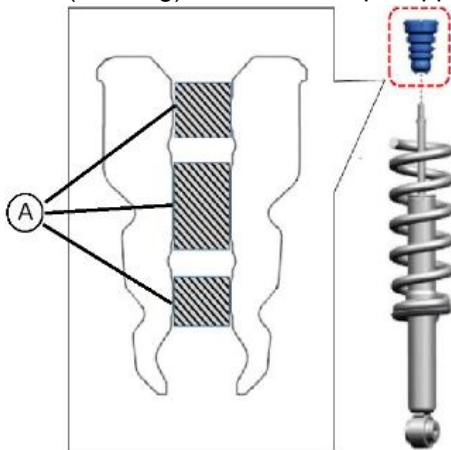
Some customers may complain about squeaking noise coming from the rear of vehicle when driving on bumpy roads and turning. This is caused when the lubricant coating comes out of the bump stopper, changing the resistance between the damper rod and bump stopper. To eliminate this concern, **rubber grease is being added inside the bump stoppers during the production process.**

1. Verify the customer concern.
2. Remove both rear bump stoppers according to the instructions in MGSSI (REAR SHOCK ABSORBER AND COIL SPRING REMOVAL/INSTALLATION) and (REAR SHOCK ABSORBER AND COIL SPRING DISASSEMBLY/ ASSEMBLY).
3. Apply rubber grease (0.5-1.0g) inside the bump stopper, principally at the areas indicated in the image below (A).
