Technical Service Bulletin

Mazda North American Operations
Irvine, CA 92618-2922

Subject: LOUD VIBRATION NOISE WHEN ELECTRIC A/C COMPRESSOR IS OPERATING	Bulletin No.: 07-001/24
	Last Issued : 01/10/2024

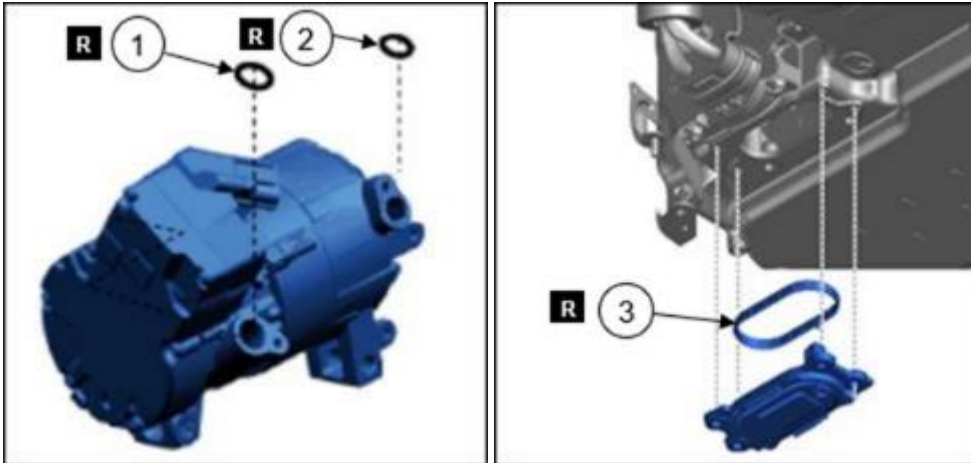
Replacement Parts Location

Parts Number	Description	Qty.	Notes
KR9P-61-4C0A	Compressor	1	
KRYP-61-K39	Oil, Compressor	1	
BBM4-61-J17	Ring, 'O' - Cooling Unit	1	[R] (1)
GJ6E-61-J19	Ring, 'O' - No.2	1	[R] (2)
KBB4-30-2K5	Gasket	1	[R] (3)

2. Replace the electric compressor with new one according to the instructions in MGSS (A/C COMPRESSOR REMOVAL/INSTALLATION [e-SKYACTIV PHEV]).
