# Technical Service Bulletin

<b>Subject:</b>  <b>SQUEAKING NOISE FROM RUBBING BETWEEN DRIVER'S SEAT BACK AND REAR CONSOLE LID</b>	<b>Bulletin No.: 09-004/24</b>
	<b>Last Issued : 01/25/2024</b>

2020-2023 CX-30

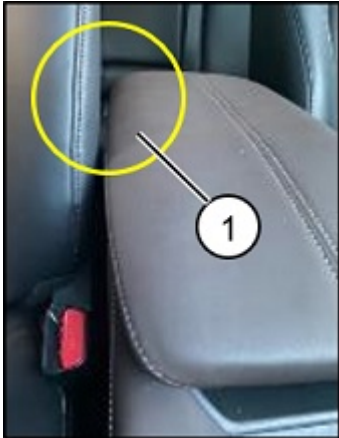
Some customers may complain of a squeaking noise from the driver side seat back. The noise may be due to rubbing between the lumbar part of the driver's seat back (1) and the rear console lid.

The lumbar support pad may be deformed outward and may rub against the rear console lid while driving or when adjusting the seat memory. This can cause a squeaking noise.

When receiving a customer complaint for this concern, install a bracket to the driver's side front seat back frame to prevent lumbar support deformation and replace the driver's side front seat back pad with a modified part according to the following procedures.

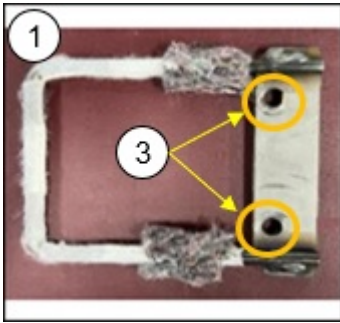
(1) Bracket  
(3) Mounting holes

1. Verify customer concern.
2. Remove the driver's side seat back trim according to the instructions on MGSS FRONT SEAT BACK TRIM REMOVAL/INSTALLATION.
3. Install the bracket (1) with the nuts and bolts to the driver's side front seat back frame (2) to prevent the seat back lumbar support deformation according to the following images.

**Tightening torque: 7.8-10.8 N·m {80-110 kgf·cm, 69-95 in·lbf}**

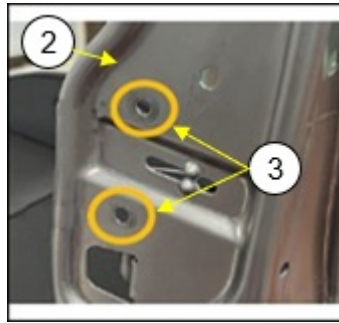
(2) Seat back frame  
(3) Mounting holes

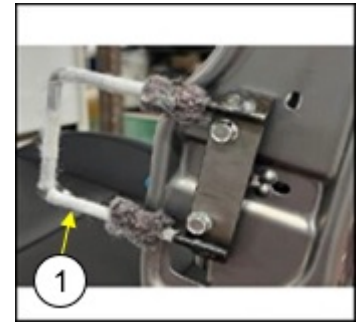
After bracket installation:  
(1) Bracket

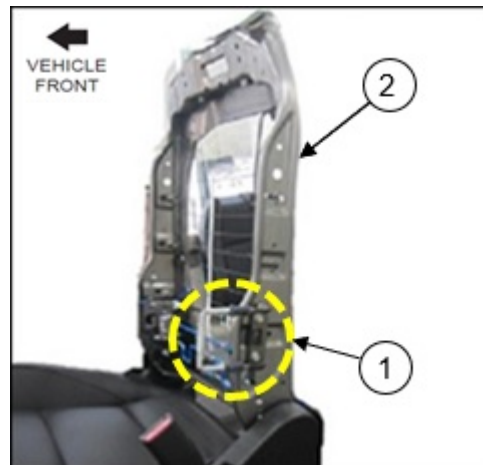
Bracket has been installed to seat back frame.

(1) Bracket  
(2) Front Seat back frame (driver's side)

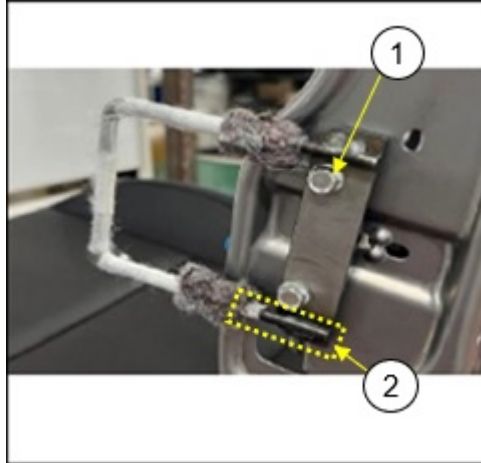
**GOOD**

- (1) Bolt head must be outside of bracket.  
 (2) Welded part of bracket must be outside.

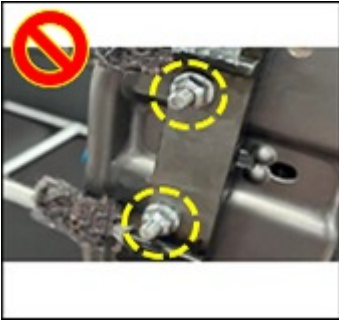
**NO GOOD**

Nuts are installed outside.

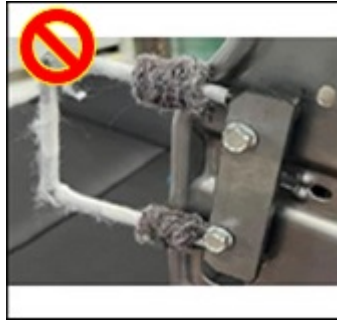
**NO GOOD**

Bracket is installed inside out.

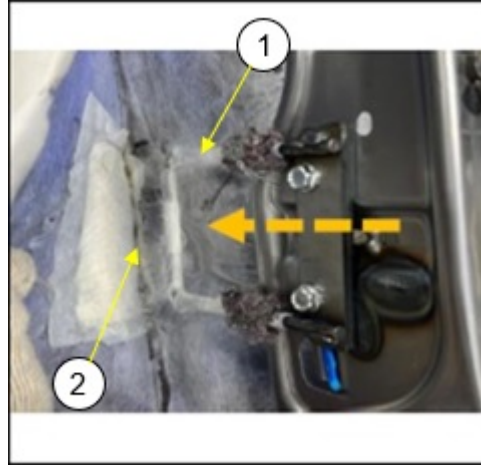
(1) Bracket  
(2) Slit of the seat back pad

**NOTE:** When installing the seat back pad to the frame, insert the bracket (1) into the slit (2) of the seat back pad.

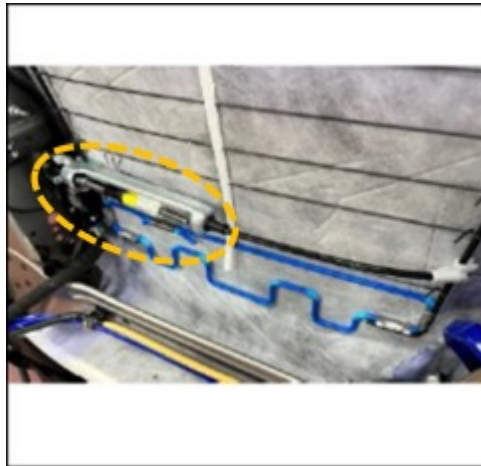
**NO GOOD:** There is no space between the seat back pad and the slider because the lumbar is set to high.

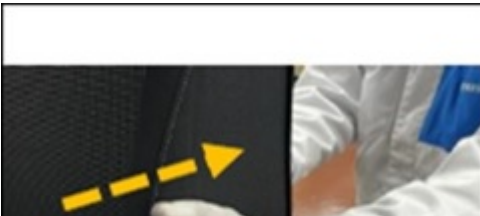
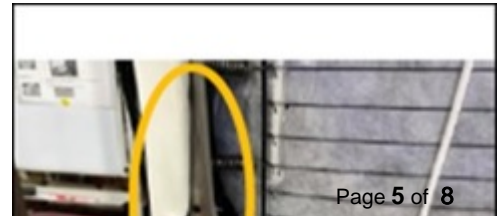
Pull the bolster and check if the bracket is inserted into the slit properly.

**GOOD:** The winding part of the seat back pad is on the seat back frame.

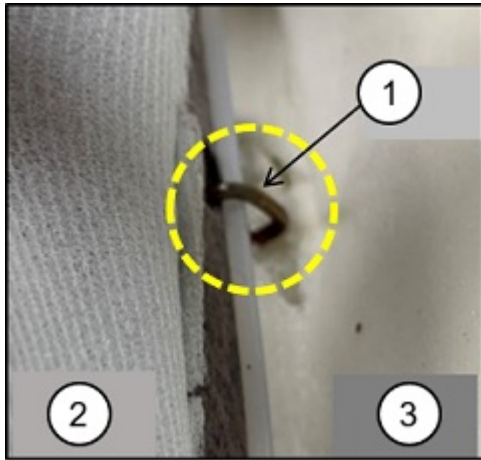
- 1) When replacing the seat back trim, the lumbar support of the seat memory must be set to "low" in advance.
  - 2) If removing the seat assembly with setting too "high" at the seat memory and replacing the trim with the new one, the C-ring (1) may not be able to be tightened properly.
- As a result, a gap between the trim's resin (2) and pad (3) may occur.

Part	Bad Example	Good Example
1	C-ring	There is a gap between trim (2) and pad (3).	Tighten until trim (2) and pad (3) contact properly.
2	Trim	-	-
3	Pad	-	-
