<b>Subject:</b>  UPDATED SOFTWARE RELEASE FOR EMERGENCY LANE KEEPING AND/OR SMART BRAKE SUPPORT OPERATION	<b>Bulletin No.:</b> 15-001/24
	<b>Last Issued :</b> 01/30/2024

2024 CX-90 with VINS lower than JM2KK\*\*\*\*\*151673 (produced before November 25, 2023)

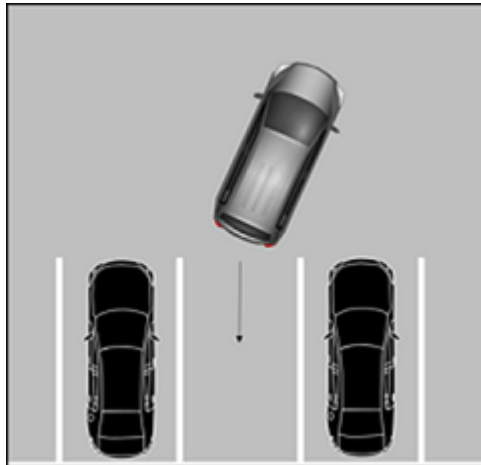
1. Sometimes the steering assist feeling by the Emergency Lane Keeping may be stronger than expected while driving at 37 mph (60 km/h) (or faster).
2. The Smart Brake Support may operate unexpectedly when parking in reverse under certain conditions, mainly while driving at 1.2 mph (2 km/h) to 9.3 mph (15 km/h) on flat ground in reverse and vehicle(s) etc. are present around the parking space.

3. While driving on a curved road condition with the MRCC activated, a vehicle in the right or left lane may be detected as an ahead vehicle and the MRCC unexpectedly reduces vehicle speed.

1. There was some room to refine the engineering for a better steering feel.
2. Too sensitive detection of vehicles or objects while in reverse and backing up.

To eliminate this concern, the control software of the Vehicle Control Module (VCM) has been modified. Customers having this concern should have their vehicle repaired using the following repair procedure.

1. Verify the customer concern.
2. Reprogram the VCM using the Mazda Diagnostic And Repair Software (MDARS). Refer to MDARS ECU Reprogramming Procedure.
