Service Bulletin

Bulletin No.: 24-NA-009

Subject: Loss of Forward Gear, Slipping, Malfunction Indicator Lamp Illuminated - DTC P2714 Set

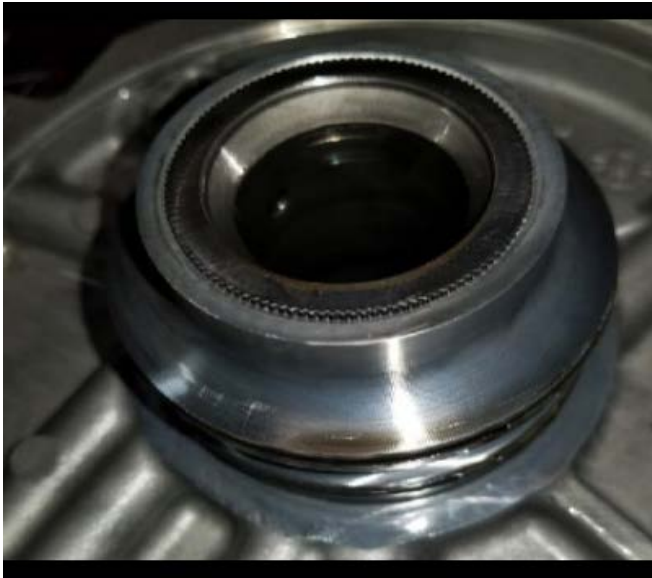
5892611

If signs of wear are seen as shown, this indicates the Primary Pulley Bearing has spun in the bore and is allowing the Turbine Shaft to become off center. When this happens, it causes a pressure leak.

If this concern is found, the transmission will need to be replaced.
