Anti-theft alarm system triggers without obvious cause

Topic number	LI80.50-P-077350
Version	1
Function group	80.50 - Anti-theft alarm system (ATA), Interior motion sensor/Tow sensor
Date	1/16/24
Validity	MODEL 118,177,243,247,167
Reason for change	Update of content regarding workshop information to be supplied

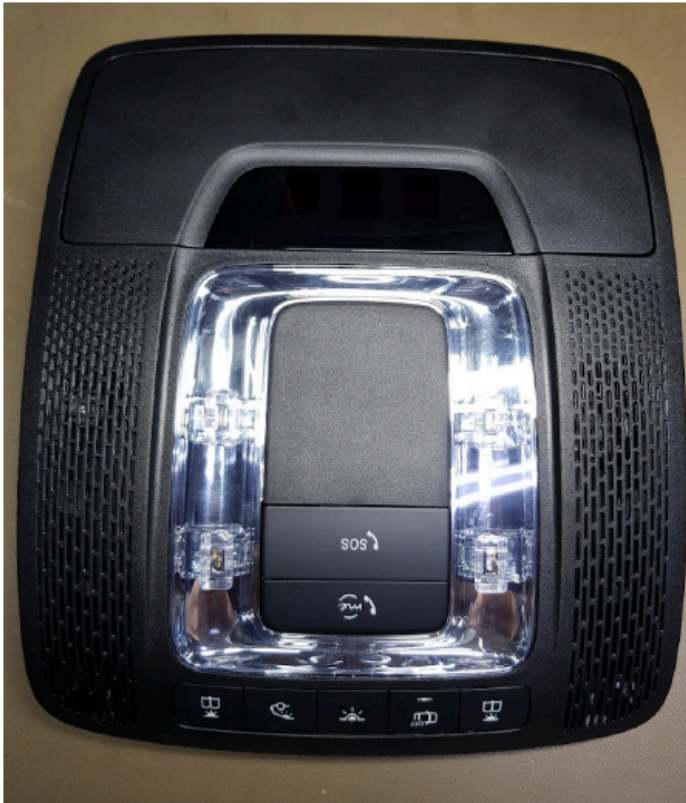
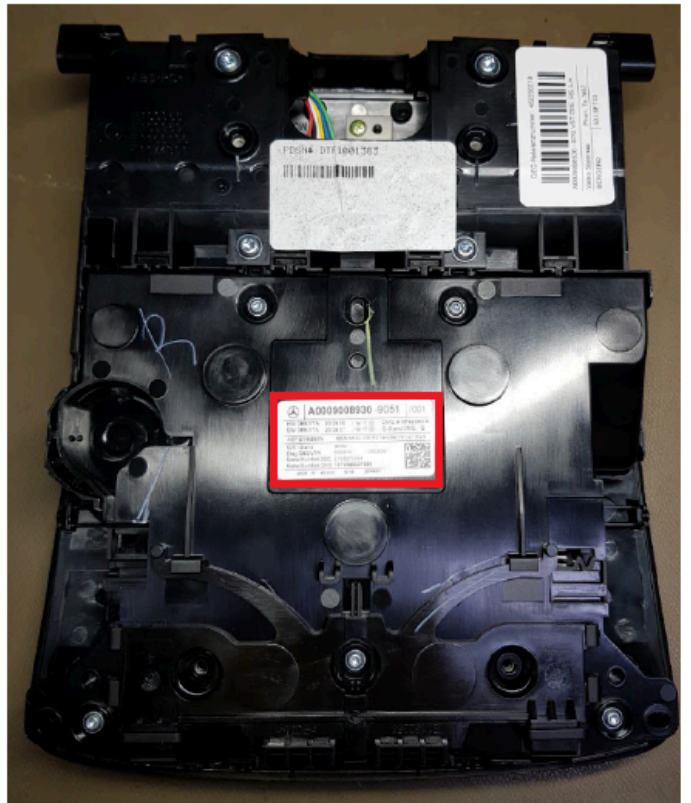
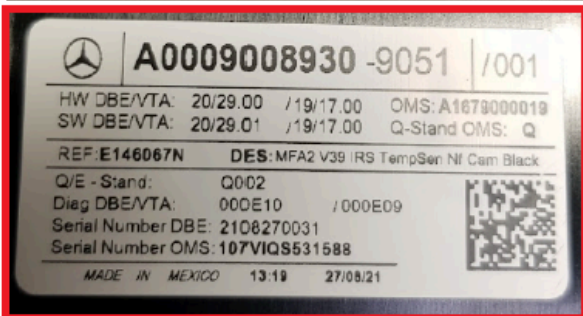
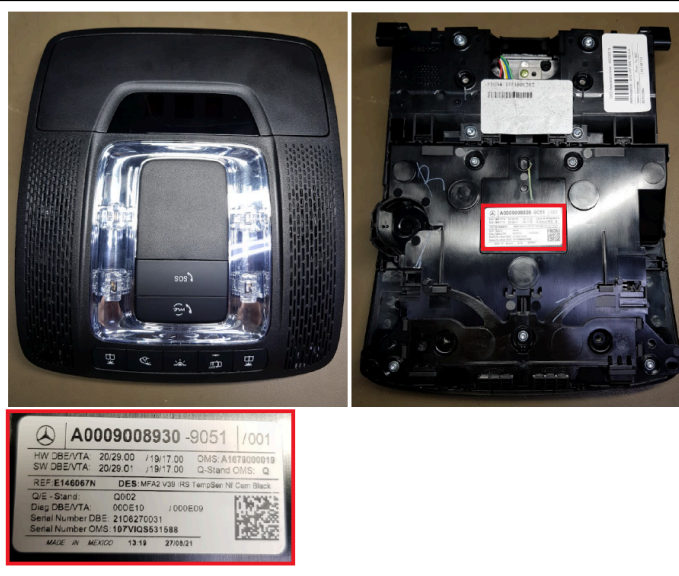
Attachments	
File	Description
Pic_1_DBE.png

- Open a TIPS case for vehicles:
 - As of manufacturing date 01.02.2022, except production plant 4831 Aguascalientes Mexico or 1380 Tuscaloosa
 - As of manufacturing date 01.08.2022 and production plant 4831 Aguascalientes Mexico or 1380 Tuscaloosa
- Attach photo of overhead control panel label (see example images)
- Add control unit log of anti-theft alarm system [N26/6]
