Service Alert

Subject:		
RATTLE FROM SUNROOF AREA	Service Alert No.: SA-001/24	
	Last Issued : 01/05/2024

2023-2024 CX-50

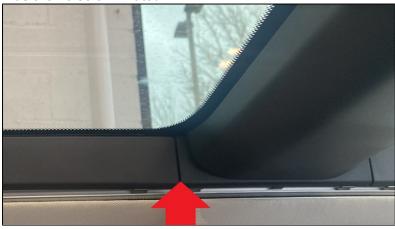
The noise comes from the side cover vibrating against the assembly at the location marked by the arrow due to poor retention of the cover clips.

1. Test drive the vehicle and if you hear the noise, press the edges of the side covers (6 total) as shown in the example below.
