Service Alert

Subject:	
WARNING LIGHT WITH P0531 AND/OR A/C DOES NOT WORK	Service Alert No.: SA-003/24
	Last Issued : 01/18/2024

2024 CX-90 PHEV

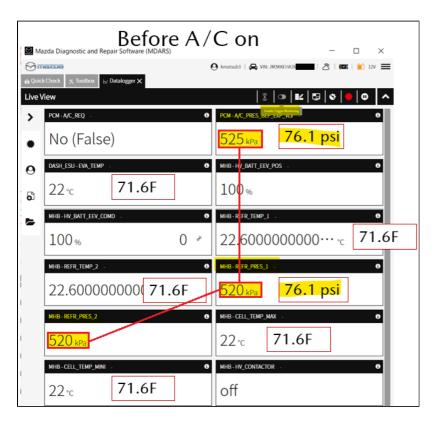
NOTE: After a few hours without using the A/C, the readings from the three A/C pressure sensors should nearly align if the sensors and wiring are OK.

- If your test results do not find any fault, **do not replace any parts.** The customer's concern may be software related and this is under investigation.
- 4. Clear all DTC and test drive the vehicle using the A/C or defrost function to confirm no DTC sets again.
 - If no DTC is set, release the vehicle back to the customer and explain to them the following:
 - a. This issue is triggered by using the timed and remote heat/cooling functions and is under investigation.
 - b. Until a solution is developed, turn off any timed heating/cooling functions in your vehicle and refrain from using the MyMazda app to remotely heat or cool your vehicle.
- 5. Verify any repairs.
