Mack Medium Duty (MMD) Rear Suspension Bump Stop Bending

Published 29 January 2024

Mack Medium Duty (MMD)

Model Year 2021-2024

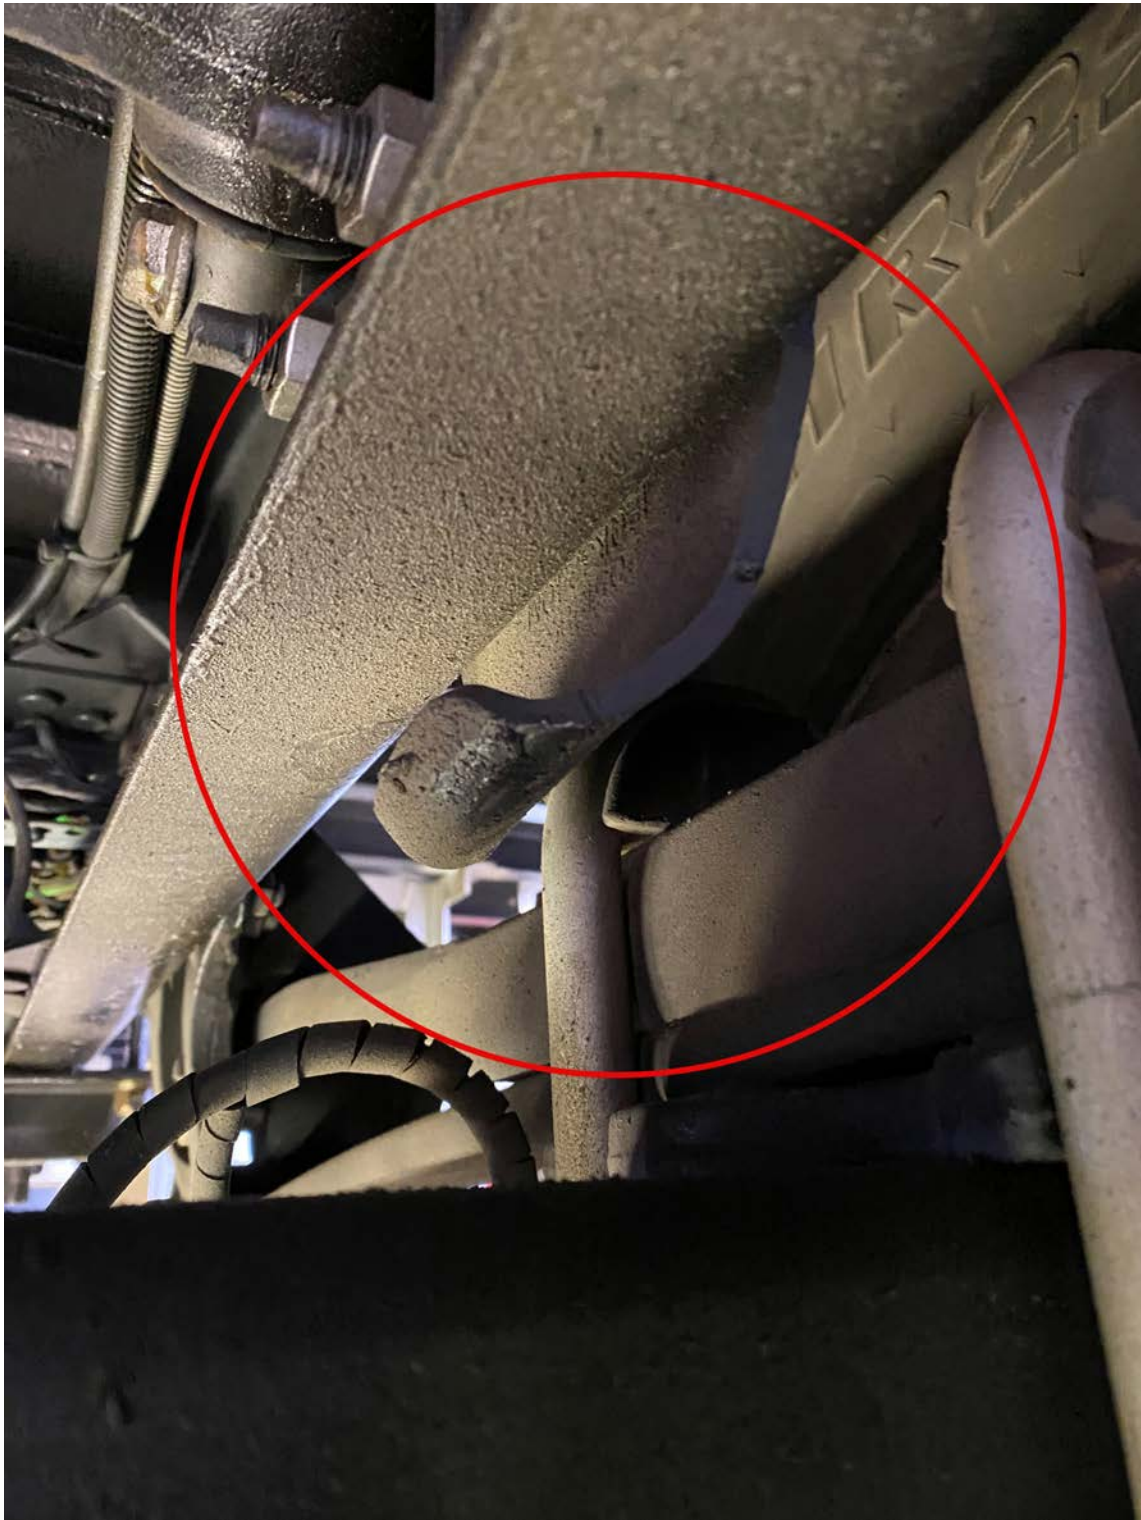
During certain operational scenarios and duty cycles, the rear suspension stamped steel bump stop in Mack MMD trucks with the 21,000lb VOAS rear suspension may bend. If this occurs, the bent bump stop may lead to the suspension bottoming out, causing the leveling valve arm to flip over and preventing the system from airing back up.

1. Remove the bent stamped steel bump stop.
2. Install updated class 8 cast bump stop. **P/N 24194608**
