LVO LR Power Steering Assist Cylinder Castle Nut Torque

Section Function Group 642

Model Years	Models
2024	LR

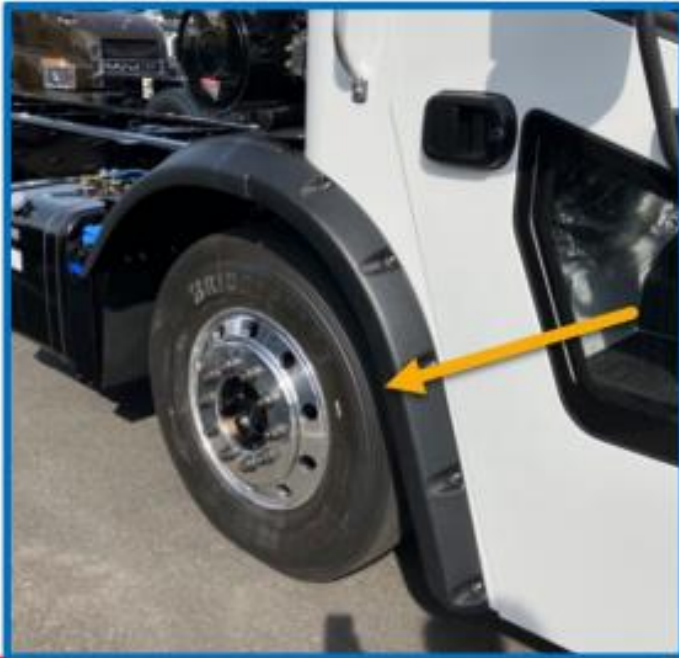
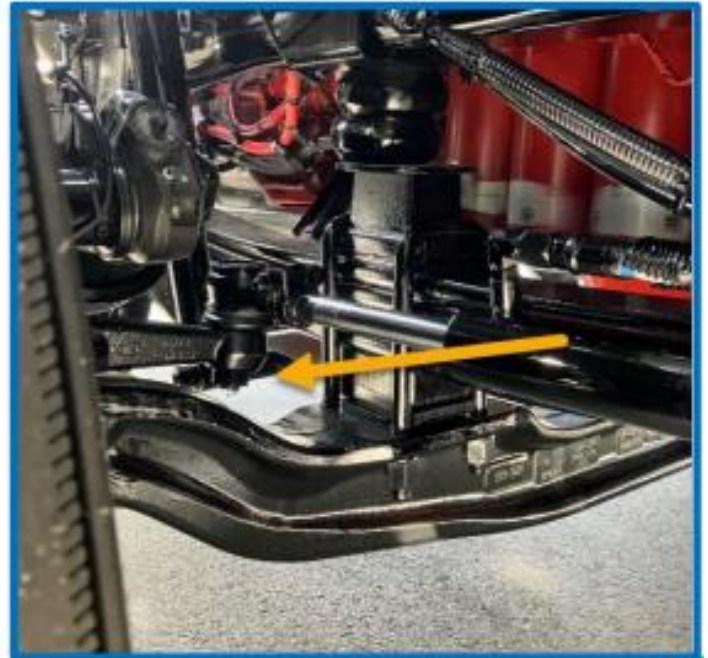
Mack trucks has determined that certain model year 2024 Mack LR vehicles may have insufficient torque on the Power Steering Assist Cylinder Castle Nut. Please follow the instructions below to inspect the castle nut, re-torque, and install new cotter pin.

- Locate the castle nut on the power steering assist cylinder connected to the steering arm on the right side of the vehicle.

- Torque tighten the castle nut to specified torque.

Tightening Torque
238-264 Nm (176-195 lb-ft)
