EDPC Loss of Communication

Topic: eDiff warning or Check Engine Light displayed in cluster

Diagnostic Trouble Codes: P18A000

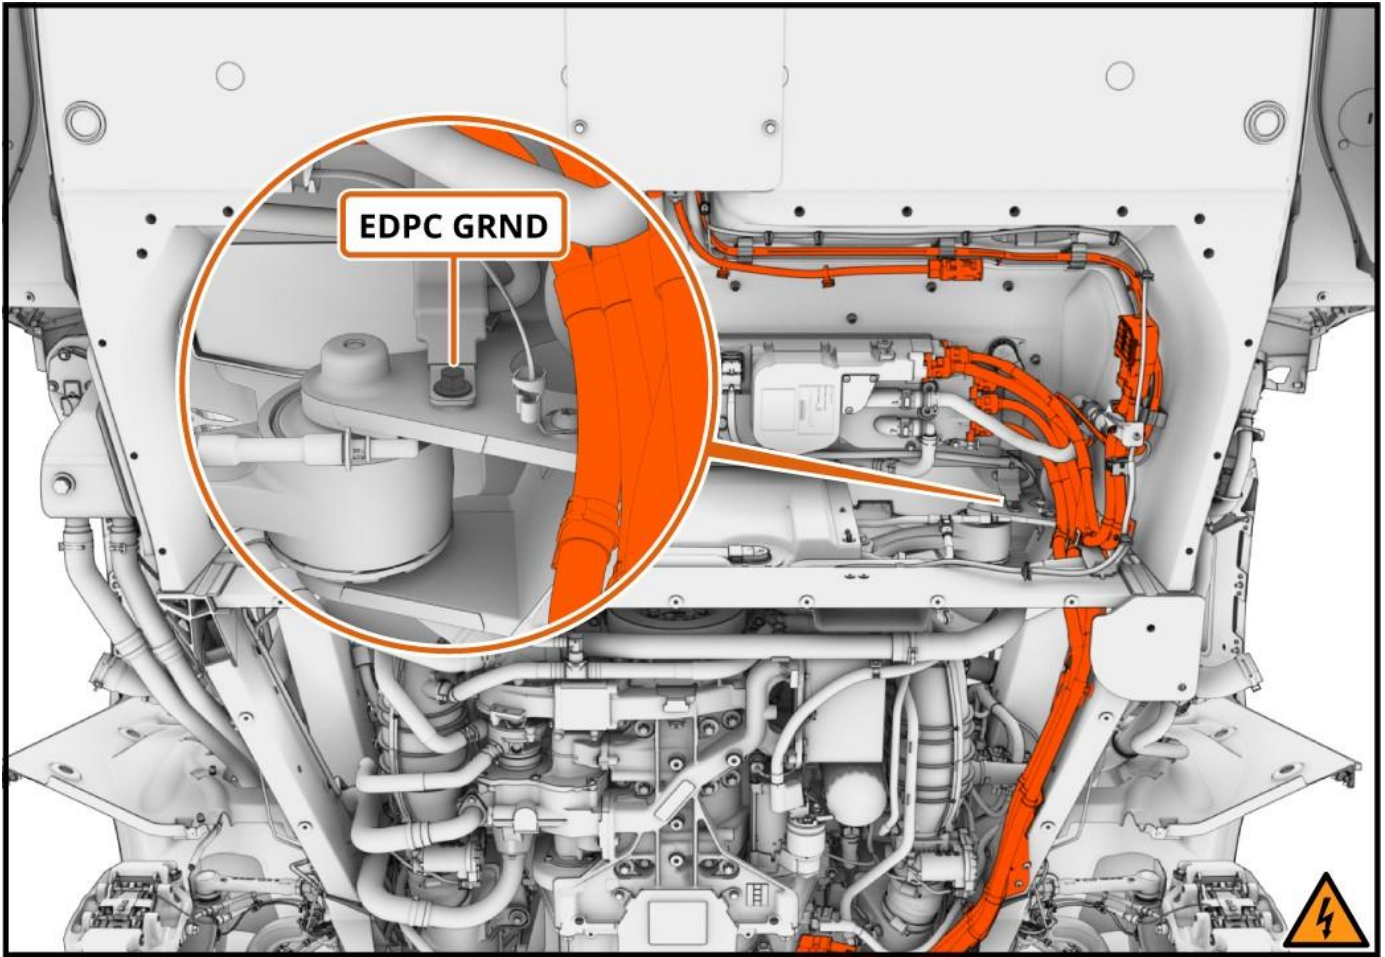
In the event that DTC P18A000 Integrated Power Unit - Unauthorised Tethering in ZC1 is stored and the vehicle has either a Check Engine Light or eDiff warning displayed on the instrument cluster, which could also cause the vehicle start to be inhibited intermittently. Proceed to inspect the EDPC Ground point as shown below.

If found loose then remove the fixing and inspect and clean the contact area. The fixing should then be refitted and torqued to 7nm.

If this ground is not loose, then all other busbar grounds will need to be checked as per KA-01625
