SERVICE BULLETIN

APPLICABILITY: 2020-23MY Outback NUMBER: 03-91-23

SUBJECT: Clicking/Cracking-Type Sound on Slow Turns

Front Drive Axle Shaft - Design Change

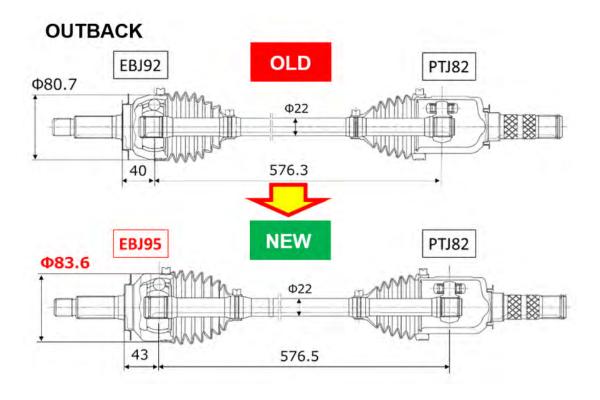
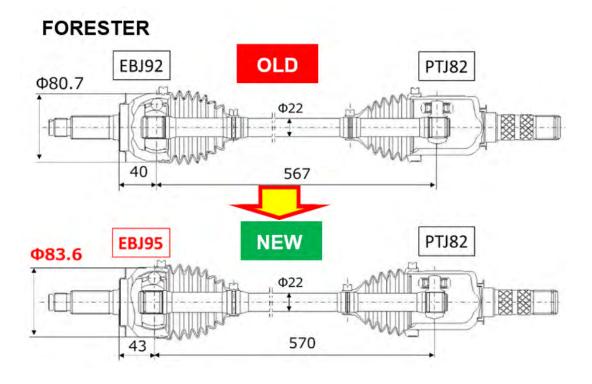
DESCRIPTION OF DESIGN CHANGE:

This bulletin announces the design change made to the front drive axle shaft assemblies to address cases of a clicking/cracking-type sound heard when driving with the steering wheel in the fully locked (left or right) position. Size of the joint has been increased to provide added durability. If a clicking/cracking-type sound is duplicated while driving the vehicle with the steering wheel in the fully locked position, replaced the affected side with the newly designed drive axle shaft assembly. The assemblies are not required to be replaced in pairs.
