# McLaren Artura – Starter Motor Cable Inspection and Rework

<b>Bulletin type:</b>	Service Information
<b>Reference number:</b>	AFT.006.2024
<b>Campaign reference:</b>	N/A
<b>Attention:</b>	Retailer Aftersales Managers, Retailer Service Managers, Retailer Service Advisors, Retailer Technicians, Retailer Parts Managers
<b>Affected vehicles:</b>	McLaren Artura
<b>Situation:</b>	Confirmation of the 12V starter motor cable correct routing and retention
<b>Procedure:</b>	Confirm correct routing and retention through visual inspection whenever the engine floor is removed
<b>Date:</b>	18 <sup>th</sup> January 2024

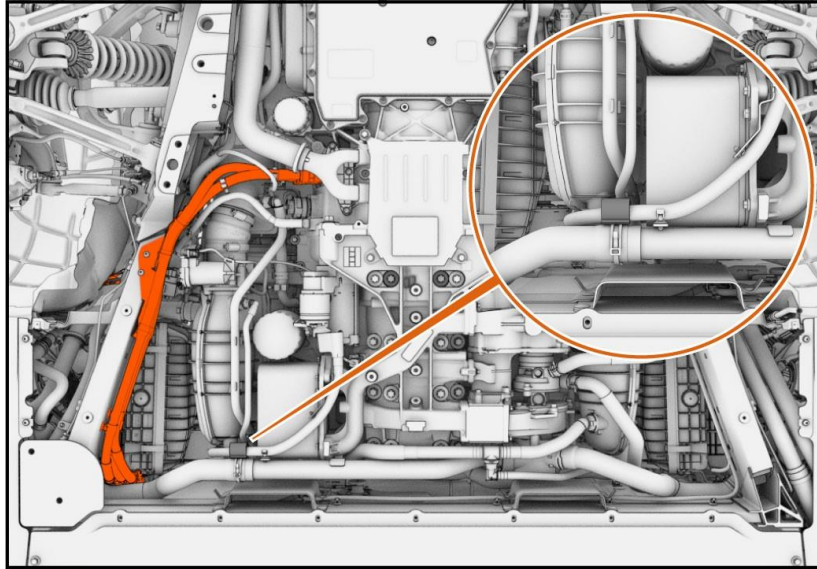
**Image 1** Location of the starter motor 12V cable

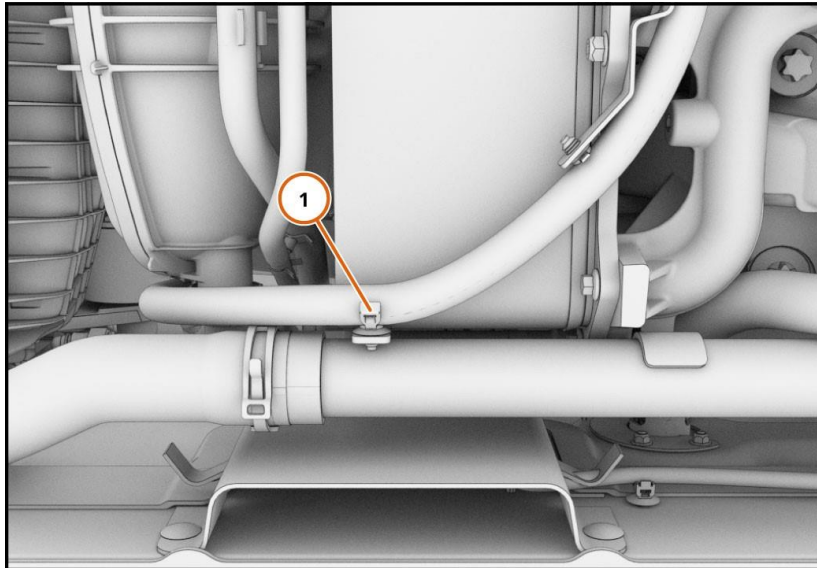
Inspect the fir tree (1). If the fir tree is fully engaged in the anchor point, undamaged and retaining the 12v cable, then no action is required, continue to Step 2.

**Image 2** Location of fir tree (1)

If the fir tree (1) is damaged and not holding retention, cut it with suitable side cutter pliers and fit a new fir tree 00RL001 in the same position (1).

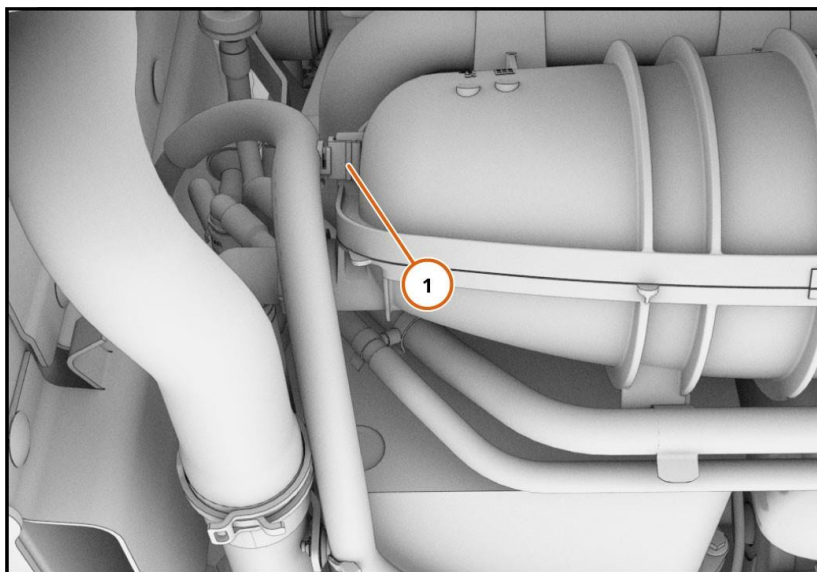
Inspect the edge cable tie clip (1) retaining the 12V cable to the air intake manifold shown in the image below. If the edge clip is damaged or not holding retention, cut it with suitable side cutter pliers and fit a new edge cable tie clip OORL022 in the same position (1).

**Image 3** Location of edge cable tie clip (1)

**CARE POINT:** Make sure that the edge clip has sufficient retention to the airbox.  
Take care not to damage the 12v cable and its insulation. Do not use a sharp blade, only side cutter pliers.

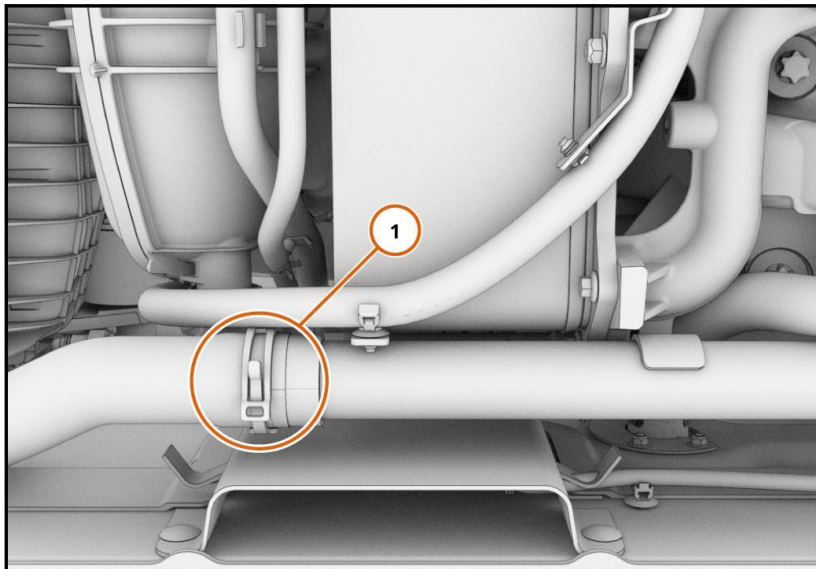
**Image 4** Location of coolant pipe spring clip (1)

**Care Point:** The coolant pipe spring clip must be orientated with the ears facing downwards.

Make sure that the spring band clip is orientated as shown in the illustration below.

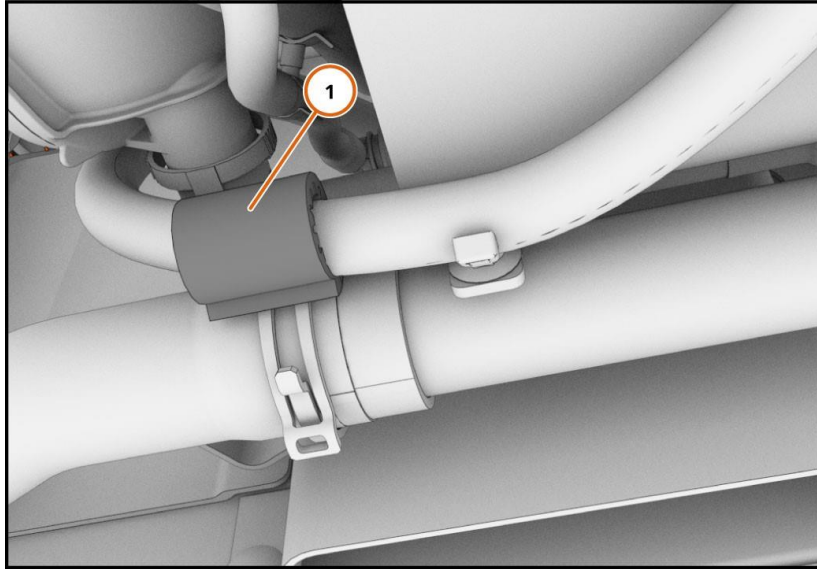
**CARE POINT:** The new protective rubber sleeve is used to create a mechanical clearance gap to the metal spring band clip on the cooling hose and the 12v cable.

**Image 5** Location and orientation of protective rubber sleeve (1) fitment

Fit the protective rubber sleeve 00RA357 (1) around the 12V starter motor cable in the area shown. The protective rubber sleeve must be fitted in the same orientation as shown and be fully secure.
