SERVICE BULLETIN

APPLICABILITY: 2017-22MY Forester

NUMBER: 09-113-23

SUBJECT: DTC P2404 / Reprogramming Files

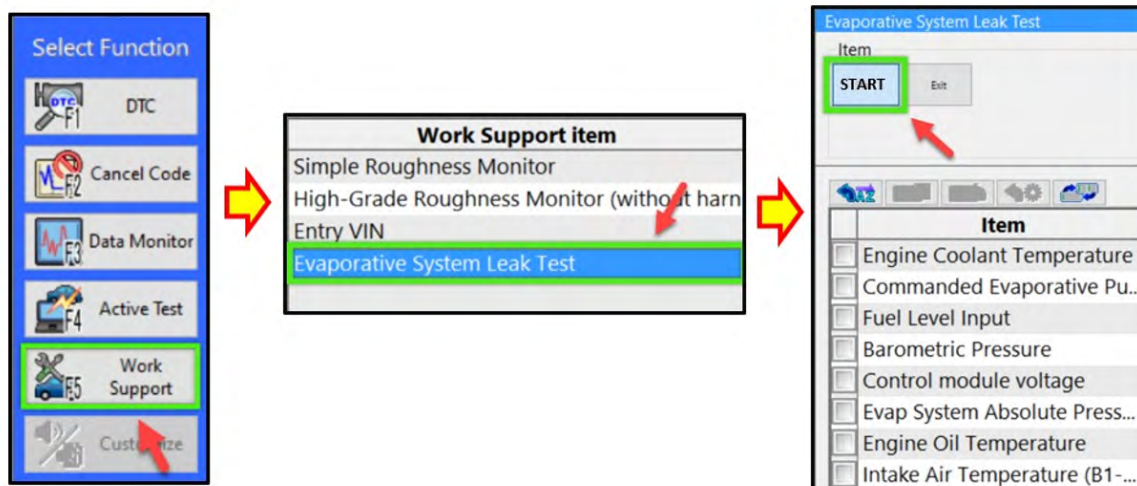
STEP 6: Connect the vehicle to a recommended power supply. See **APPENDIX A** for additional information regarding the power supply. Using SSM, perform the Evaporative System Leak Test. Collect and save all data.

Once the evaporative system leak test is complete, check the DTCs and examine the vacuum value results. Record the value shown in the row labeled MID: \$3C, TID: \$C4, and Scaling ID: \$FE. This value should be lower than -0.26 PSI.

Value Must Be Lower Than -0.26 PSI

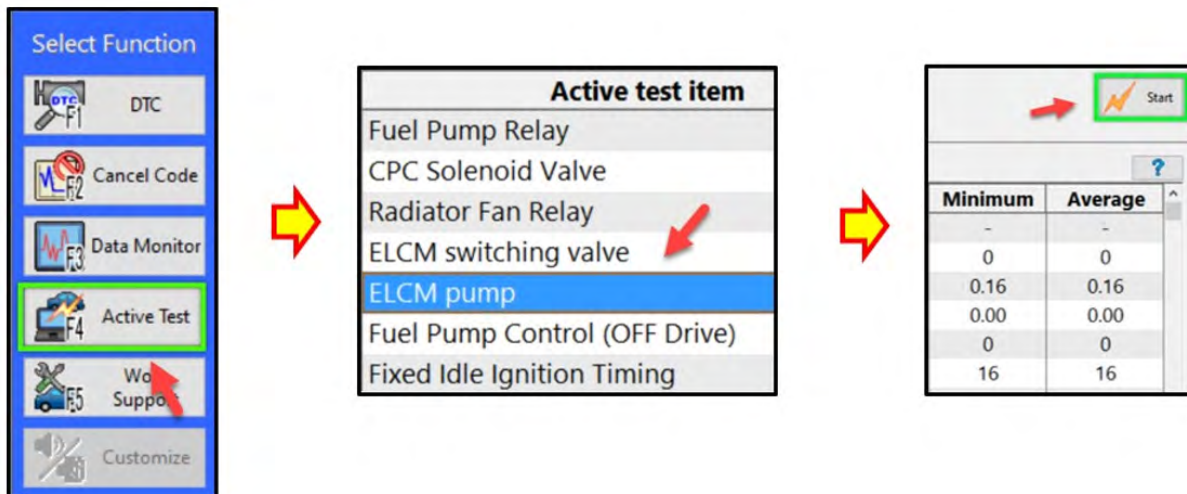
STEP 8: Using SSM, perform the ELCM Pump Active Test for a period of 35 minutes or more. See **APPENDIX A** for additional information regarding power supply.

Once the ELCM Pump Active Test has been performed for a period of 35 minutes or more, repeat the Evaporative System Leak Test outlined in STEP 6. Check the DTCs and the vacuum value results.
