STARLINK TELEMATICS - COMM CHECK, TEST CALLS, REMOTE SERVICES REQUESTS, FAILED CALLS

15 EyeSight HALT Codes 41, A0 and CC

Unit Registration, Codes/DTCs After Replacing a Module, U1C00, U0146, B28A2, B28A1, U1P07, U1P08, U1C07, U1C08C

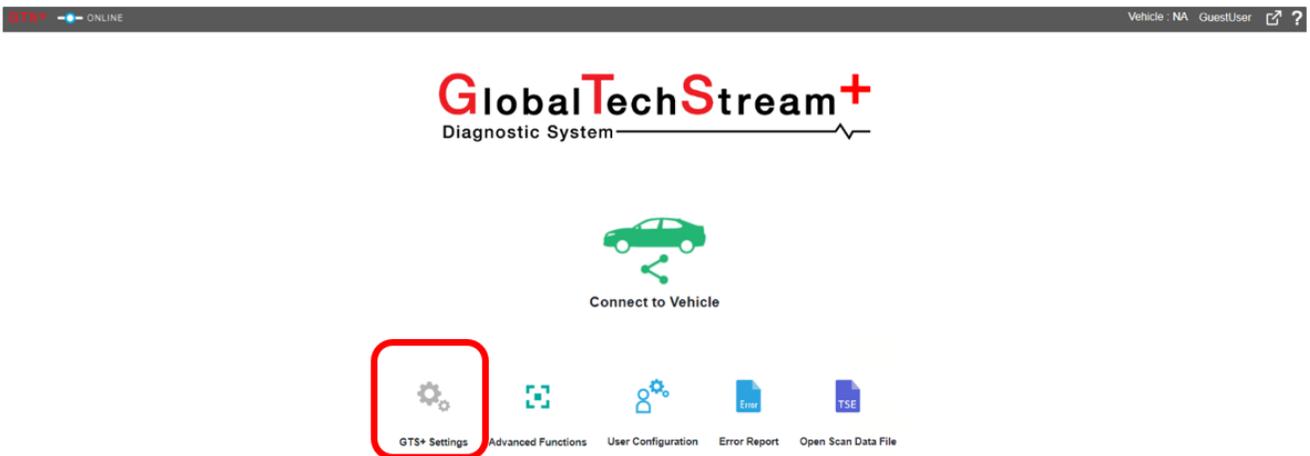
If a customer requests to have the Reverse buzzer turned off, follow the directions below. Before starting this procedure verify the “Vehicle Area Selection” is set to North America. To change this setting, select “GTS+ Settings”

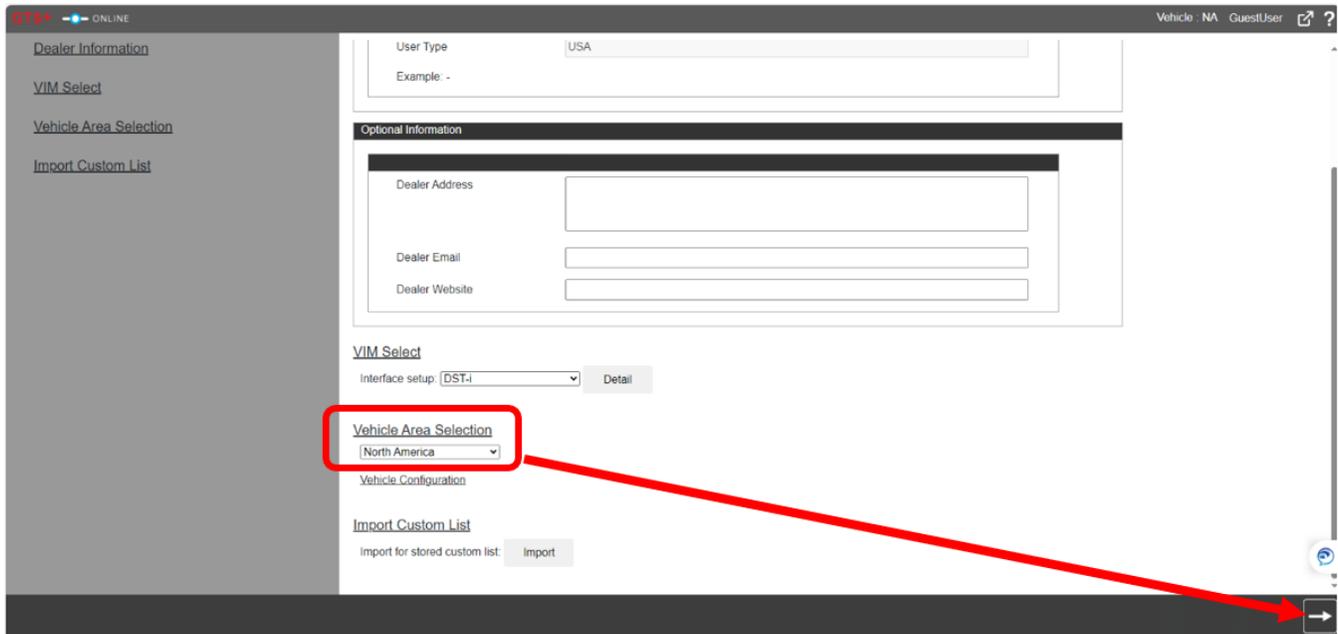
If needed change the “Vehicle Area Selection” to North America and press the arrow on the bottom right to save this setting.

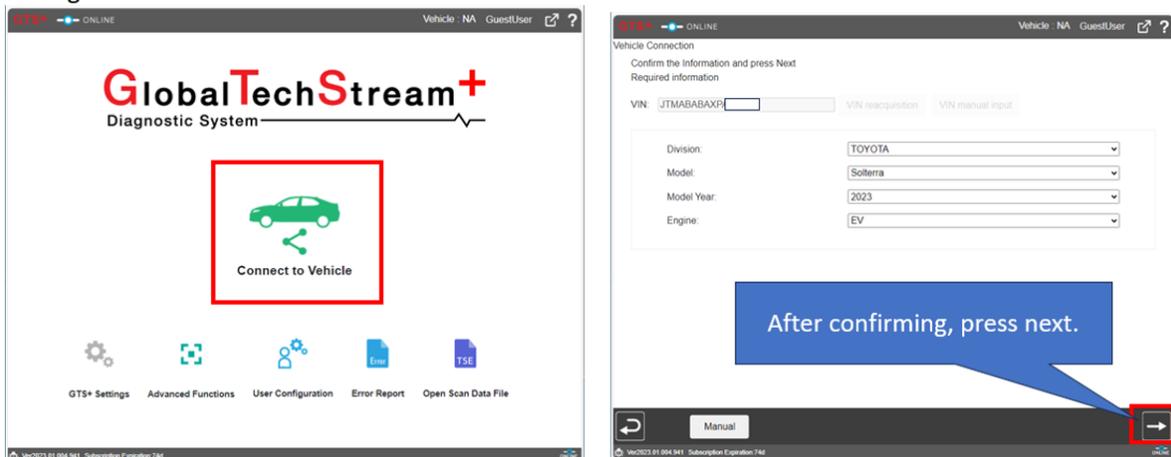
Once GTS+ is set to “North America”, follow the screens shot below to navigate to the Reverse buzzer setting.
