SERVICE BULLETIN

APPLICABILITY: 2018-2021MY Crosstrek 2.0L DI & PHEV
 2017-2021MY Impreza 2.0L DI
 2021MY Crosstrek 2.5L DI
 2019-21MY Forester 2.5L DI
 2020-22MY Legacy & Outback 2.5L DI

NUMBER: 09-81-21R

SUBJECT: Fuel Injector- Design Change
 Misfire DTC P030* / Engine Knocking / DTC P219C-D-E-F

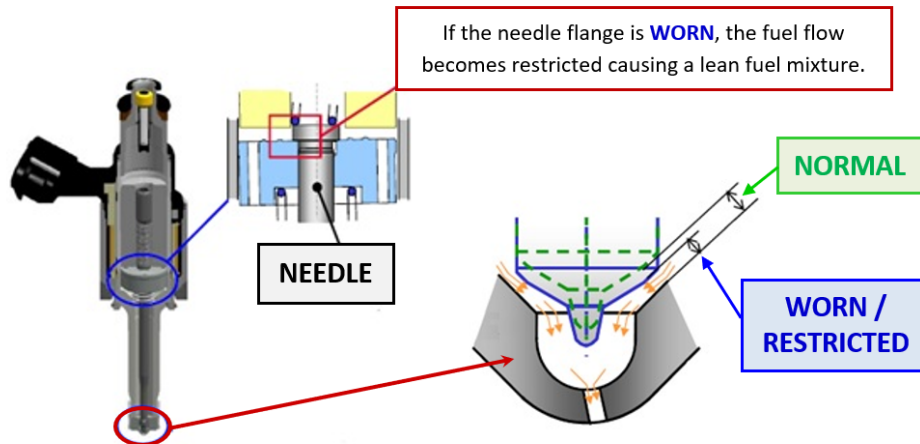
Injector Assembly Part Number	Flow Rate Number
16611AA971	MARK 4
16611AA981	MARK 5
16611AA991	MARK 6
16611AB071	MARK 7
16611AB081	MARK 8
16611AB091	MARK 9
16611AB030 (2.5L)	N/A
16611AB06A (2.5L)	N/A

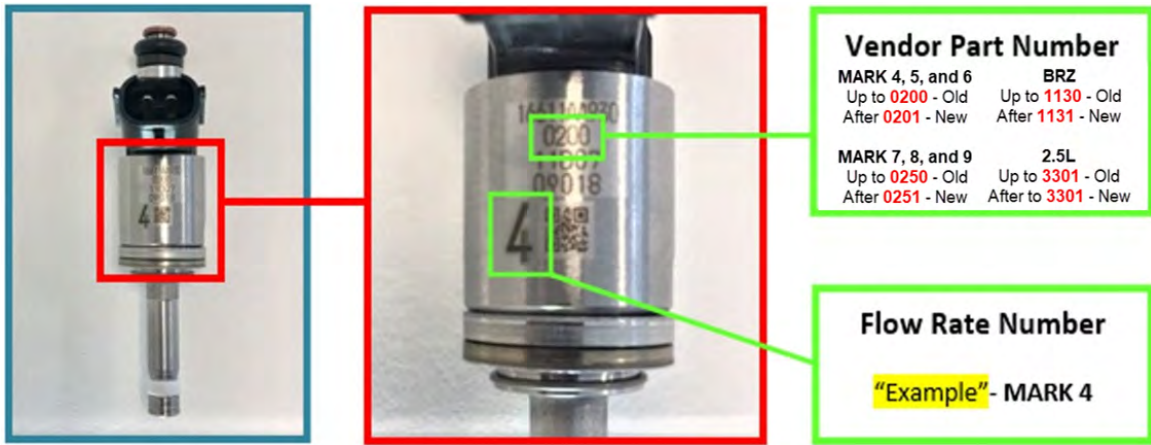
- Using the illustration below for identification reference, always replace an injector assembly with the newer vendor part number than the originally equipped.
- Using the illustration below for identification reference, always replace an injector assembly with the same flow rate number as originally equipped. The flow rate does not apply to 2.5L engines.

STEP 8) Identify the injector assembly(s) by confirming the vendor part number and flow rate number engraved on the injector body as shown in the Parts Information section above. Replace the injector(s) as necessary with the **NEW** part(s) having the matching flow rate. Remove any carbon build-up found during replacement:
Engine > FUEL INJECTION (FUEL SYSTEMS) > Fuel Injector.
