48-23-02 - Steering wheel / airbag: grinding/creaking/clacking noises when steering (cornering/parking/maneuvering)

Release date: 1/30/2024

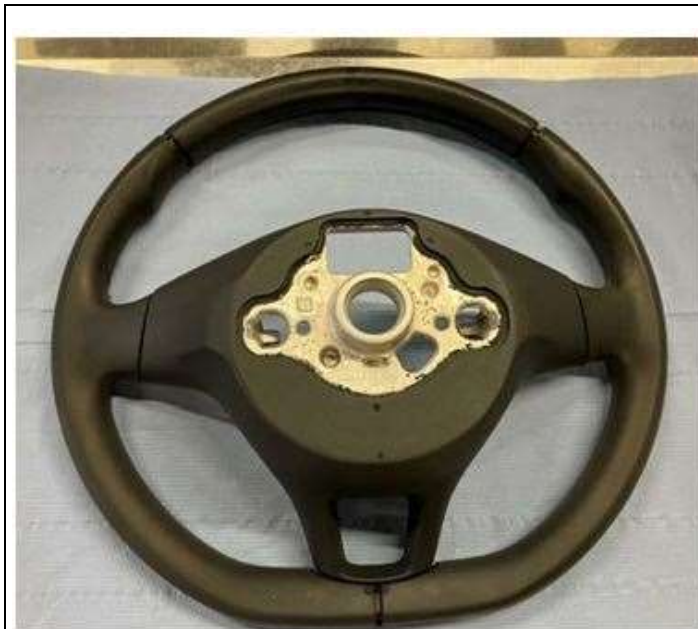
Figure 1.

1. Rear of steering wheel when removed.
