Technical Service Bulletin

GROUP CAMPAIGN	NUMBER 24-01-010H
DATE JANUARY 2024	MODEL(S) TUCSON (NX4)

SUBJECT: INTEGRATED THERMAL MANAGEMENT (ITM) MODULE
OIL COOLER O-RING INSPECTION/REPLACEMENT
(SERVICE CAMPAIGN TBA)

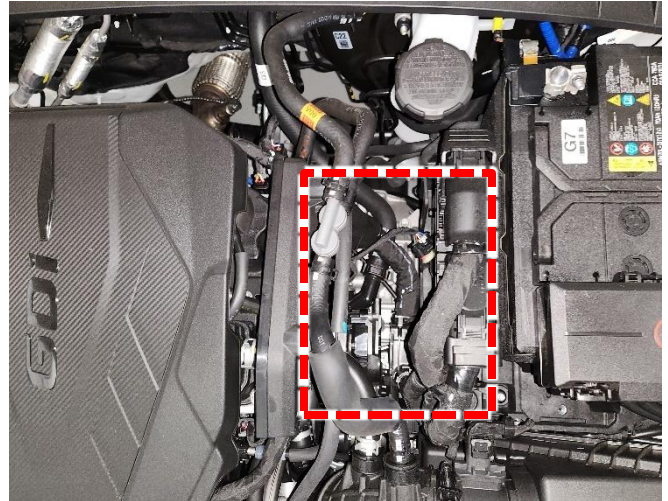
Area to be inspected is indicated by the red square in the photo at right.

2. Open the hood and remove the engine cover.

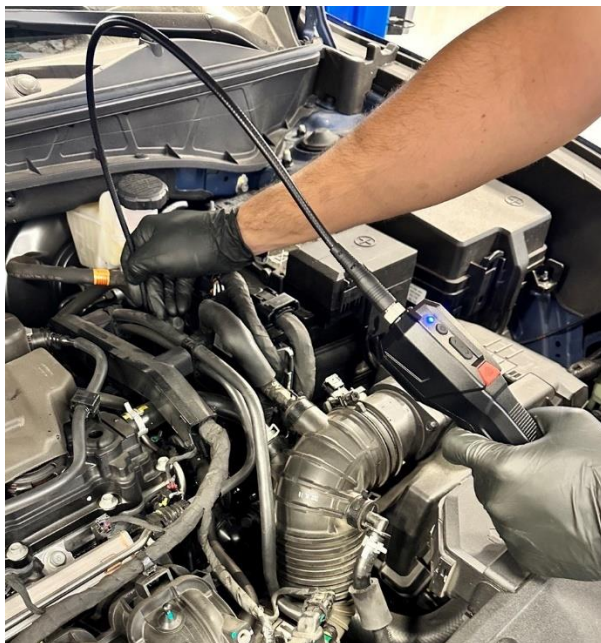
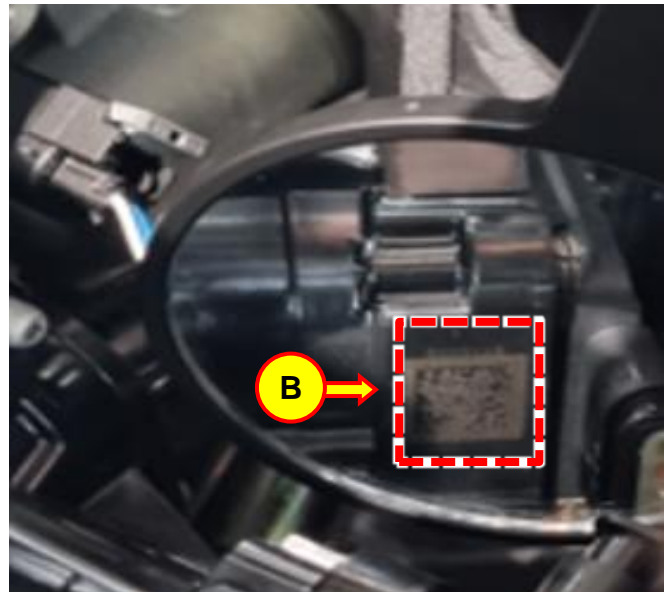
The LOT Code is located behind the ITM Connector.

3. Using the Borescope camera, locate the label with the LOT number located on the side of the ITM (B).

Use the 90-degree camera lens on the borescope for best view of the LOT Code.

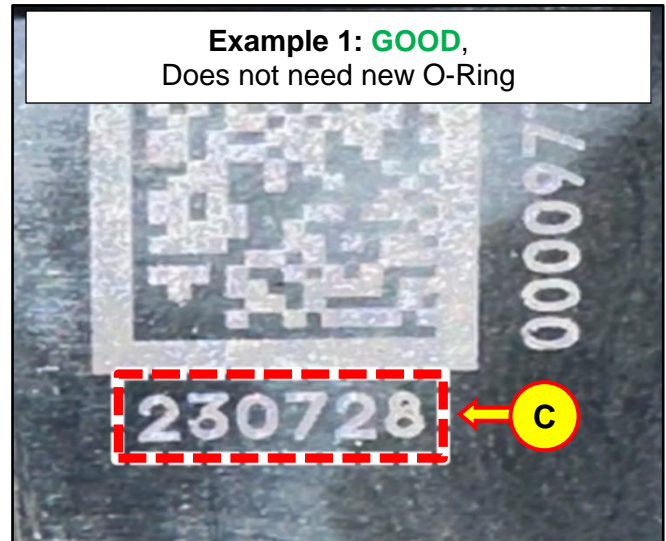
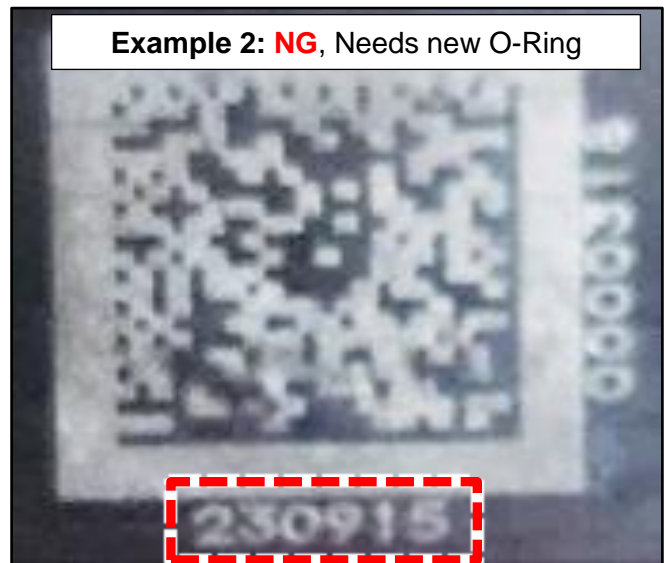
Lot # 230915 Details		
Year	Month	Day
23	09	15

5. Closely inspect the LOT number (C).

- If the LOT number is any of the following:

230911	230912	230913
230914	230915	230916
230917	230918	230919
230920	230921	230922
230923	230924	230925

Then replace the O-Ring with a new one. Continue to the “**O-Ring Replacement Procedure**”.

- For all other LOT numbers, replacement is not necessary. **Inspection is complete.**
