| RE: <b>Service Campaign Launch Notification</b><br><b>Retrofit Headlamp Housing Screws</b><br><b>MY22 SL (232 platform)</b> | DATE: January 19, 2024 |

## Retrofit Headlamp Housing Screws

Campaign No. 2023120019, January 2024

## **Retrofit Headlamp Housing Screws**

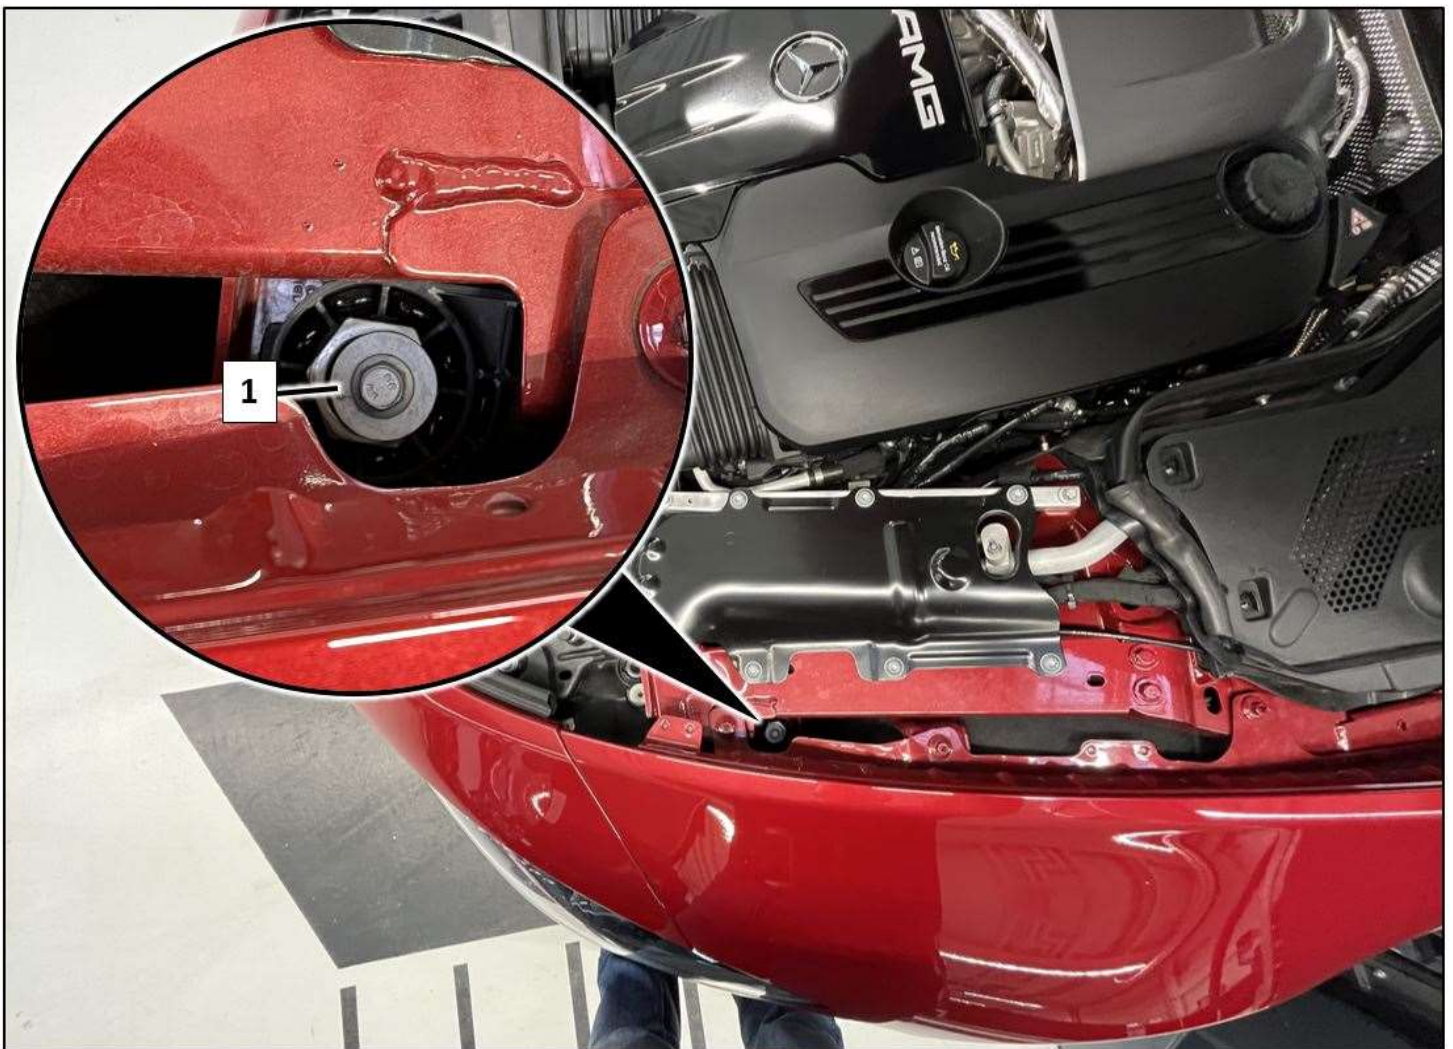
Mercedes-Benz AG ("MBAG"), the manufacturer of Mercedes-Benz vehicles, has determined that on certain MY 2022 SL vehicles, certain banjo bolts on the headlamp housing may cause corrosion on the body-in-white over the service life of the vehicle.

Figure 1: Washer on left headlamp shown

1. Clean and dry bonding area on washer (**1, Figure 1**) of left and right headlamp housing screws. Use a suitable cleaning agent for this purpose. Subsequently dry the bonding area on the washer (**1, Figure 1**) with a lint-free cloth.

**i** The bonding area on the washer (**1, Figure 1**) must be completely free of dust and grease. There may otherwise be problems with adhesion.
