# Service Bulletin

Bulletin No.: 22-NA-166

**Subject:** Waterleak into Interior of Vehicle

Brand:	Model:	Model Year:		VIN:		Engine:	Transmission:
		from	to	from	to		
Chevrolet	Equinox	2018	2024	-	-	All	All
GMC	Terrain

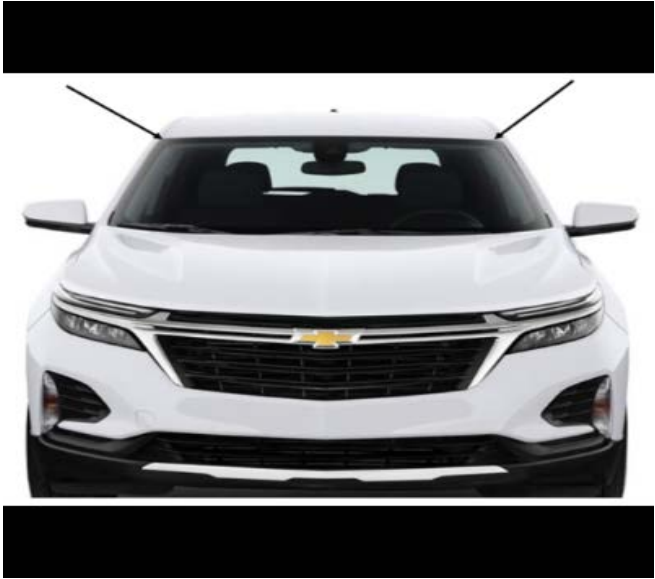
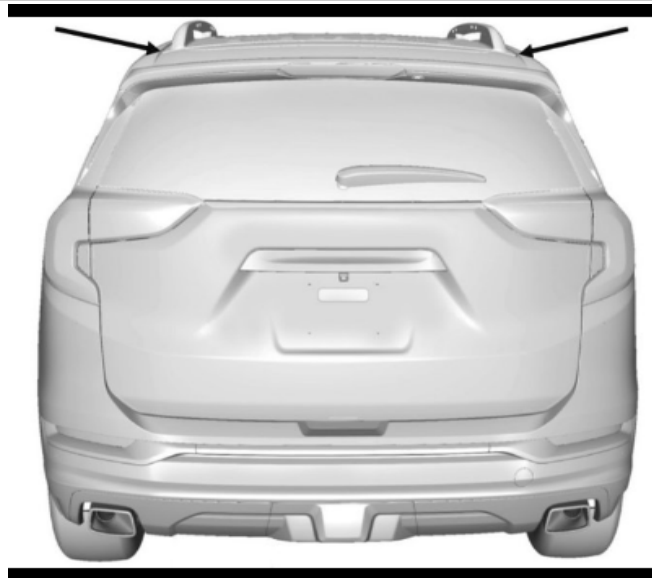
- "Pin hole" voids in the roof panel to outer ring laser braze and seam sealer. The pin holes are most commonly found near the top of the windshield or the top of the liftgate near the D-pillars.

2. Seal any of the suspected leak areas following the recommendations below:
  - Cowl and other less visible body seams can be sealed with Kent® Brushable Seam Sealer\*, Kent® High-Tech Seam Sealer Clear\* P10200, or Wurth Euroseal Gel Clear\* 18920104, or equivalent.
  - Seal the pin holes/crack in any laser braze area following the steps below:
    - 2.1. Mix a small amount of Kent® High-Tech Seam Sealer Clear\* P10200, or Wurth Euroseal Gel Clear\* 18920104, or equivalent WITH the proper touch-up paint color.
    - 2.2. Avoiding excess sealer build up within the ditch, work a small amount of the sealer into the hole with a gloved finger.
    - 2.3. Wipe away any excess sealer with a light amount of solvent on a rag or paper towel. The solvent will help the sealer flow into the hole/crack.
3. Clean and dry any wet trim. Refer to *Floor Carpet Drying*, in SI.

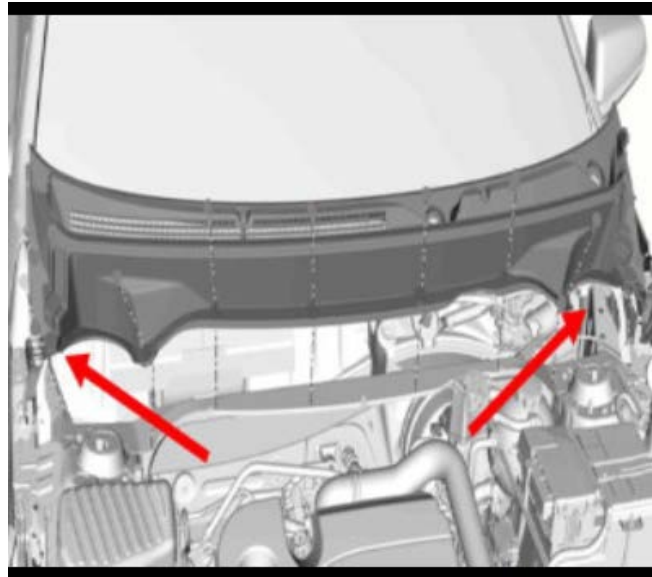
6140949

- Seam leak or "Pin hole" voids at the front cowl area.
- Disconnected sunroof drain hoses at the front cowl or at rear locations.
- Missing or misapplied body seam sealer along any of the body seams.

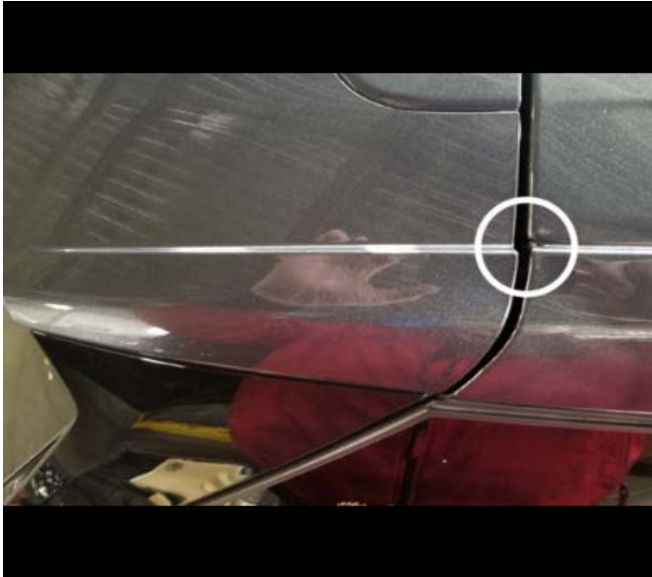
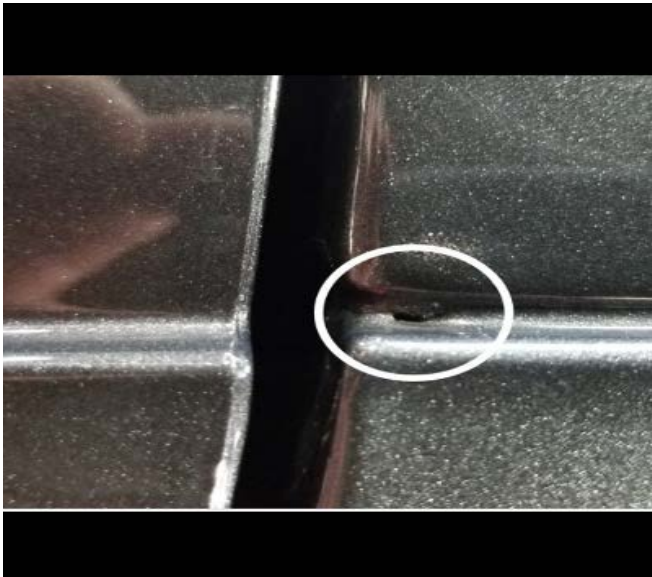
**Note:** The pin holes/cracks may be more difficult to see on darker color finishes.

- Visually inspect the front and rear, right and left roof laser braze corners, for pin holes or a crack.
- Also inspect for missing or poorly applied seam sealer at the right and/or left cowl, under the air inlet screen. Refer to *Air Inlet Grille Panel Replacement*, in SI, as necessary.
- If equipped with a sunroof, make sure the 4 sunroof drains are properly installed, and not plugged. Refer to *Sunroof Drain Inspection and Cleaning*, in SI.

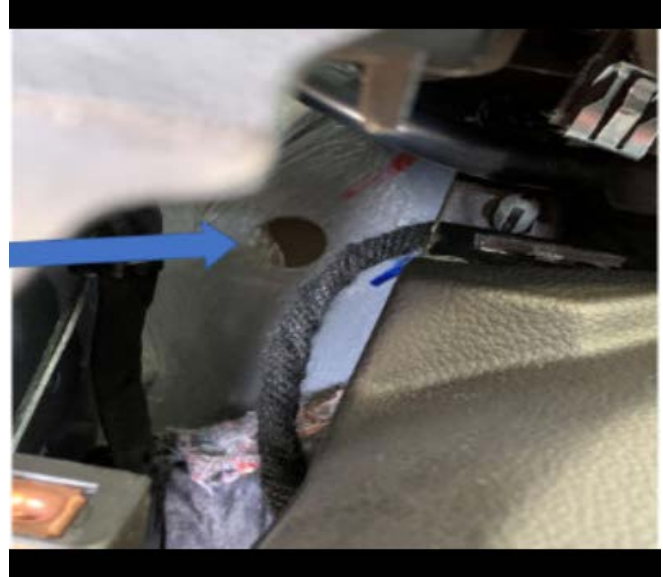
6140963

- Check for Sunroof Grommet / Close-out plug missing or not fully seated.
- Check for Paint shop sealer interfering with sunroof grommet / close out plug interfering with fit to A-pillar.
- Locate any seams that do not have sealer properly applied
