Service Bulletin

Bulletin No.: 22-NA-246

Subject: Information on Unnecessary Replacement of Extension Housing and 1-2-3-4-5-REV Clutch Piston Assembly for 8L45, 8L90 Automatic Transmissions

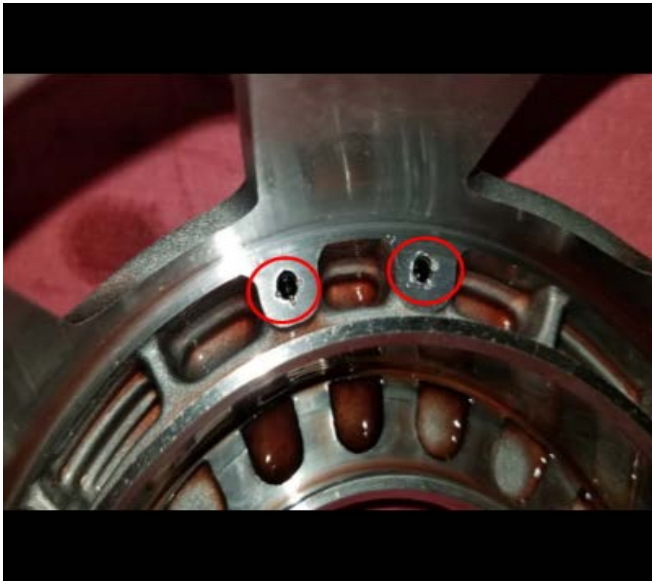
6201397

<p>The orifices are normally staked into the two passages and may become dislodged during time.</p>

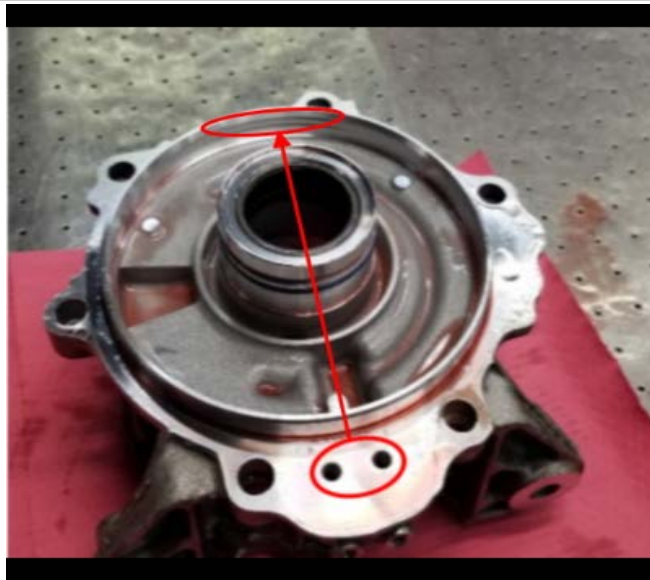
6204833

Extension housing bore showing witness marks related to the O-ring seal from the 1-2-3-4-5-REV clutch piston. These two witness marks are always located in the same general area, almost directly across from the fluid entry ports into the extension housing.

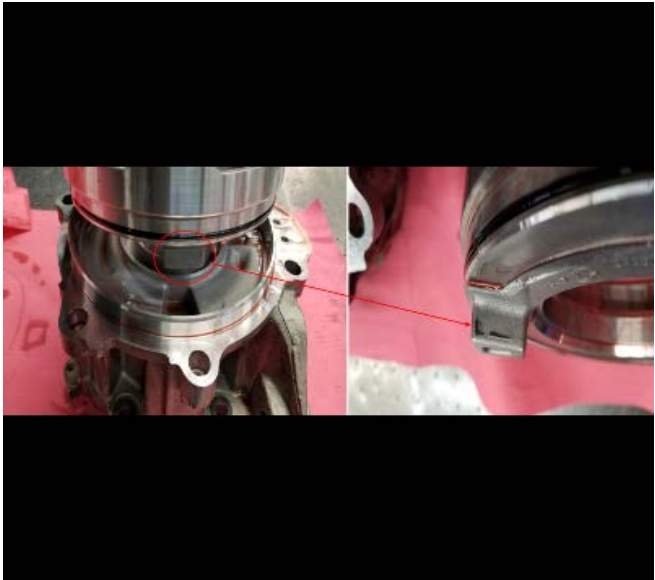
<p style="text-align: right;">6204566</p> <p>This triangle shaped boss on the 1-2-3-4-5-REV clutch piston acts as a stop, to not allow the piston to rotate when engaged. Over time, the boss will become polished on the side and matching marks will be in the area on the extension housing. Engineering has investigated and confirmed that the O-ring and boss markings have no ill effect on transmission shift quality.</p>
<p>Information</p>	<p>Note: Technicians should always road test vehicle in the same manner that the customer is defining in their concern when it can be done safely and in accordance with all State/ Provincial and Federal vehicle operating laws and within the speed limit as allotted by road conditions</p> <p>If the technician can duplicate the concern, an initial inspection of the vehicle should be performed first.</p> <ul style="list-style-type: none"> – Once the technician has verified there are no visible concerns or fluid leaks found, check service information (SI) for any bulletins on the concern: <ul style="list-style-type: none"> • Bulletin 22-NA-182 refers to possible twisted cooler lines that can cause a harsh shift concern. • Bulletin 16-NA-361 addresses customer concerns with an initial harsh 1-2 shift after the vehicle has sat for at least four hours. • Bulletin 22-NA-122 should also be reviewed for description and operation of the transmission. <p>If the technician cannot identify any obvious causes of the customers concern, the next step will be to verify the transmission fluid level is as specified in the service information, making sure to have the vehicle at the correct temperature according to the procedure outlined in SI.</p> <p>If the fluid level is correct, the technician should remove the transmission pan and inspect for debris in the fluid and on the magnets.</p> <p>If the technician finds excessive debris on the magnets, in the fluid, or signs of overheating, the transmission should be torn down and inspected to identify the cause.</p> <p>⇒ During tear down and inspection, clutch pack clearance should be measured and adjusted according to SI specifications. If needed, inspect the steels for excessive and uneven wear and replace as needed.</p> <p>Concerns related to a harsh or firm garage shift; the transmission endplay should be inspected and brought down as close to the tight end of the range, generally between 0.008"-0.012" should be acceptable.</p> <p>If there are signs of overheating, the technician should verify the TBV valve operation using a laser thermometer to measure inlet and outlet temperatures of the cooler by measuring the lines at different locations.</p> <p>If no debris is found, the transmission valve body should be replaced.</p>
