Service Bulletin

Bulletin No.: 19-NA-255

Subject: Wax Coating on Frame Peeling, Metal Shows Corrosion/Rusting (U.S. and Canada Only)

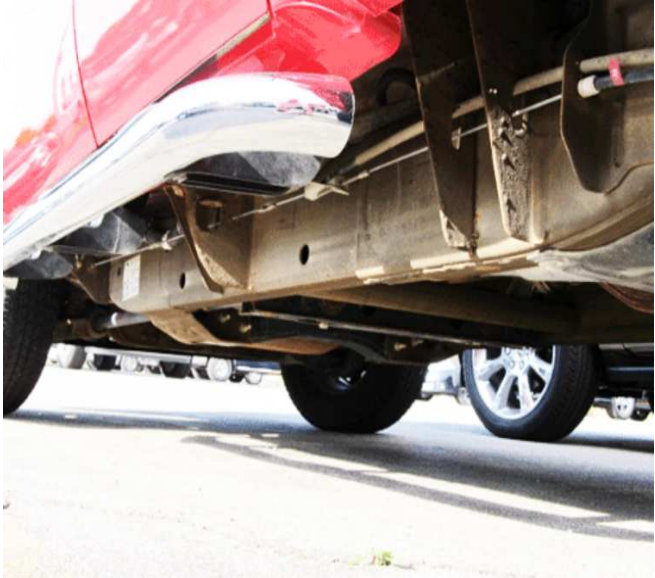
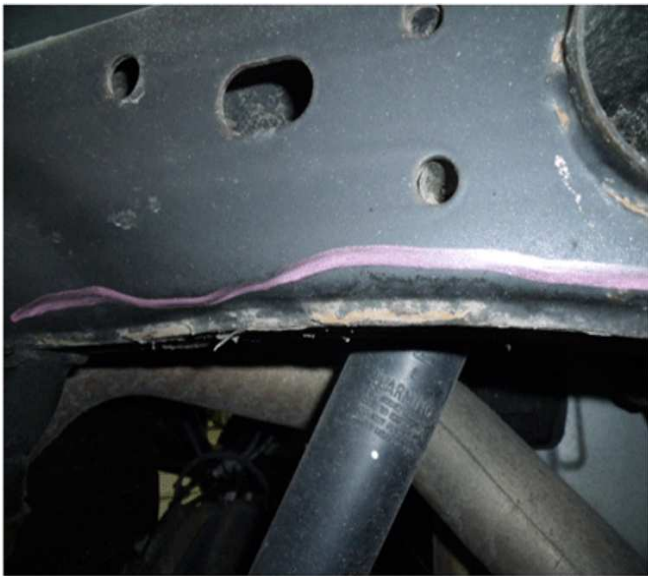
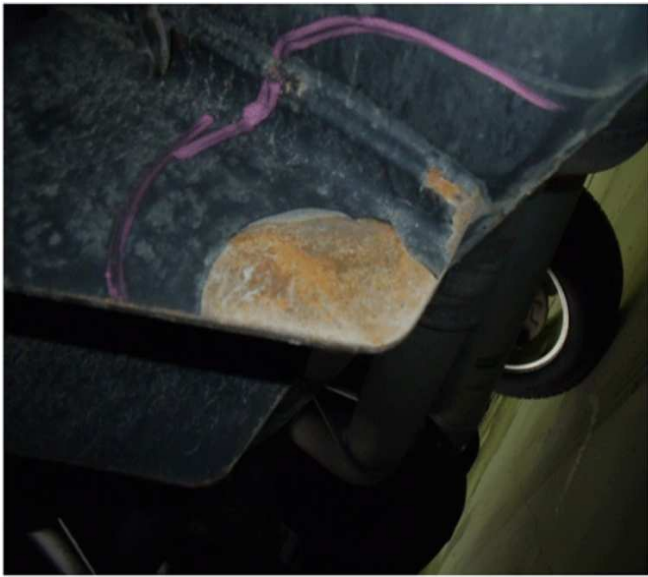
Involved Region or Country	North America, Europe, Middle East, Israel, Palestine, Chile, Columbia, Ecuador, Paraguay, Peru, Uruguay, Japan, S Korea, China, Taiwan, Thailand, Africa and Egypt, Russia, Uzbekistan, S. Africa, Australia and New Zealand.
Condition	<p>Some customers may comment that areas of the frame wax coating are peeling off and rust/corrosion is visible on the metal in these areas. Several examples of this condition are shown in each group of graphics below.</p> <p>Truck Example Photos</p>

<p>Cause</p>	<p>The cause of this condition may be that the frame supplier may not have properly prepped the metal before the wax coating was applied.</p>
<p>Correction</p>	<p>Note: A combination of specialized metal coating products manufactured by Lloyds and Daubert have been found to be the most suitable products to provide corrosion control and protection to address this type of repair. Our recommendation is to prep the metal surface using *Lloyd's Pure Prep™ Metal Surface Preparation P/N 25418, then topcoat with both *Lloyds Kryptonite™ Metal Treatment* - P/N 36500 High Temp Satin Black 455 ml (16 oz), and *Daubert Non-Rust® P/N X-121B One Coat Rust Preventative Coating. It is strongly recommended they be applied according to the manufacturer's procedures.</p> <p>*We believe this source and their products to be reliable. There may be additional manufacturers of such products/materials. General Motors does not endorse, indicate any preference for, or assume any responsibility for the products or material from this firm or for any such items that may be available from other sources.</p> <p>Prep the frame and apply the Lloyds and Daubert coatings following the steps in the Service Procedure below:</p>

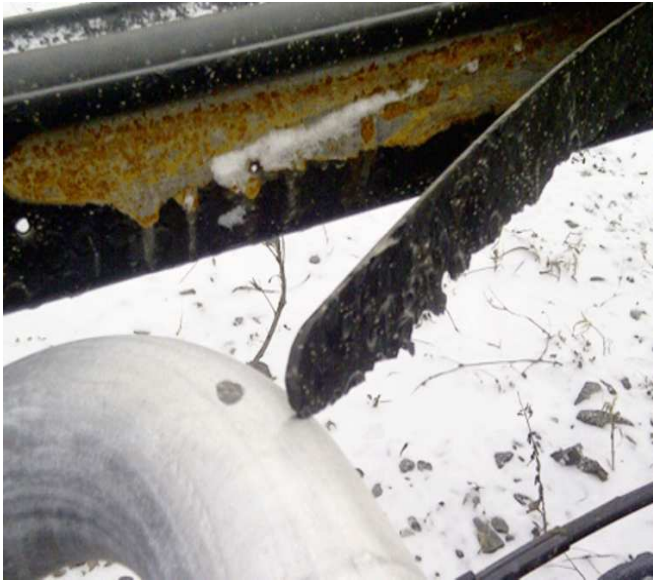
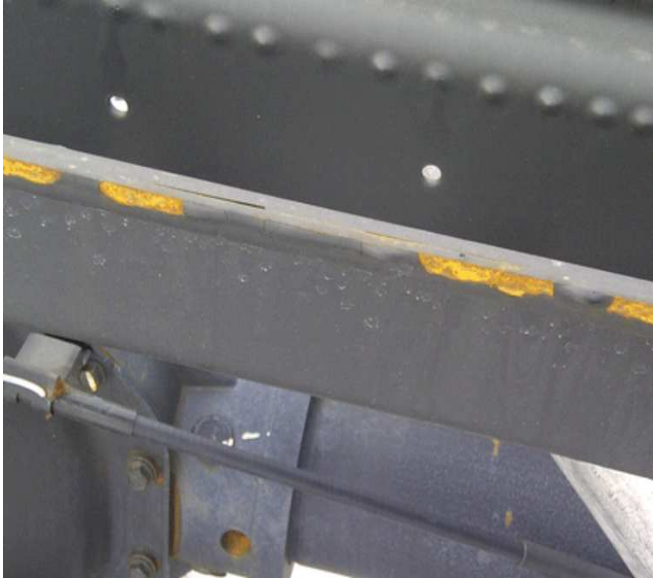
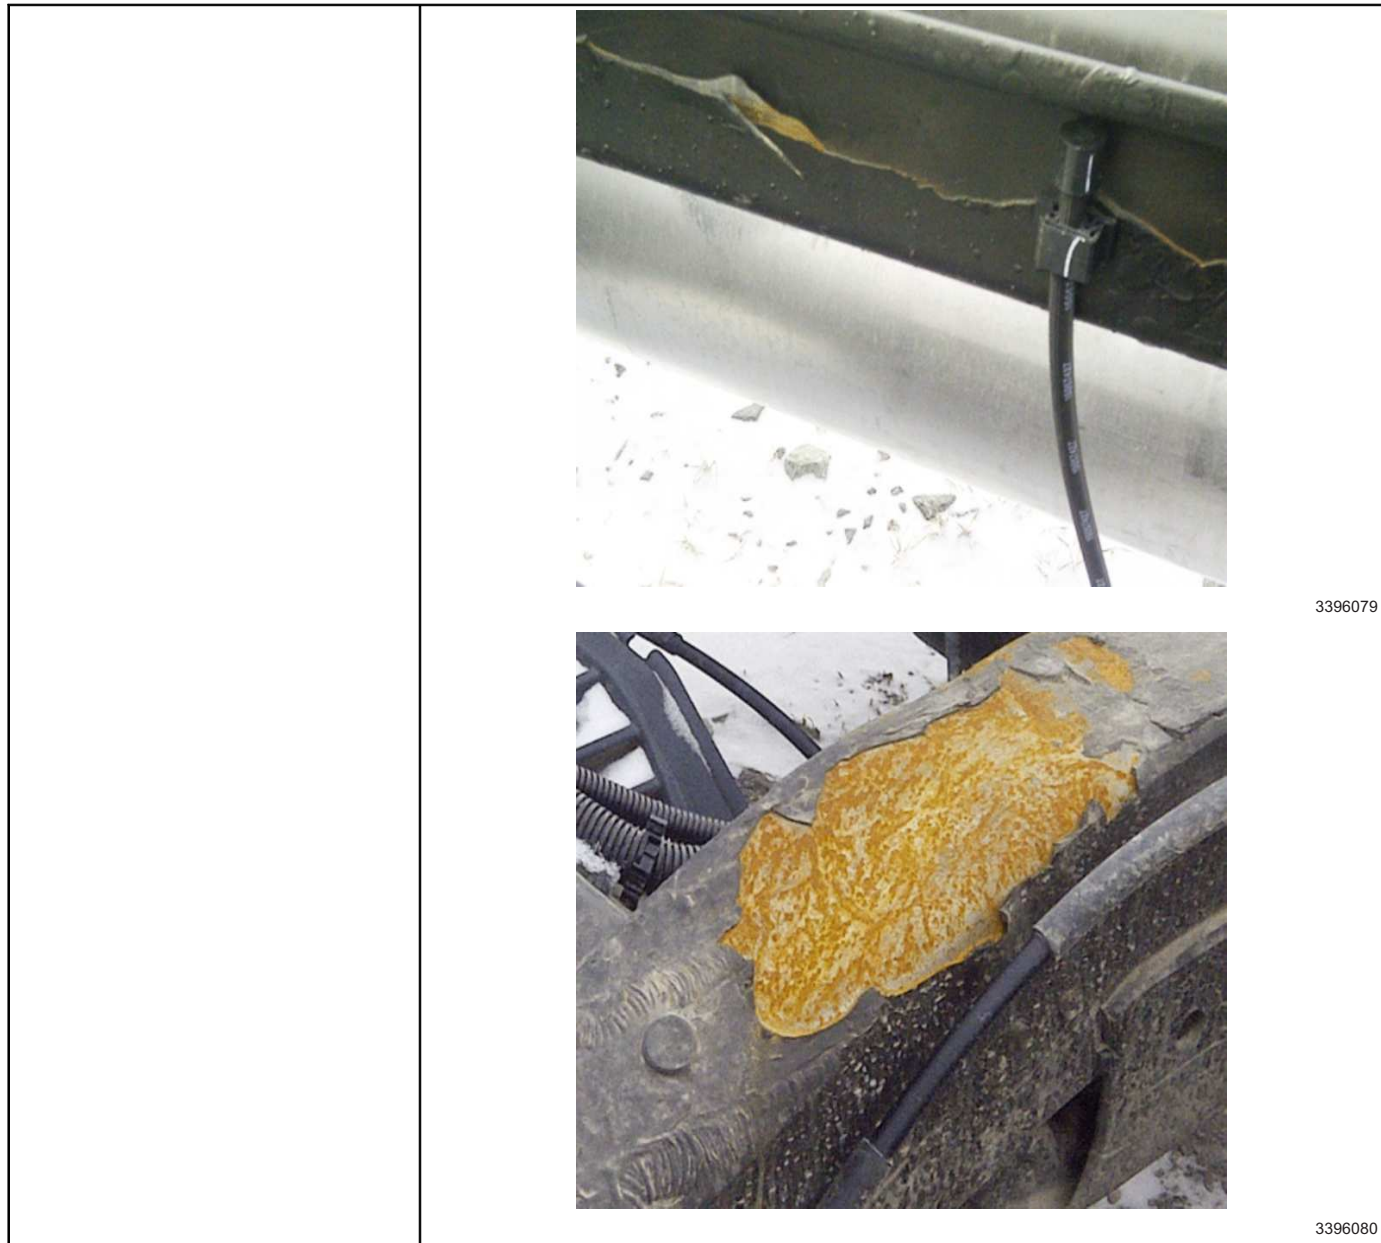
Van Example Photos
