# TECHNICAL SERVICE BULLETIN

## Rear Bumper Cover To Quarter Panel Poor Fitment And/Or Excessive Body Gap - Built On Or Before 04-Dec-2023

23-2434

Ford 2024 Mustang	Built on or before 04-Dec-2023
----------------------	--------------------------------

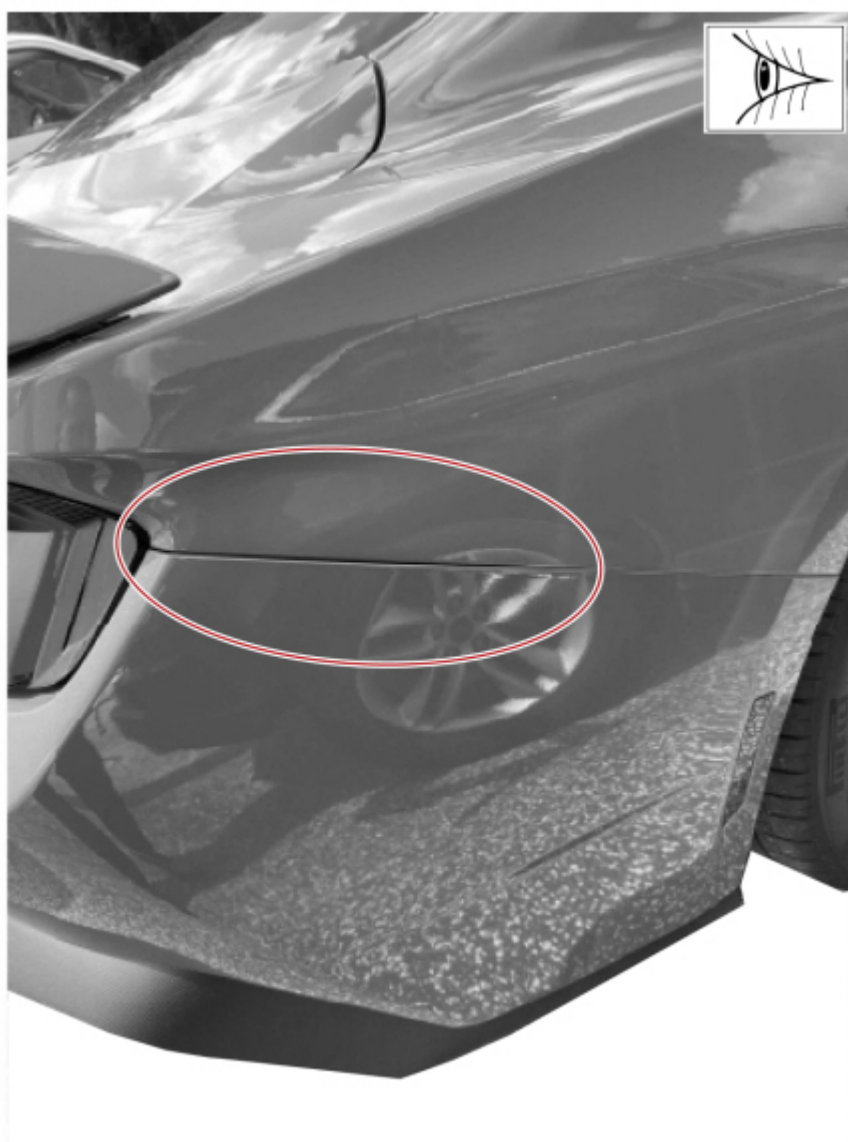
Figure 1

**Issue:** Some 2024 Mustang vehicles built on or before 04-Dec-2023 may exhibit a condition where the rear bumper cover has poor fitment and/or excessive body gap where it meets the quarter panel. This may be due to incorrect installation and/or poor attachment to the bumper support bracket. To correct this condition, follow the Service Procedure to replace the rear bumper cover side bracket with revised versions.

1. Does the rear bumper cover have poor fitment and/or excessive body gap where it meets the quarter panel as shown in Figure 1?
