Service Bulletin

Bulletin No.: 23-NA-046

Subject: Power Windows and/or Mirrors Inoperative, Power Seat Movement Inoperative and/or Moving on Its Own, Side Object Detection Inoperative and/or Unwanted Activation, Power Door Lock Cycle Inoperative, Keyless Entry Inoperative - DTC B3125, B3130 and/or B3135 Set

Brand:	Model:	Model Year:		VIN:		Engine:	Transmission:
		from	to	from	to		
Chevrolet	Equinox	2018	2024				
GMC	Terrain		2020				
Holden	Equinox

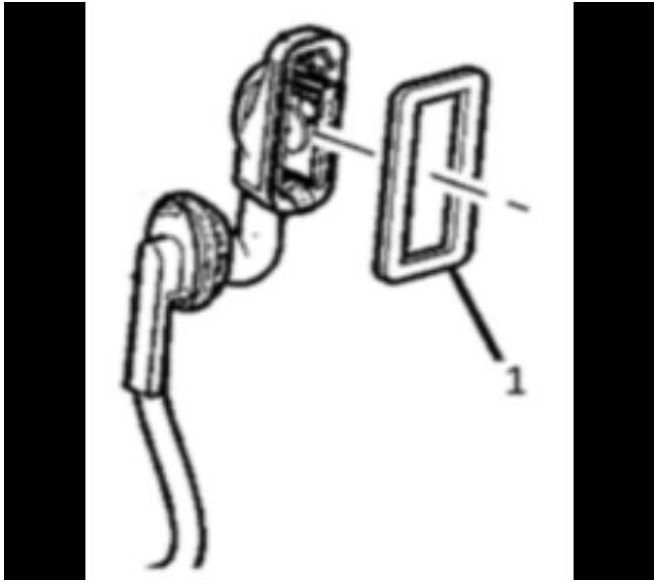
<p>6298254</p> <p>There are adhesive-backed foam seals at the X500/X600 connector locations on the lower "A" hinge pillars.</p> <p>– If the foam seal (1) is distorted, damaged or missing, replace the seal.</p>
-------------------	--

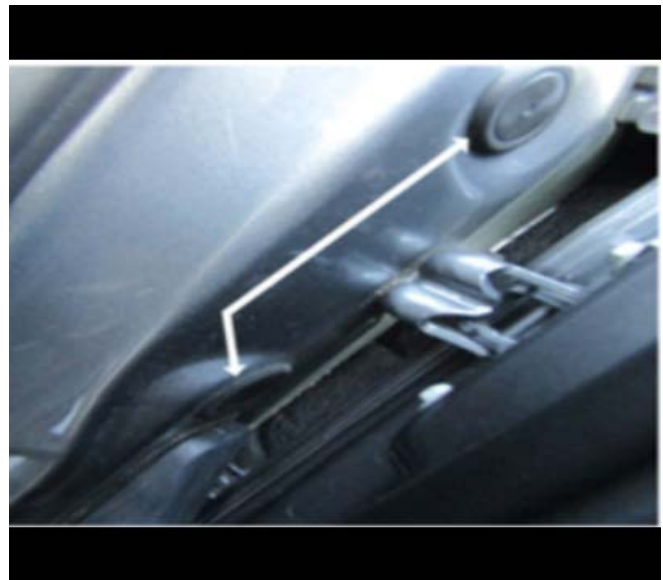
6298256

Evaluate the body plug(s) located in the "A" hinge pillar above door harness to body connectors X500 and/or X600, are seated and sealing properly.
